Landscape work issues (not a comprehensive list)

Fuel Modification Zones and Storm Water

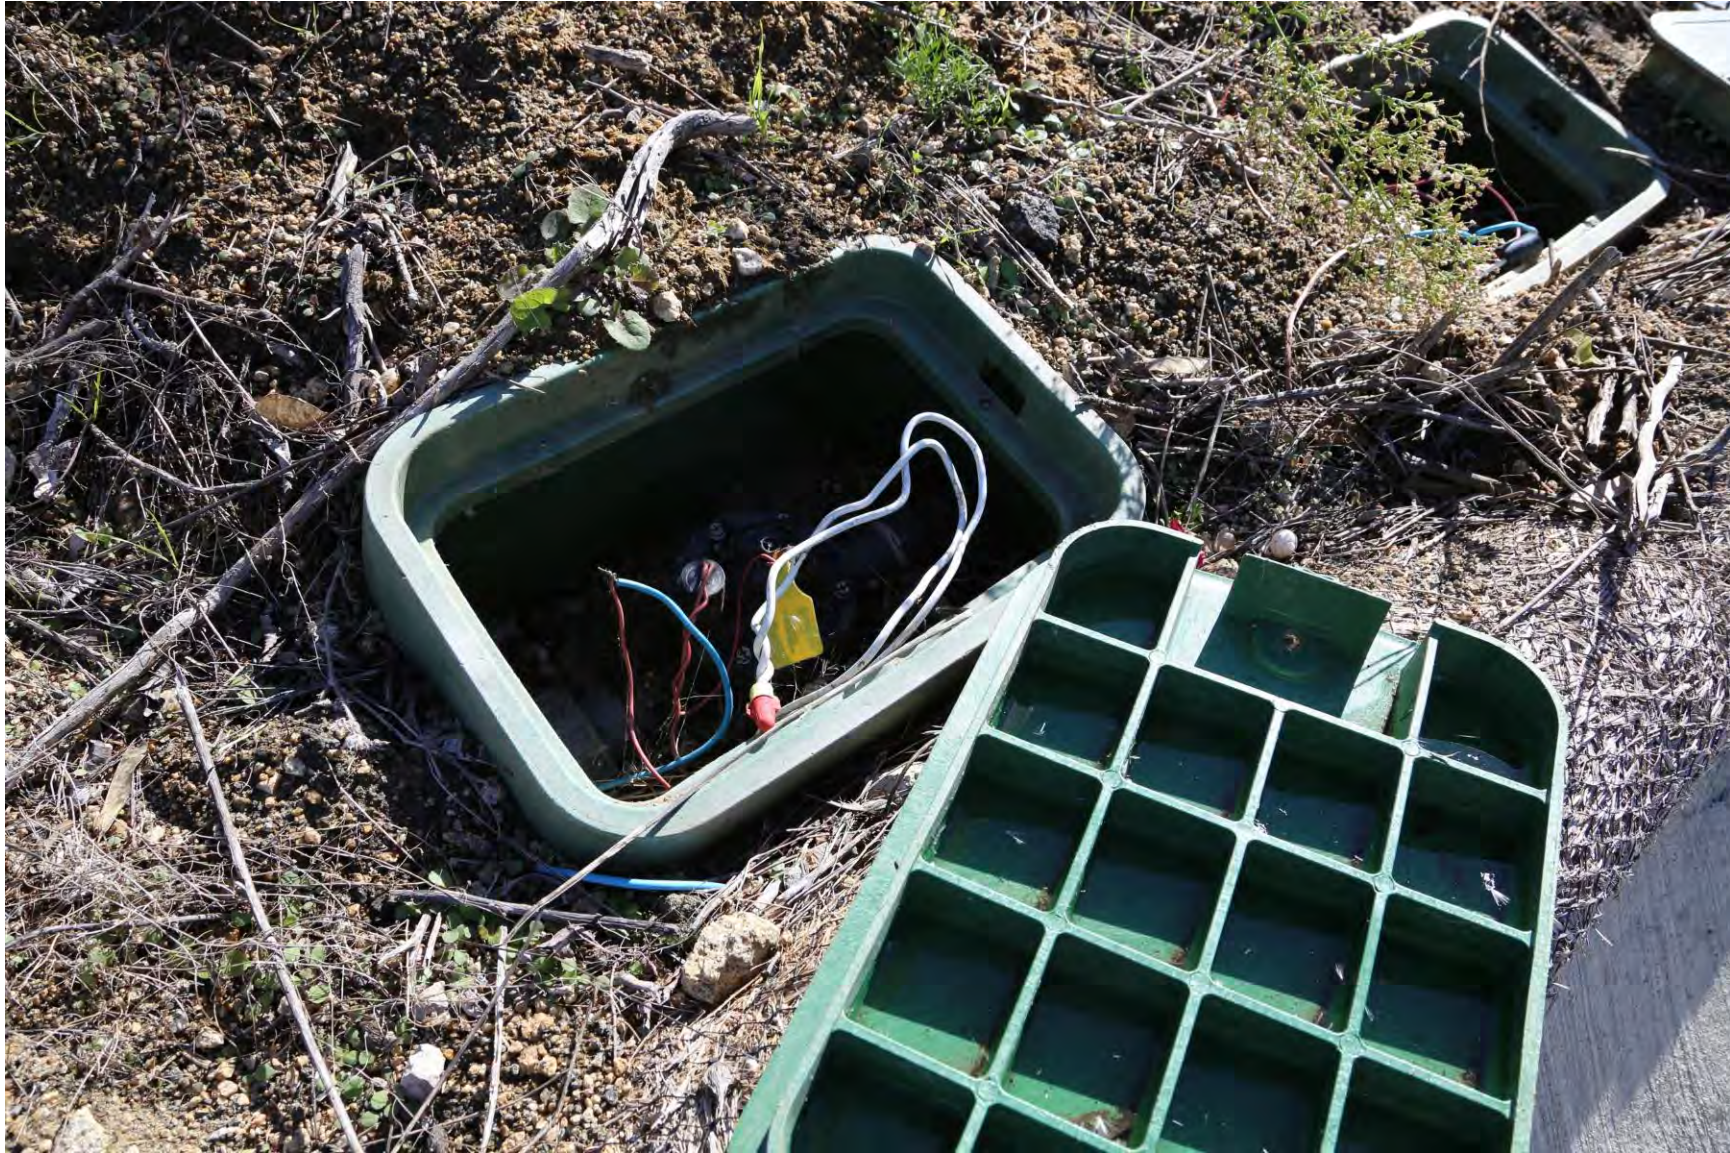
Many irrigation utility boxes are open

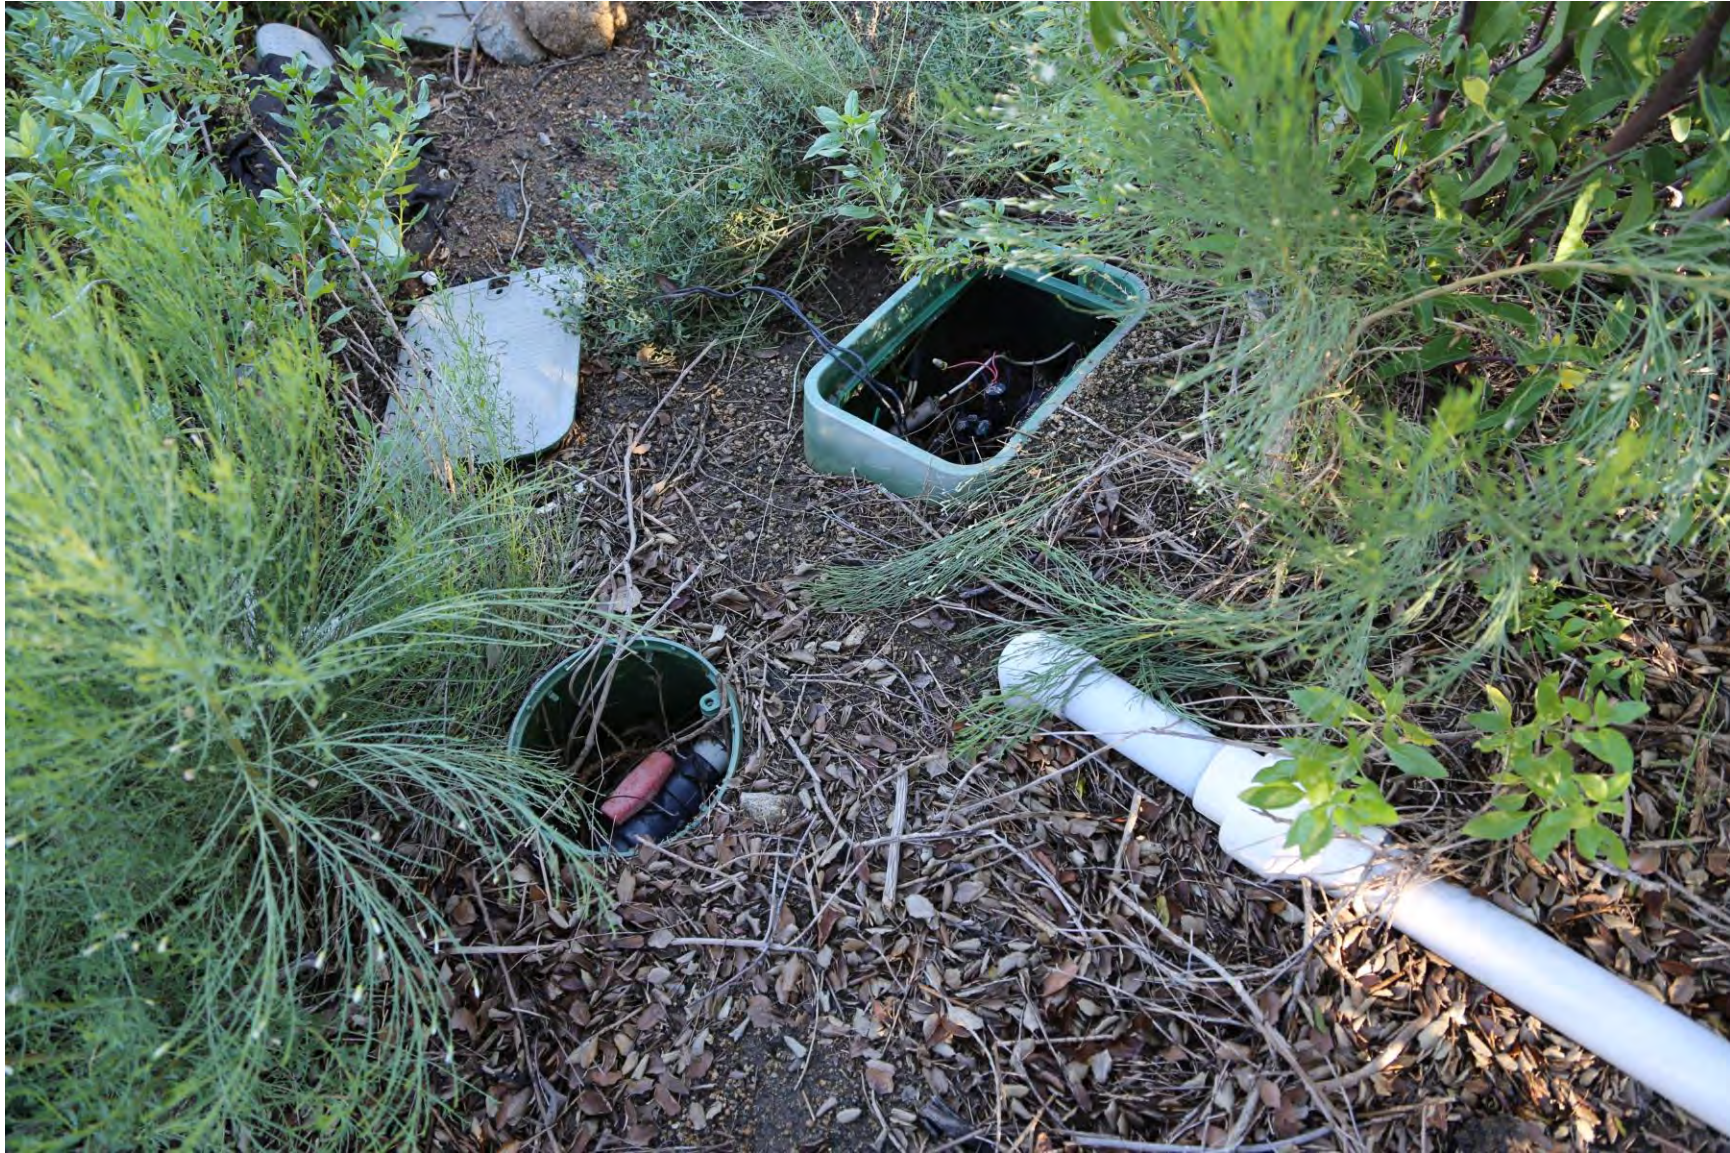
Many irrigation utility boxes are open

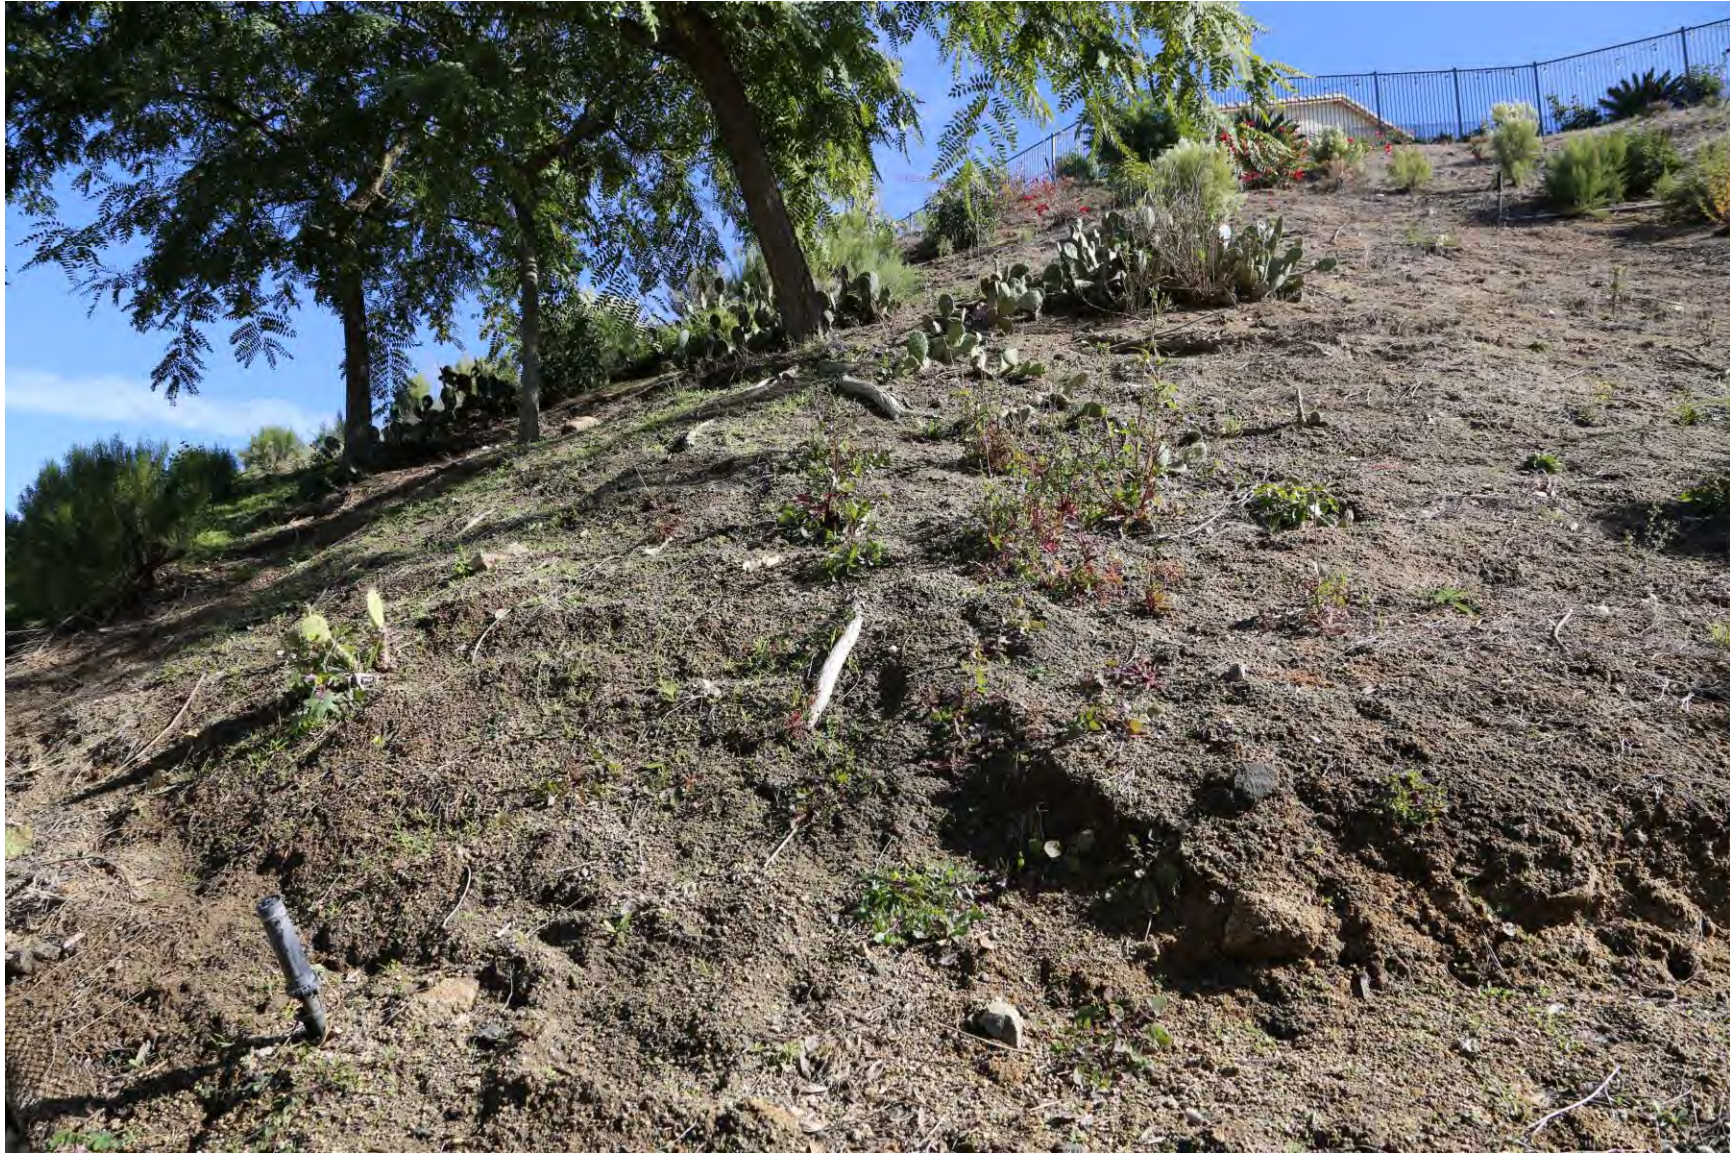
Exposed ground, erosion, failed hydroseed (gap in irrigation at the top), tree roots exposed

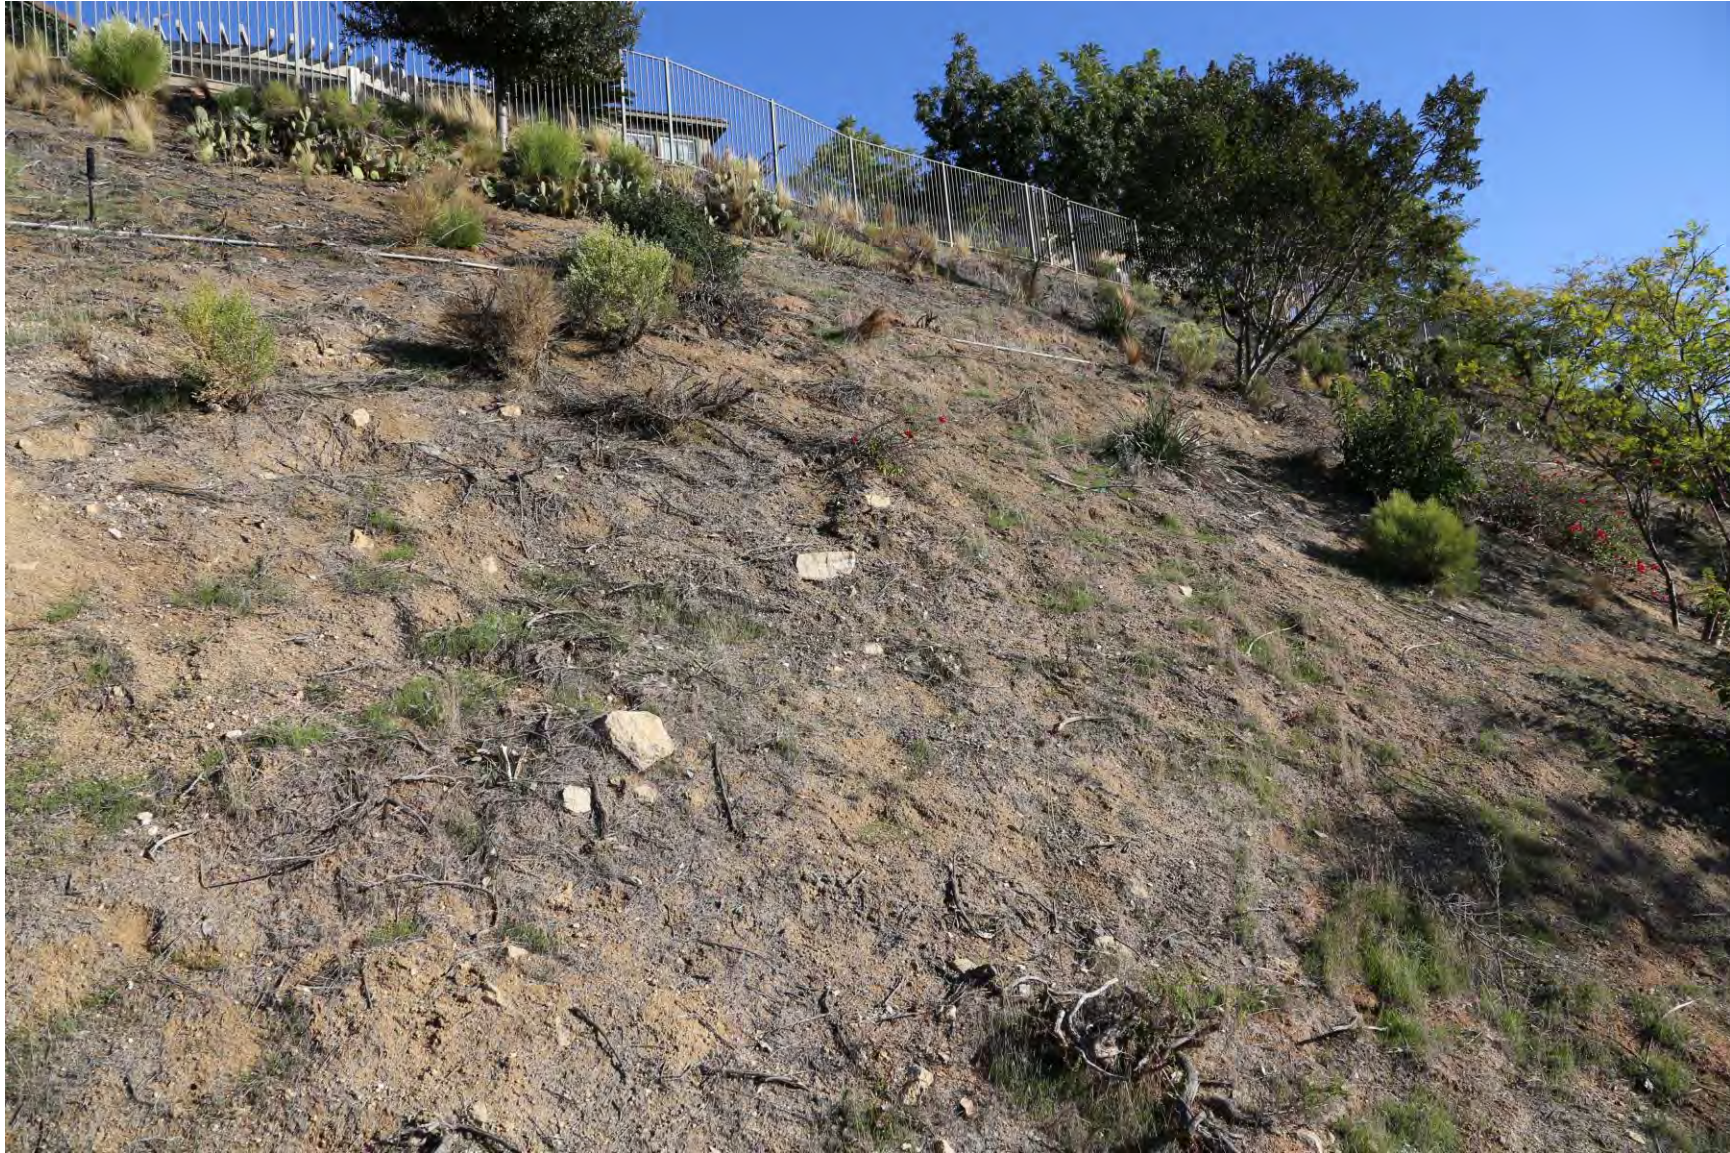
Exposed ground

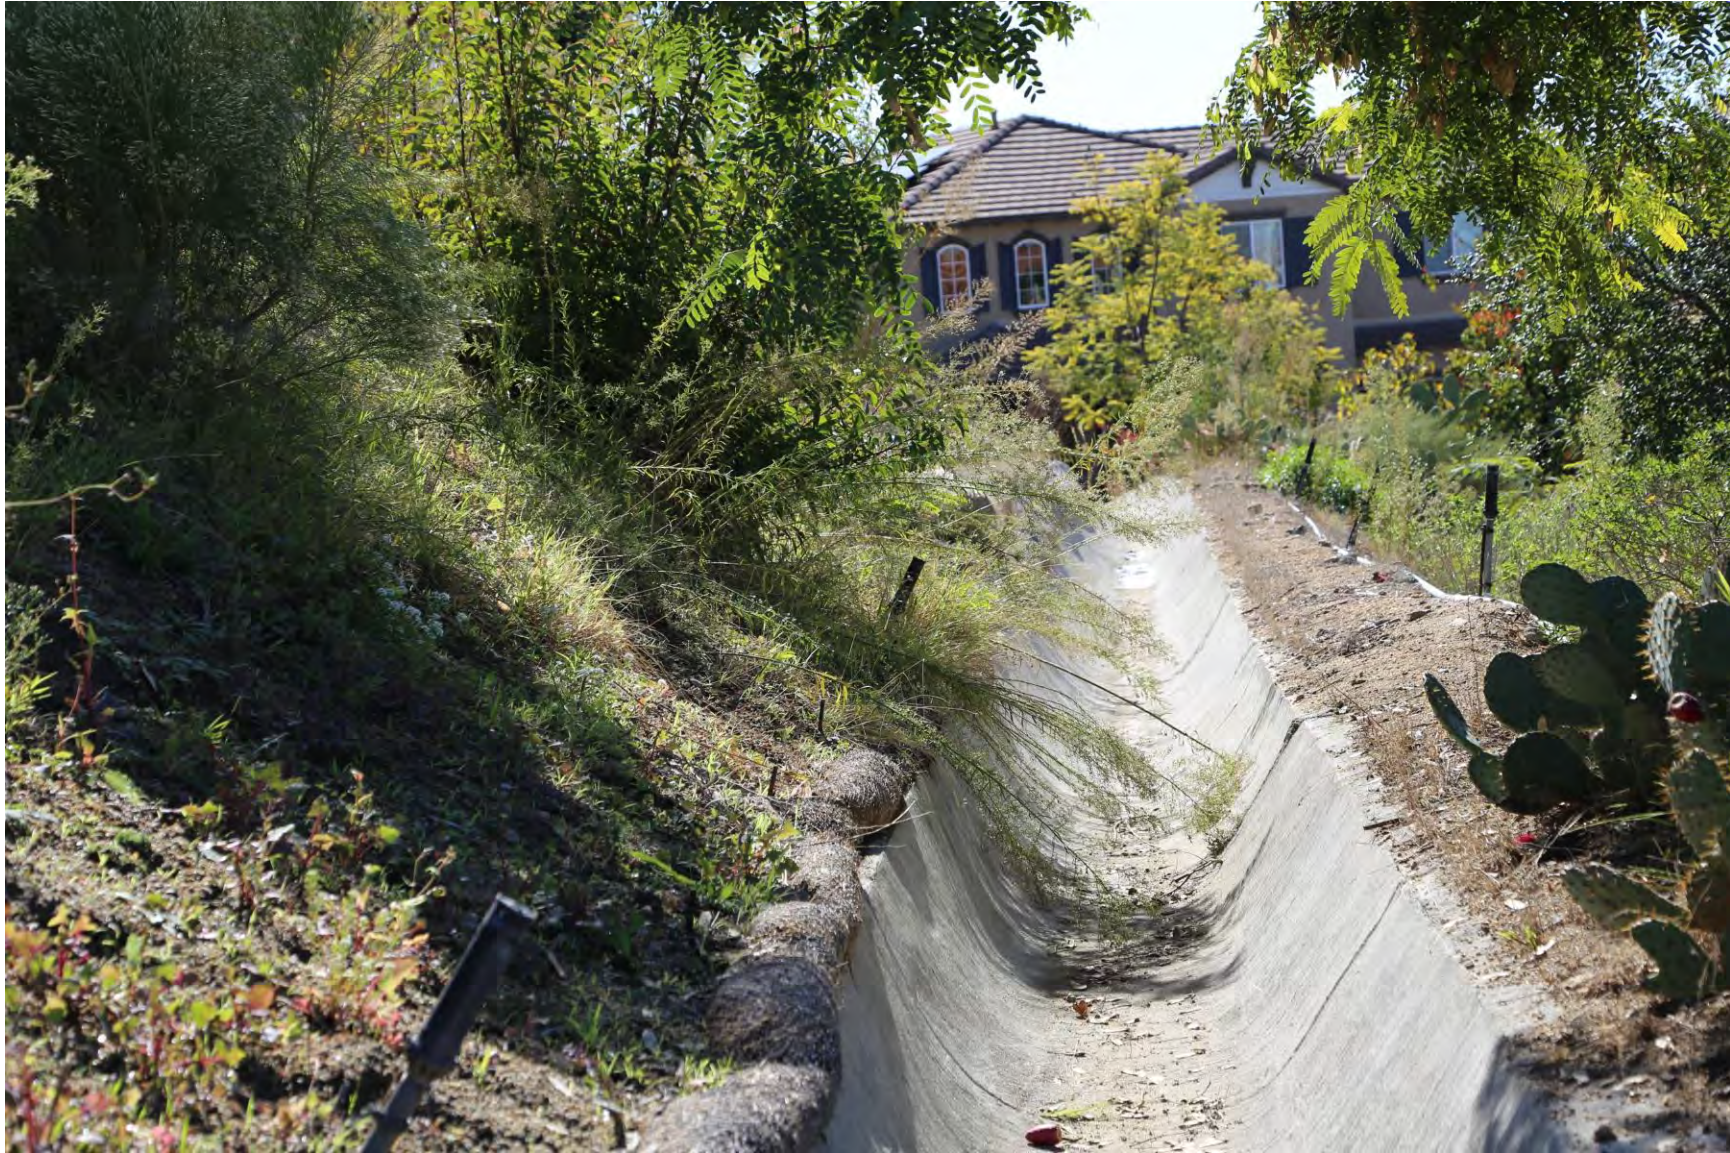
Sprinkler blocked, plants not trimmed, Sumac far taller than 24”

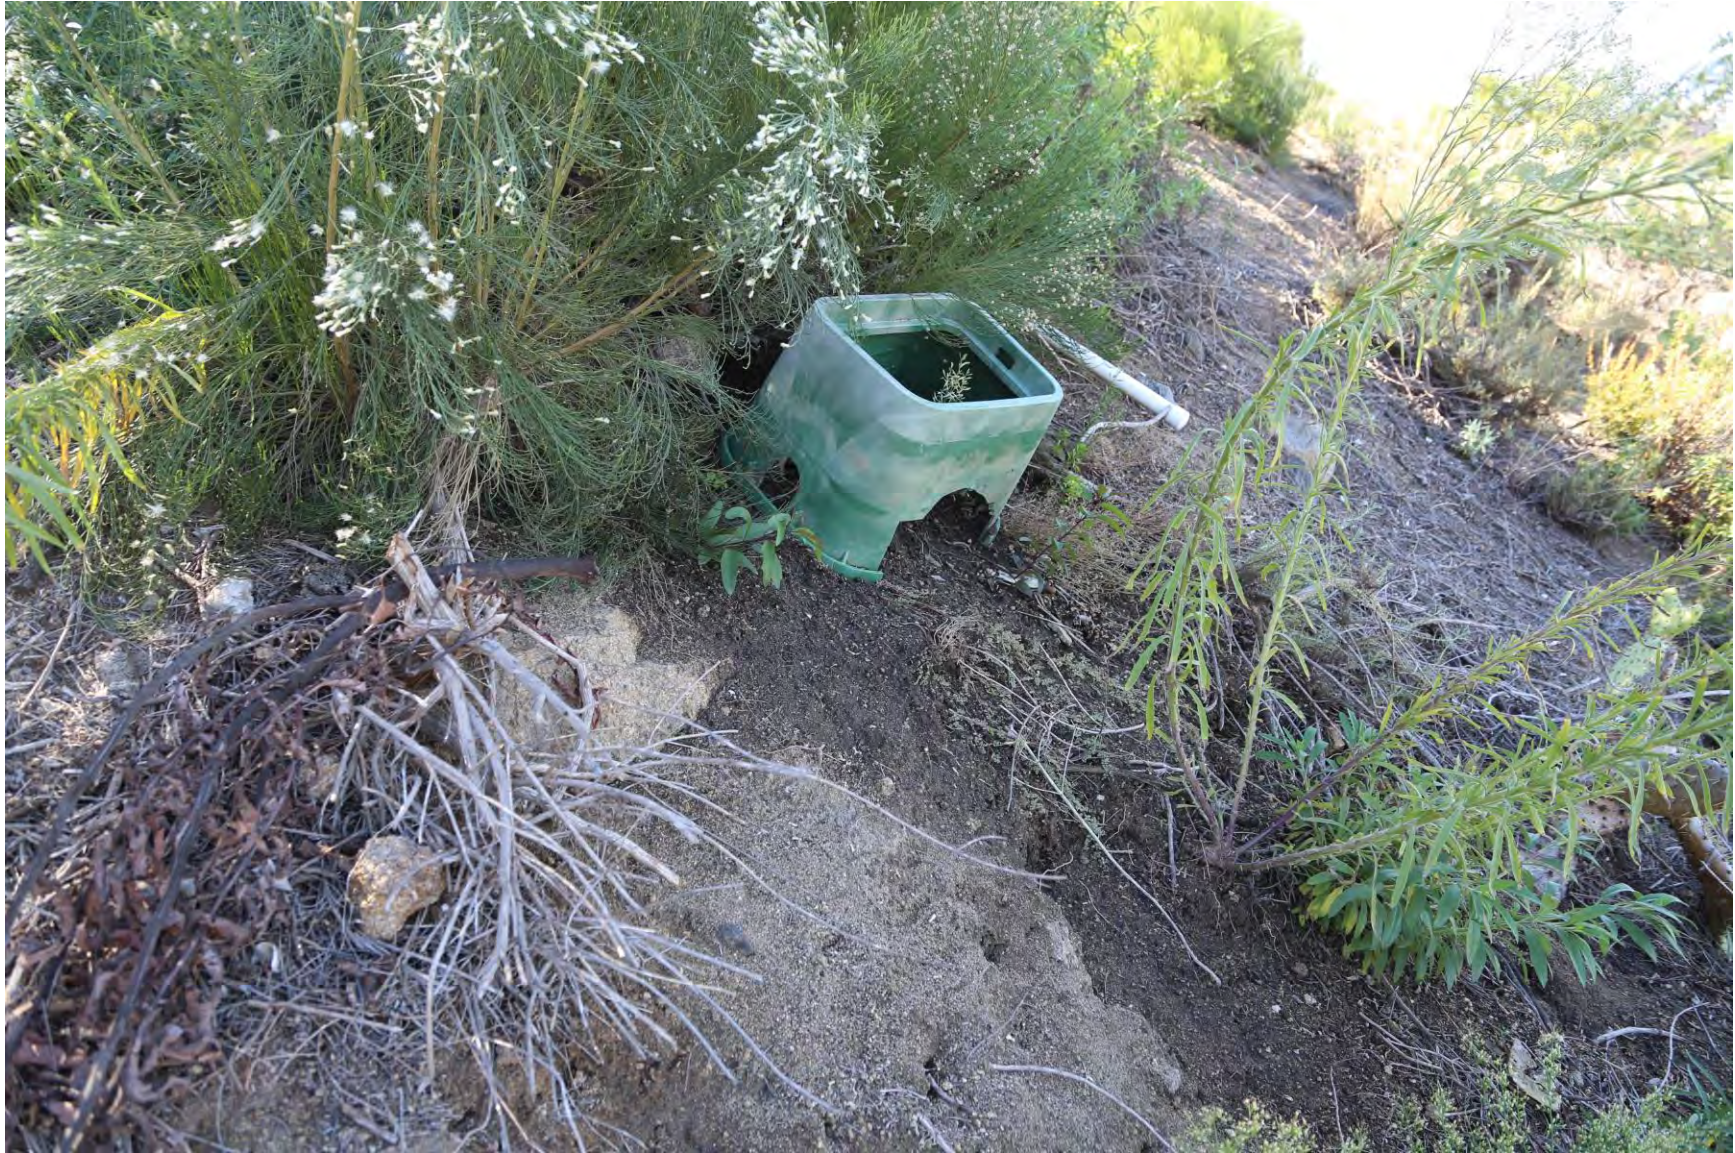
Equipment and cuttings discarded

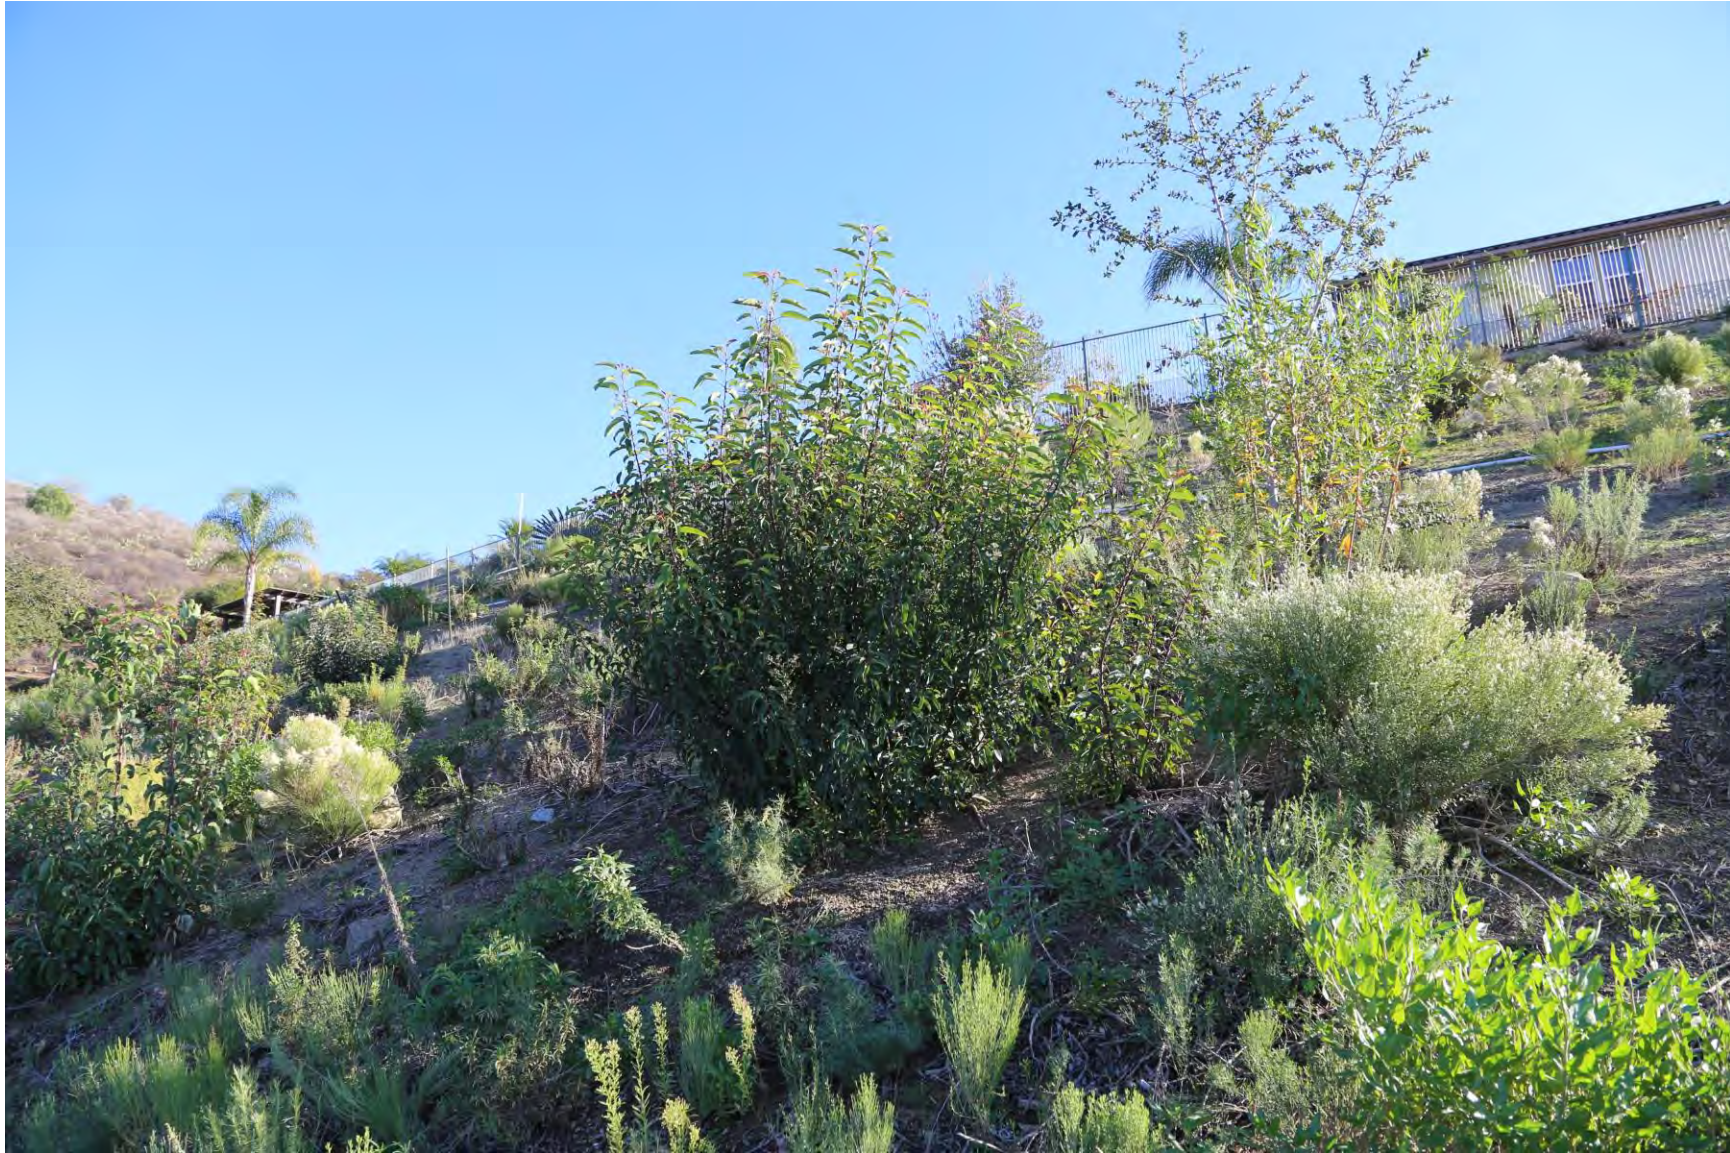
Sumac excessive height

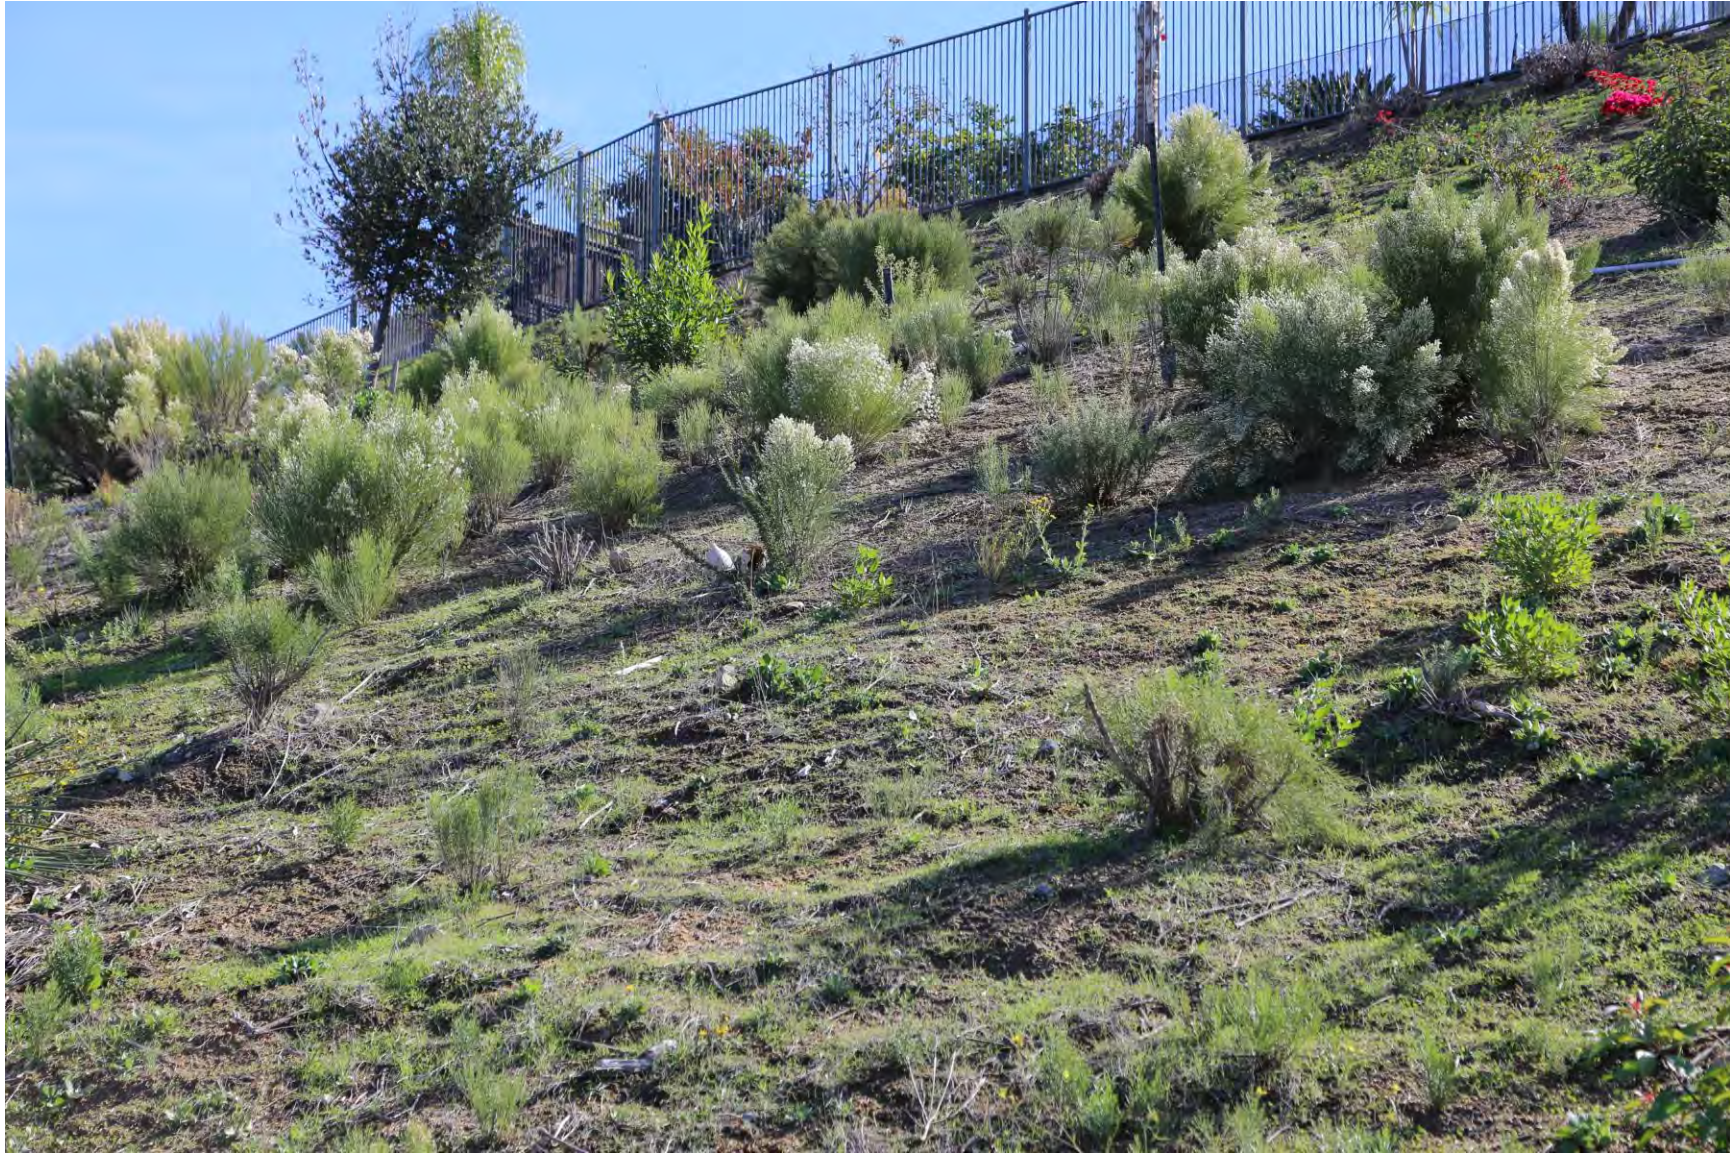
Mostly native brush

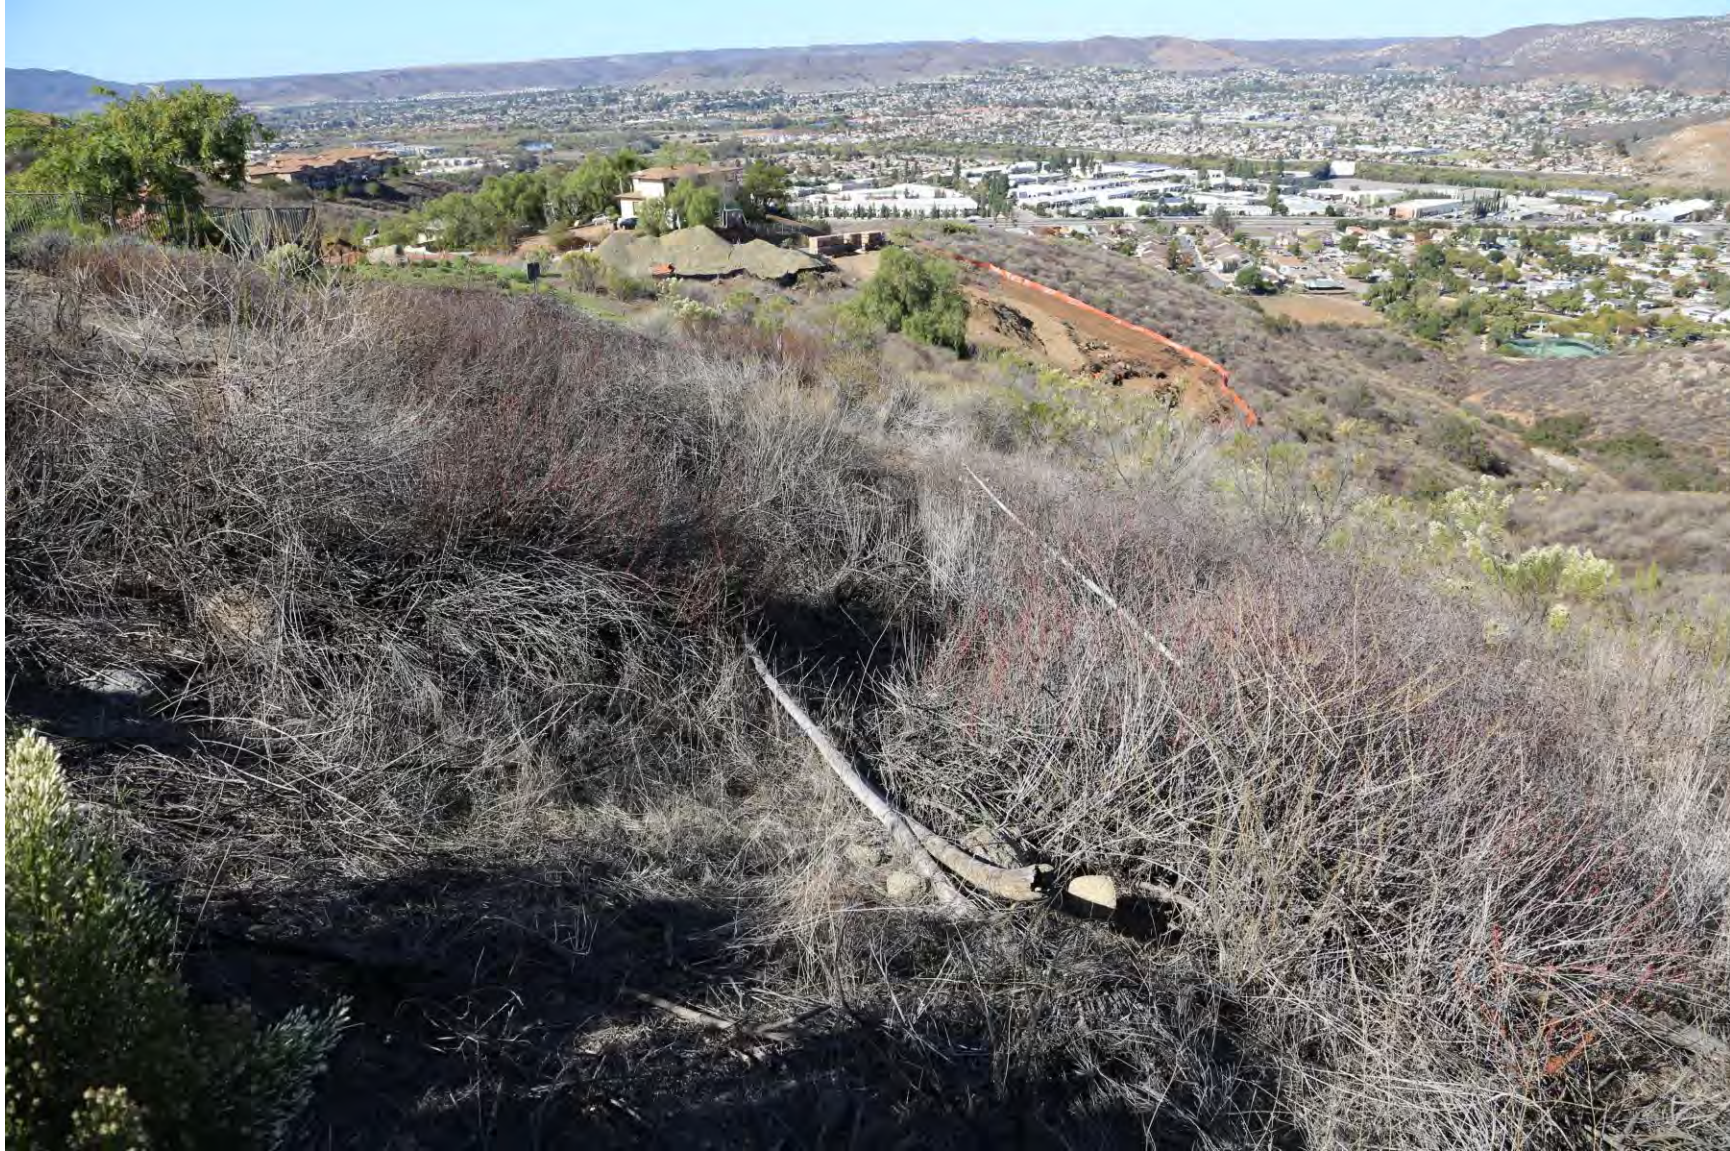
Dead brush and debris in FMZ

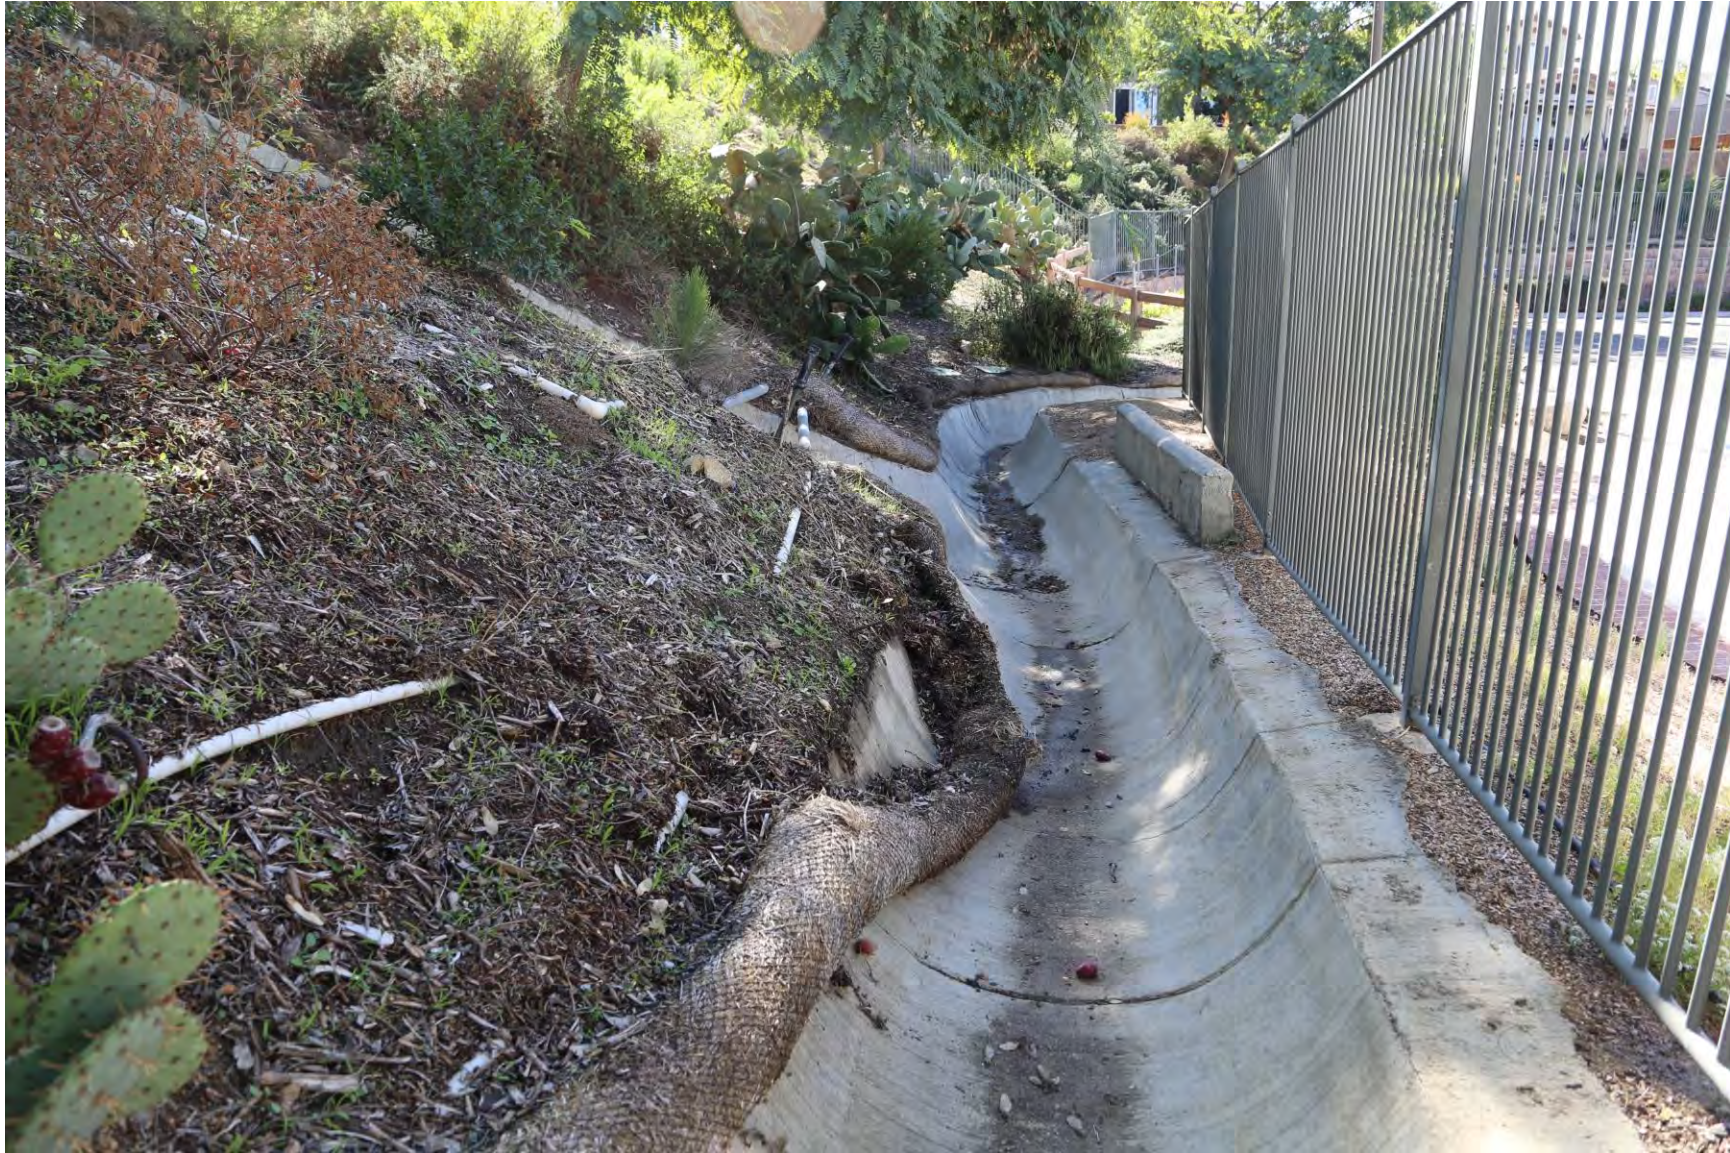
Dead plants, erosion, straw wattle falling along the entire length of the swale

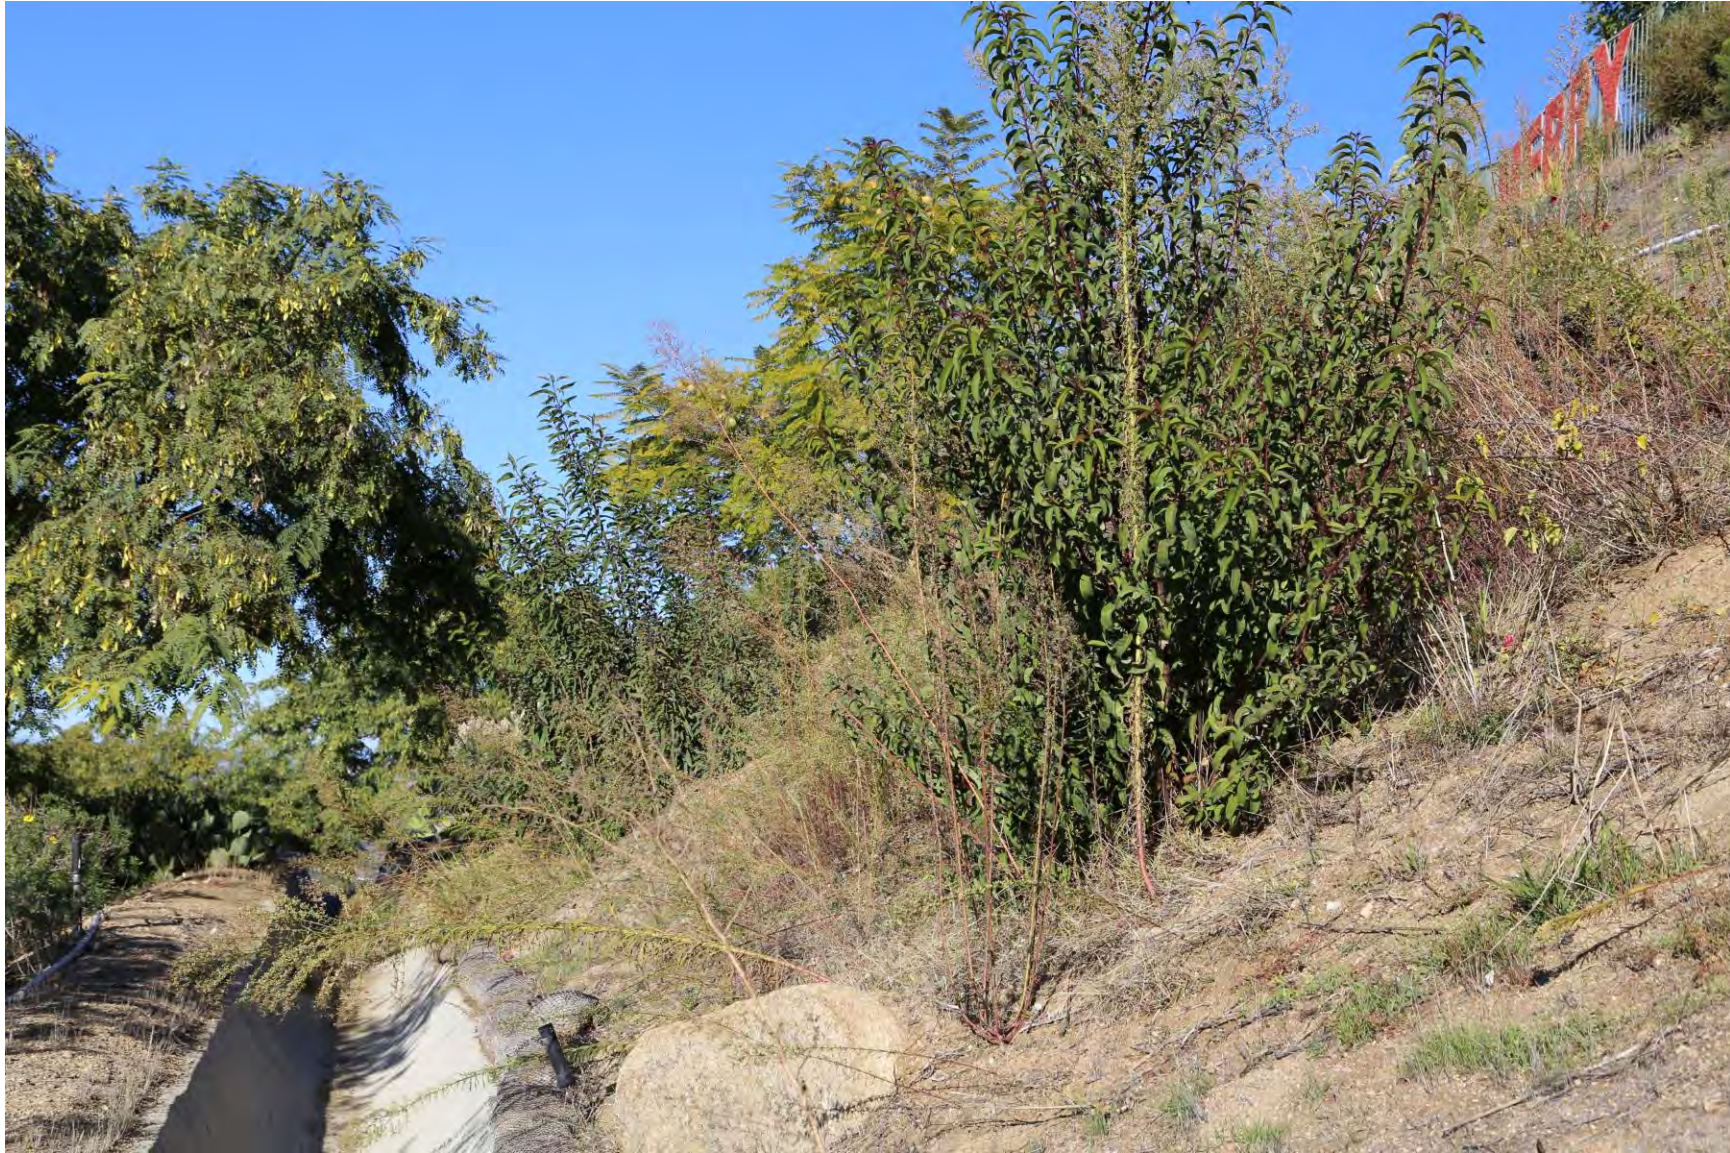
Sumac excessive height, plants massed together
