Landscape work issues (not a comprehensive list)

Fuel Modification Zones and Storm Water

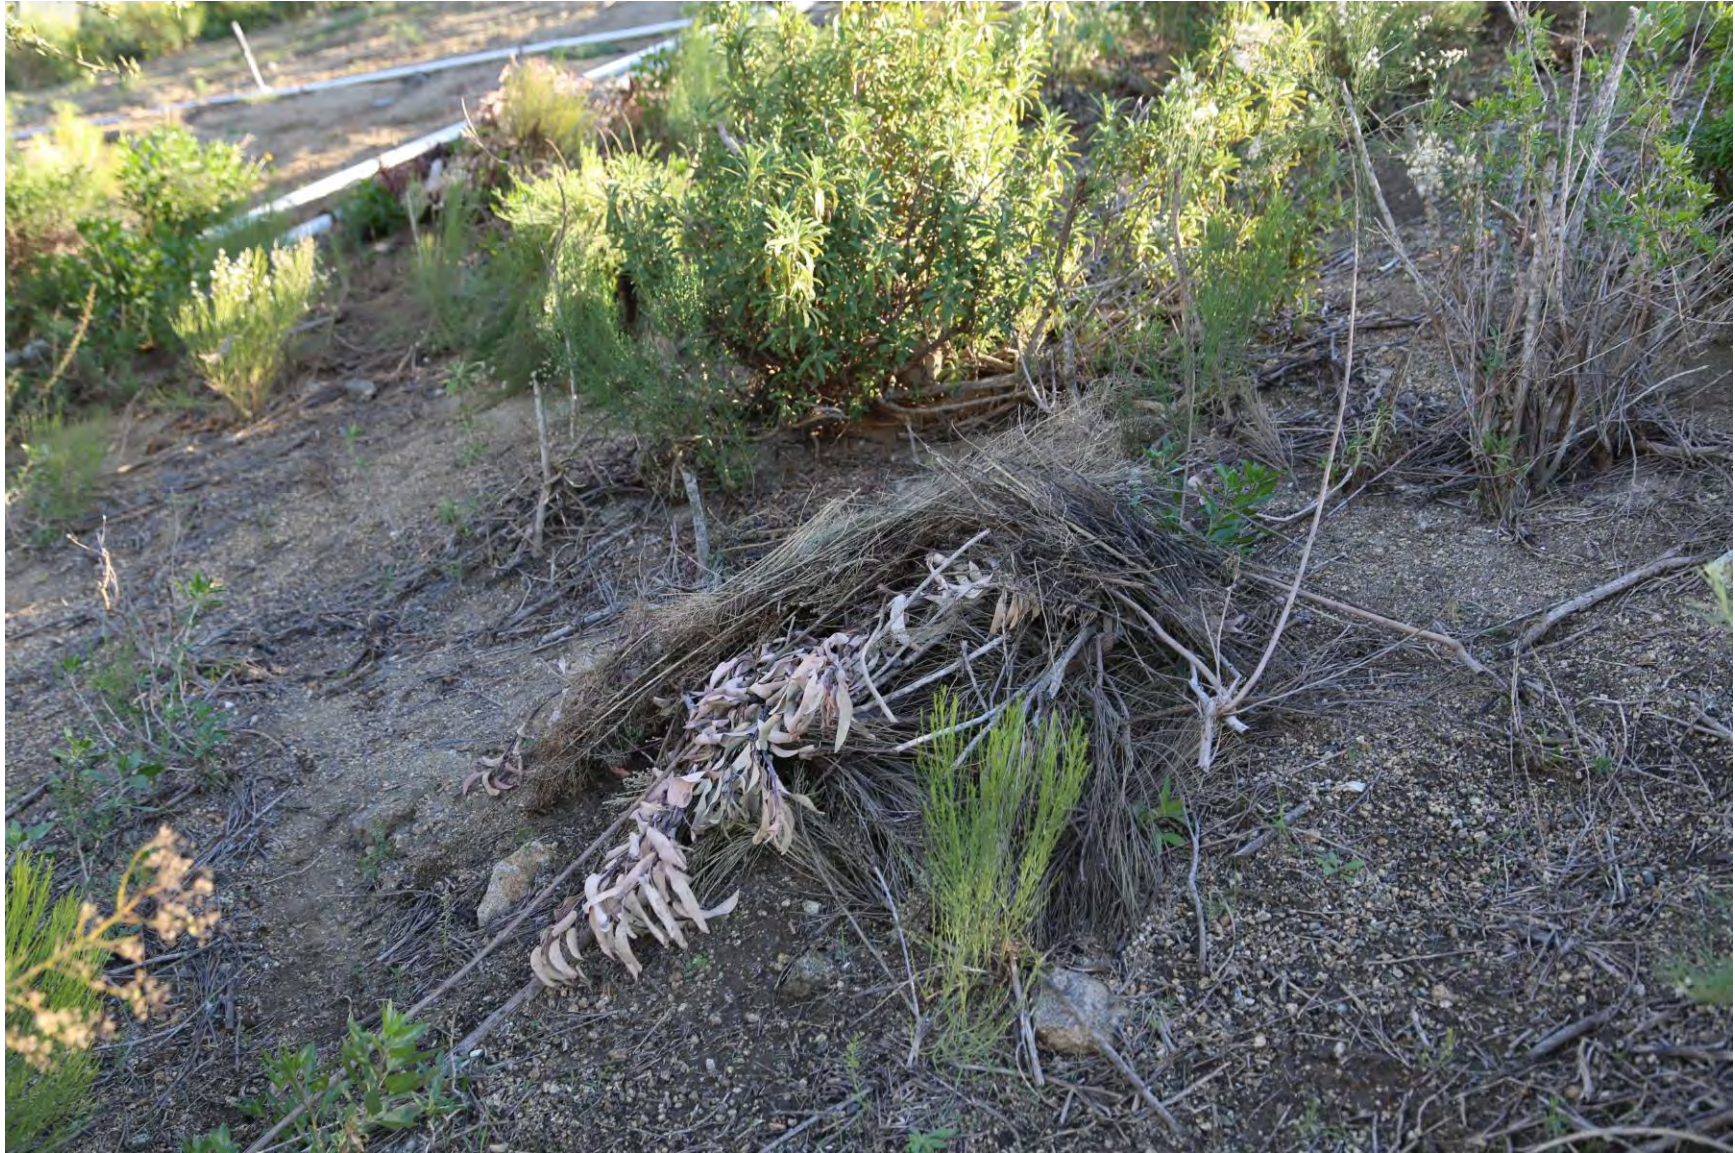
Plant cuttings discarded

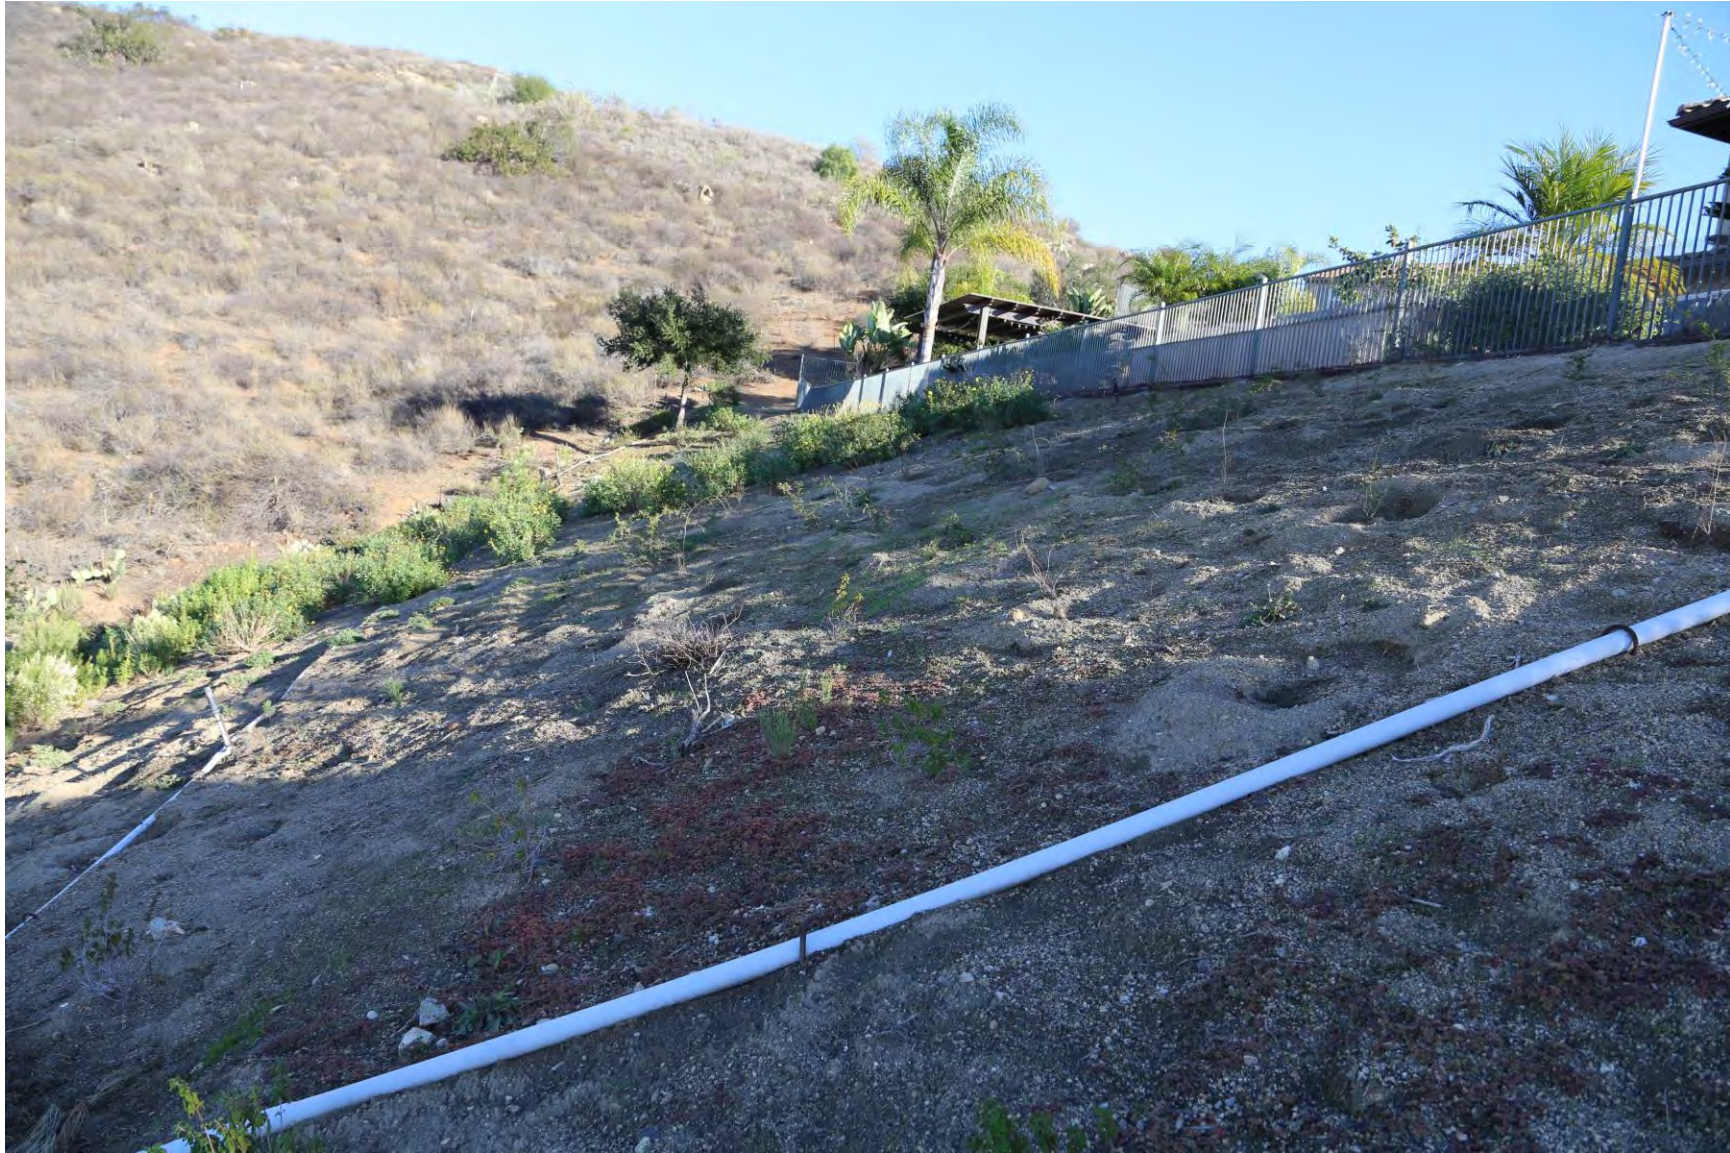
Failed shrub plantings

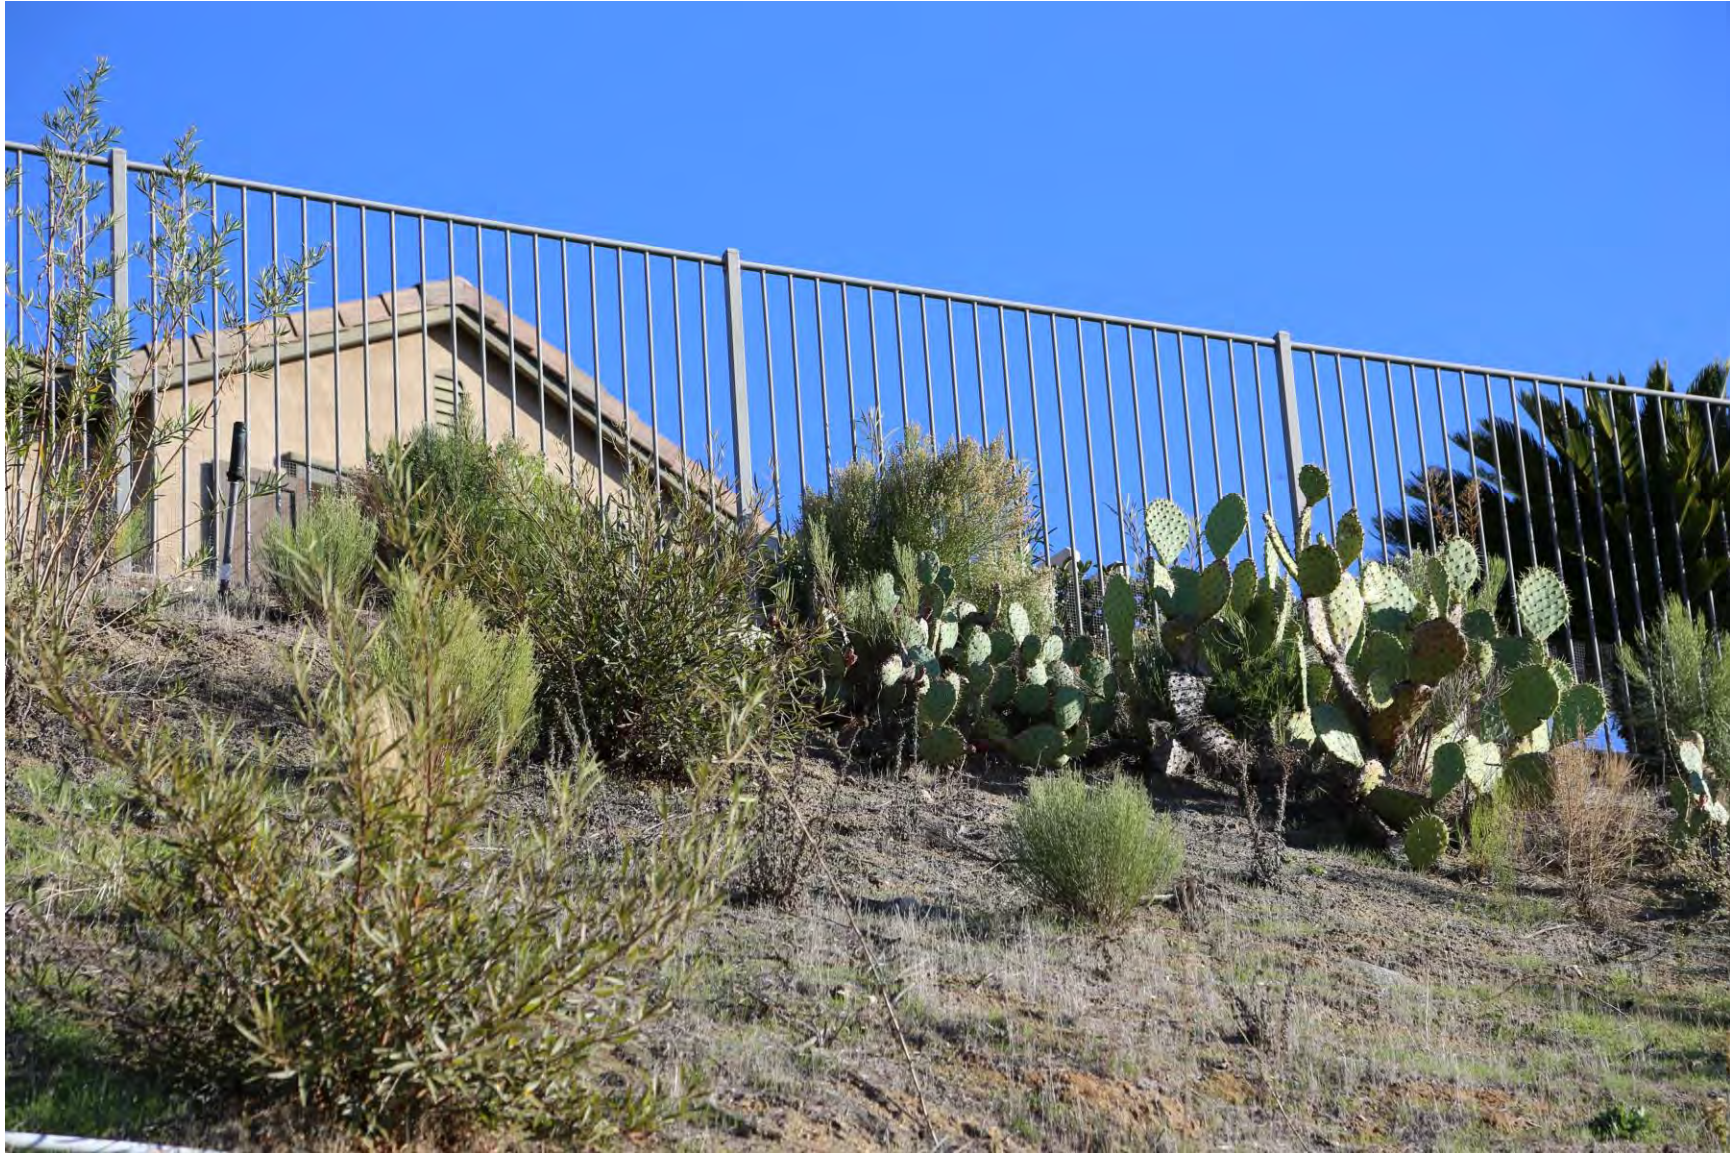
Fences not cleared by 18"

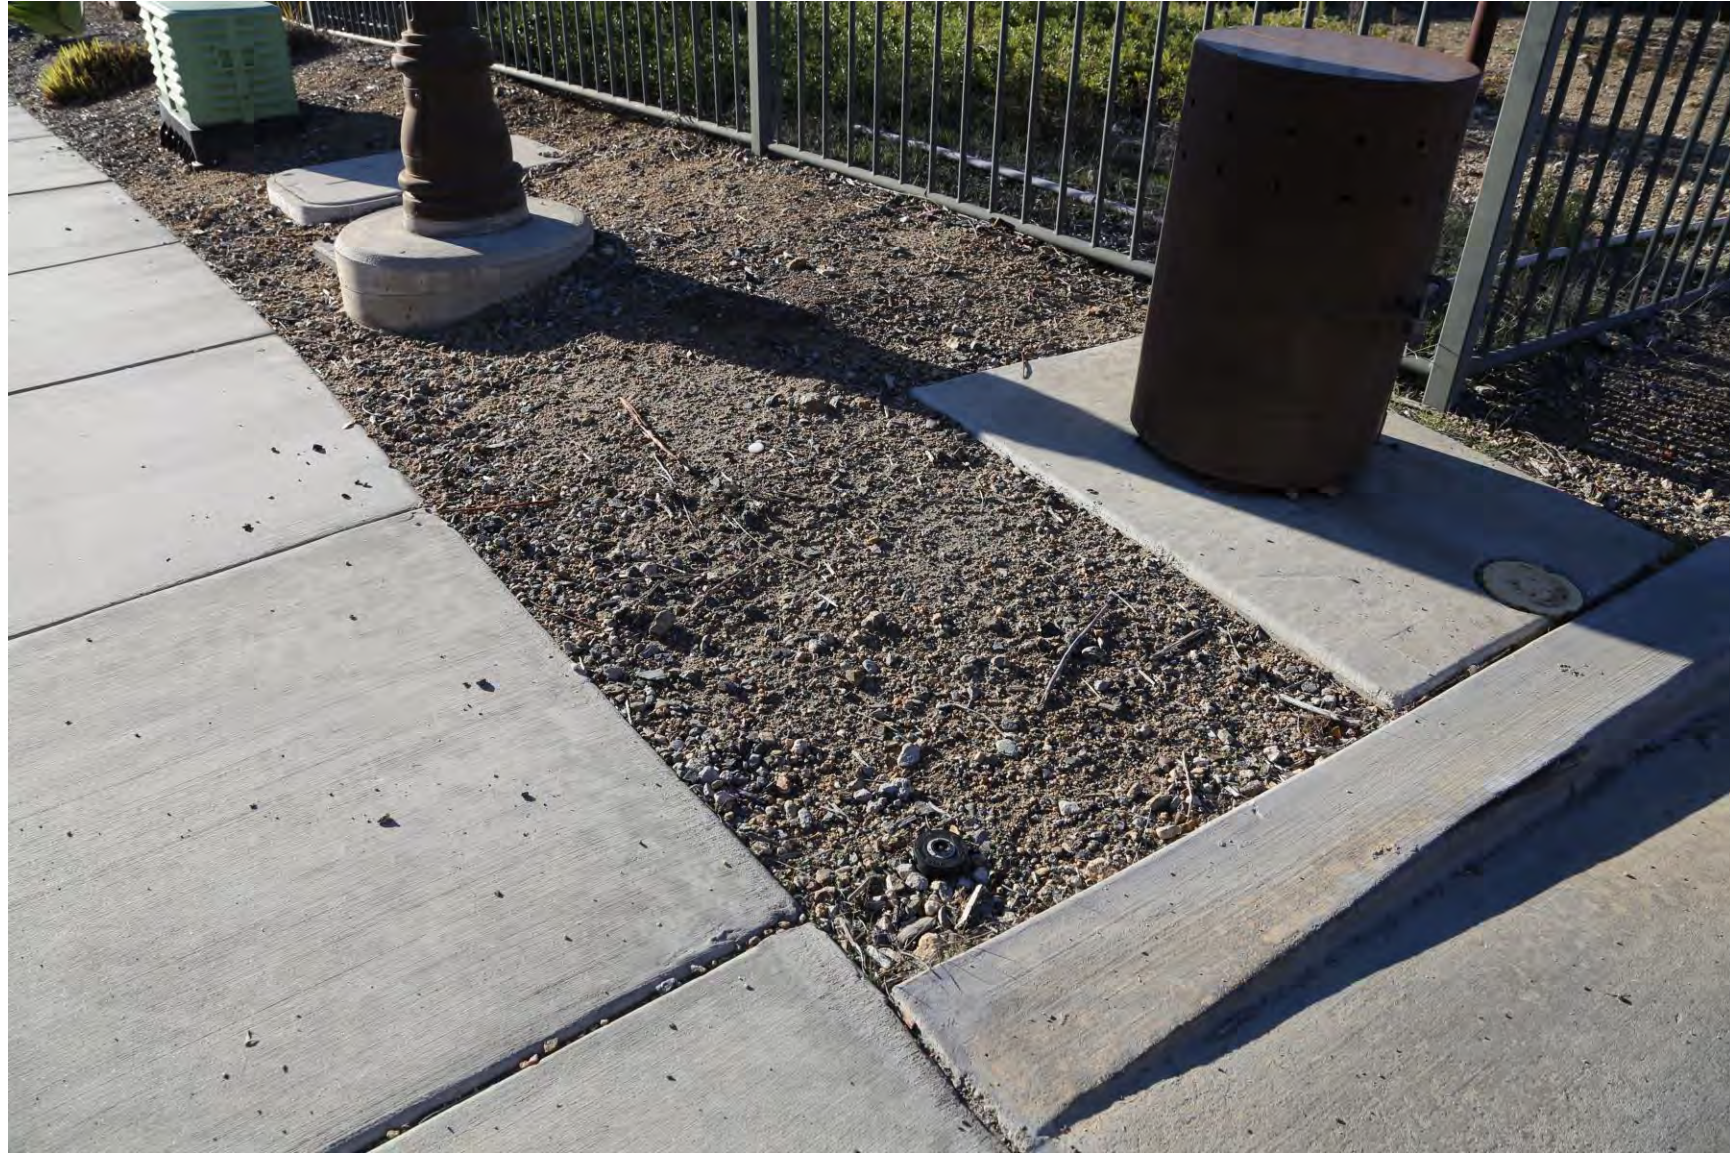
Exposed ground, sprinkler to nowhere, shrub gone

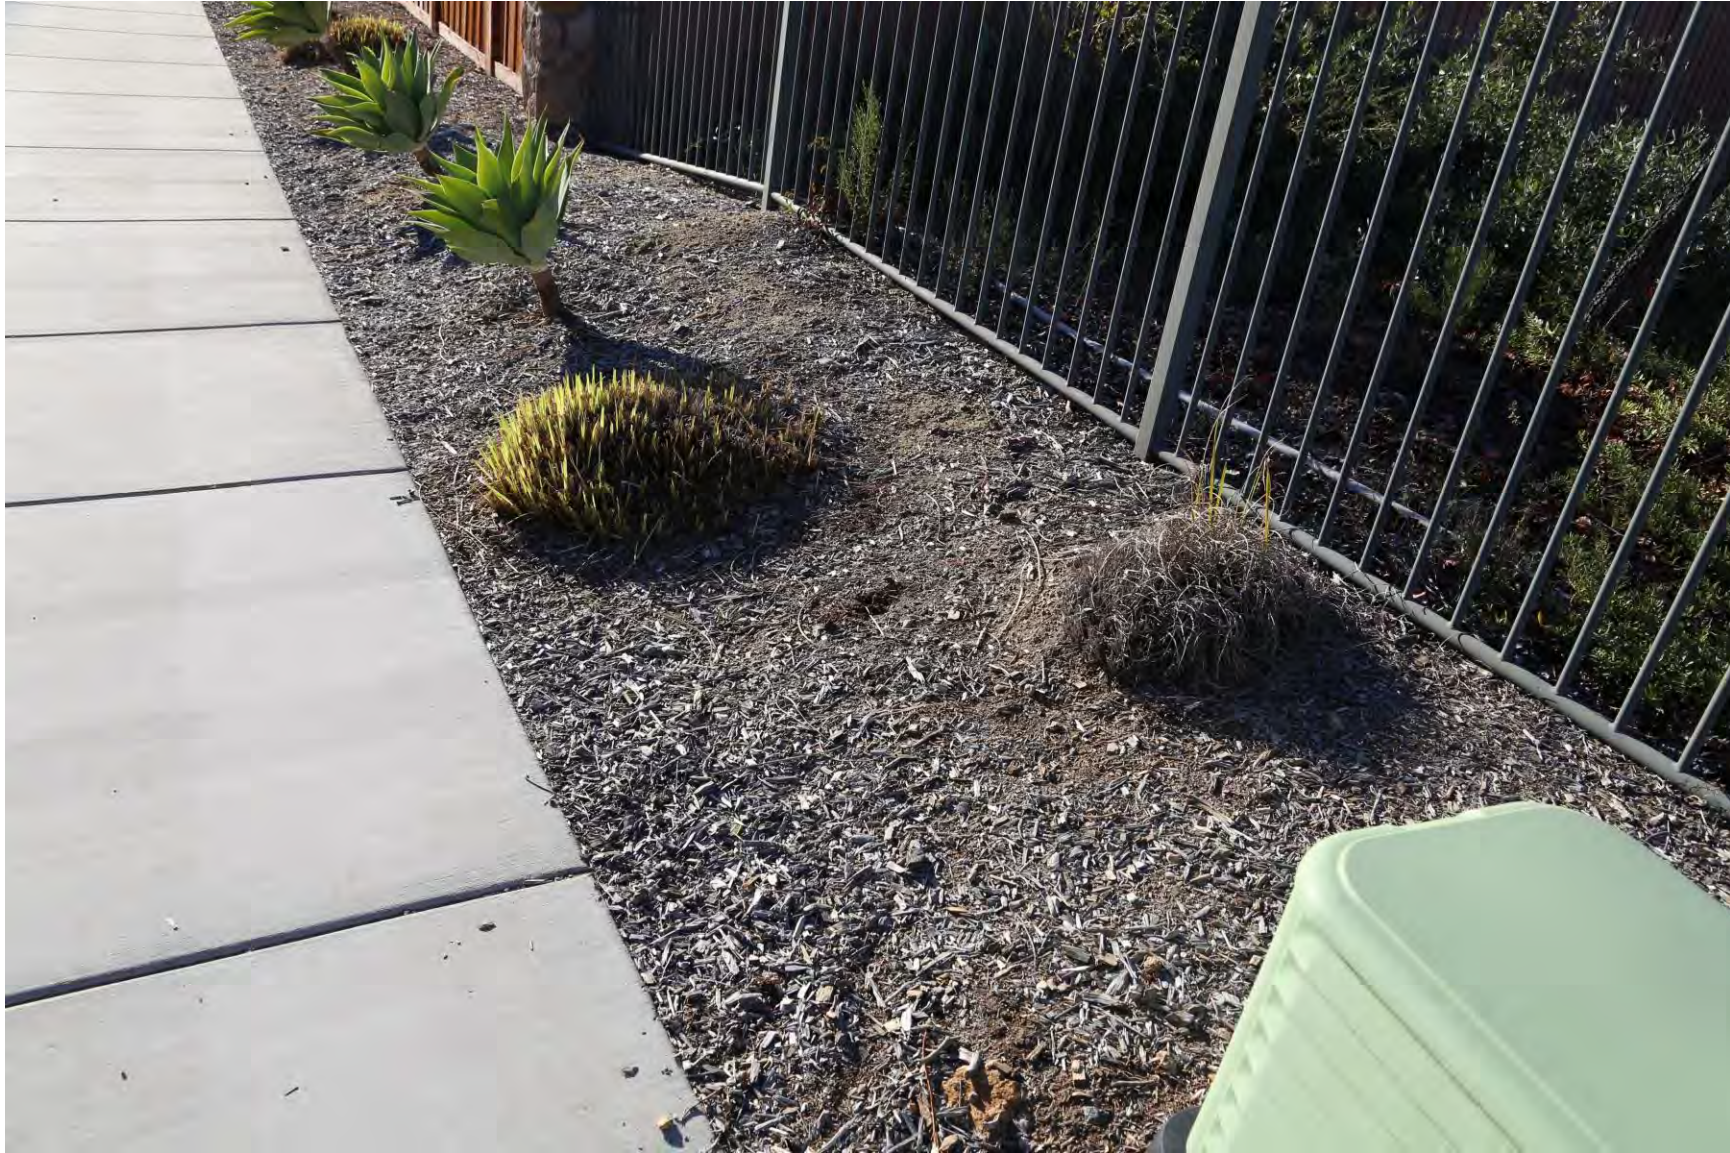
Existing plants dying through neglect, replace with Agave, resulting in inconsistent appearance.

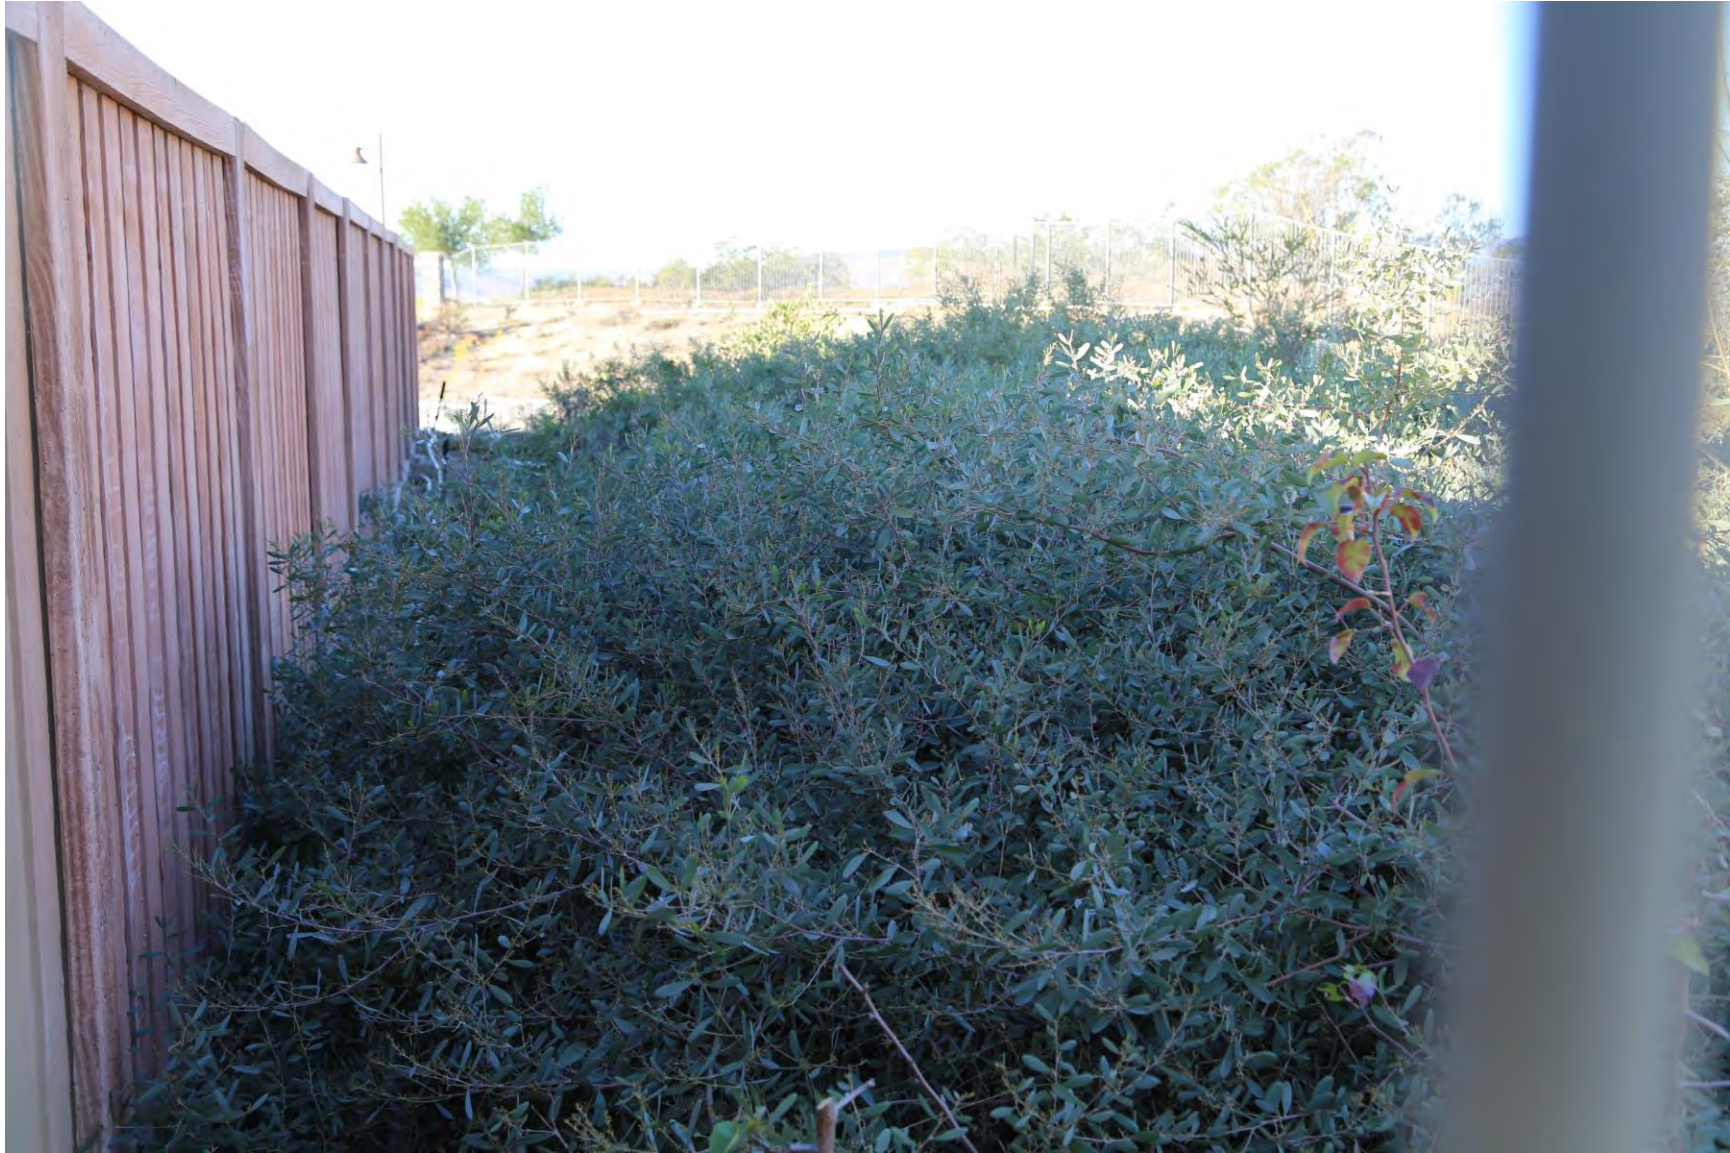
Prohibited Acacia, homeowner fence not cleared 18"

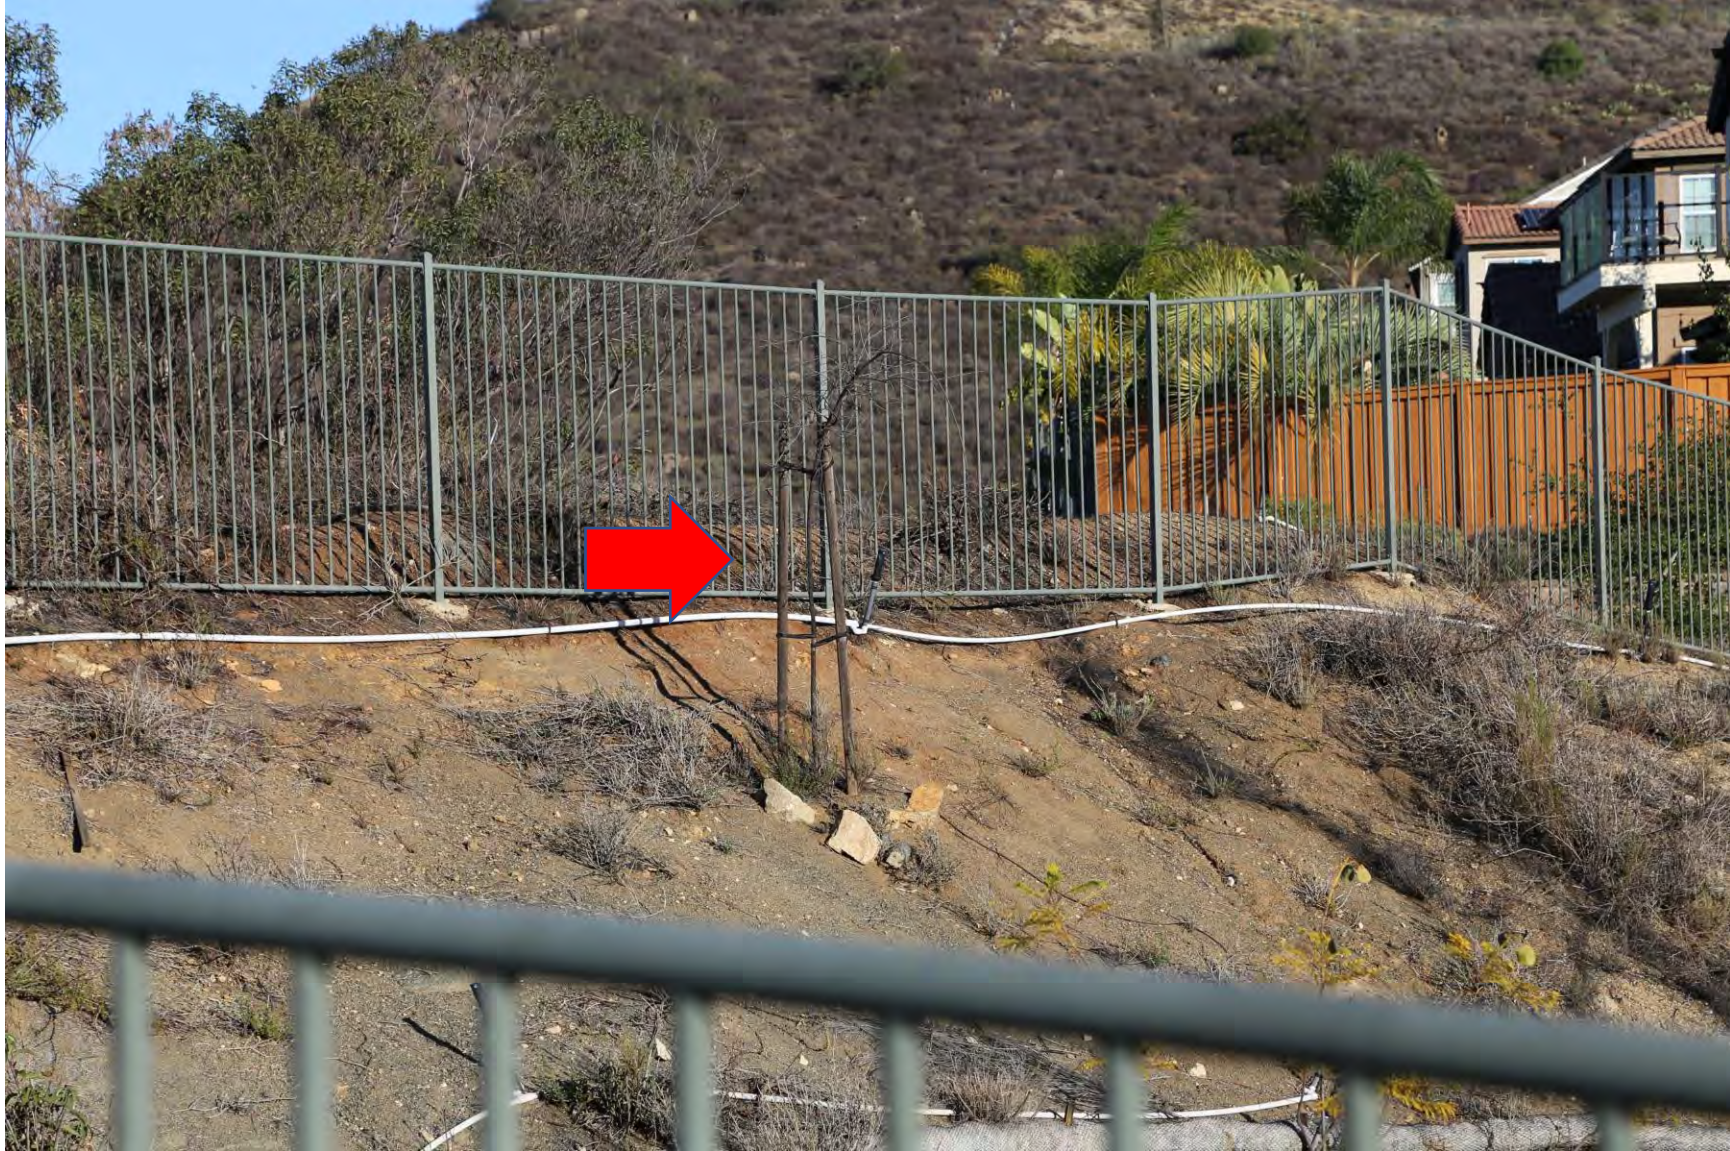
Dead tree. Exposed ground

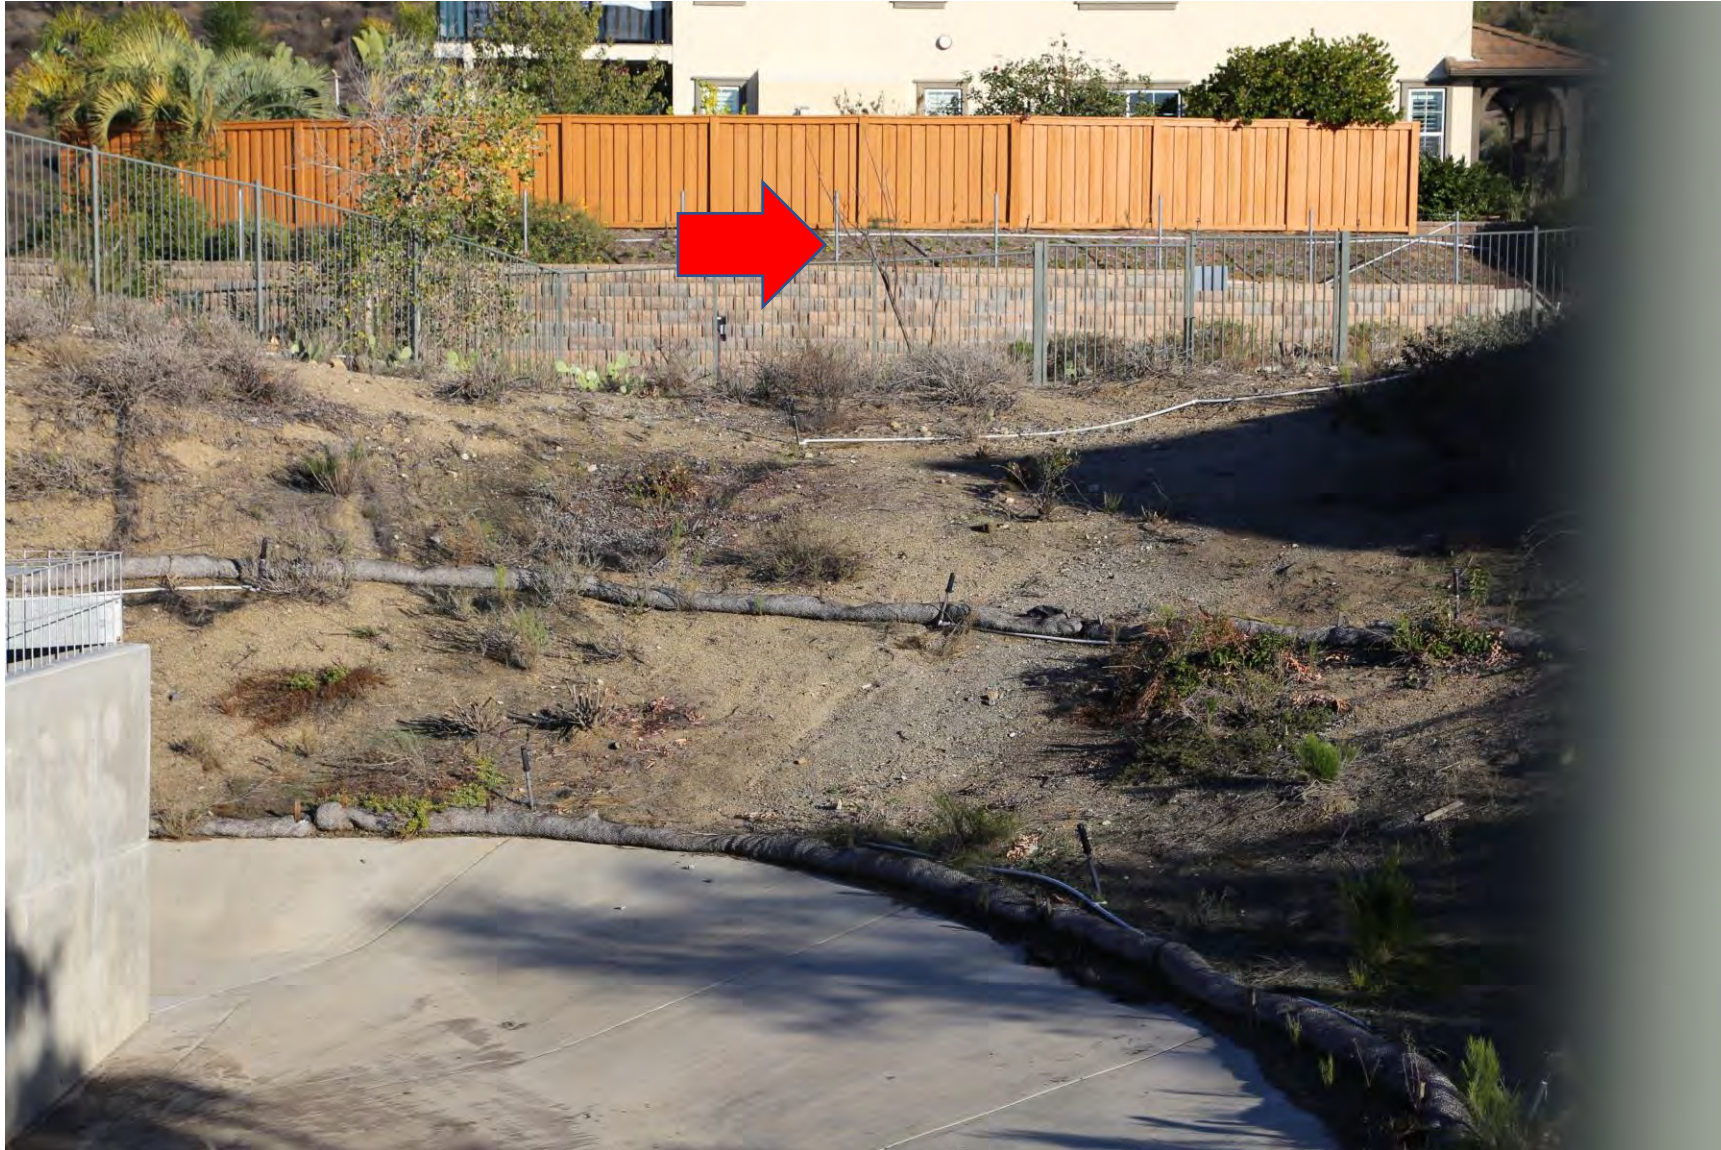
Dead tree, exposed ground, erosion

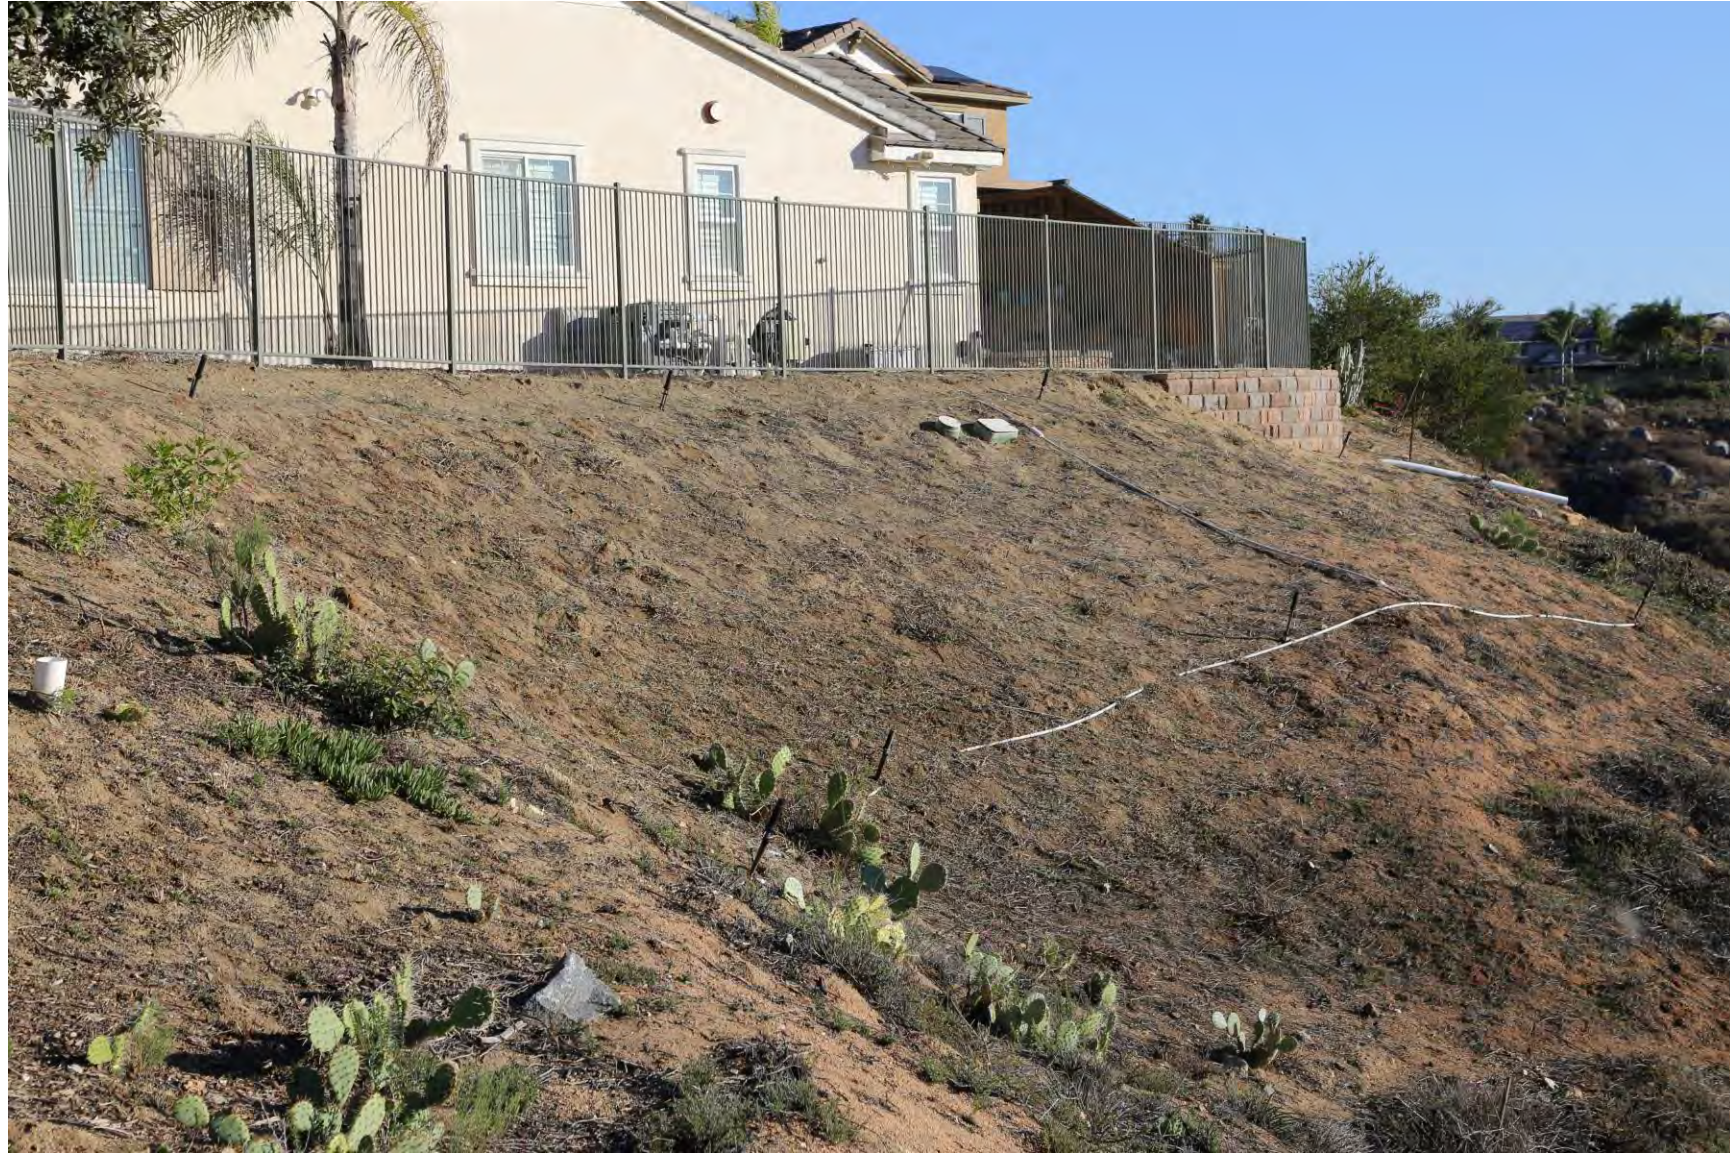
Exposed ground in FMZ

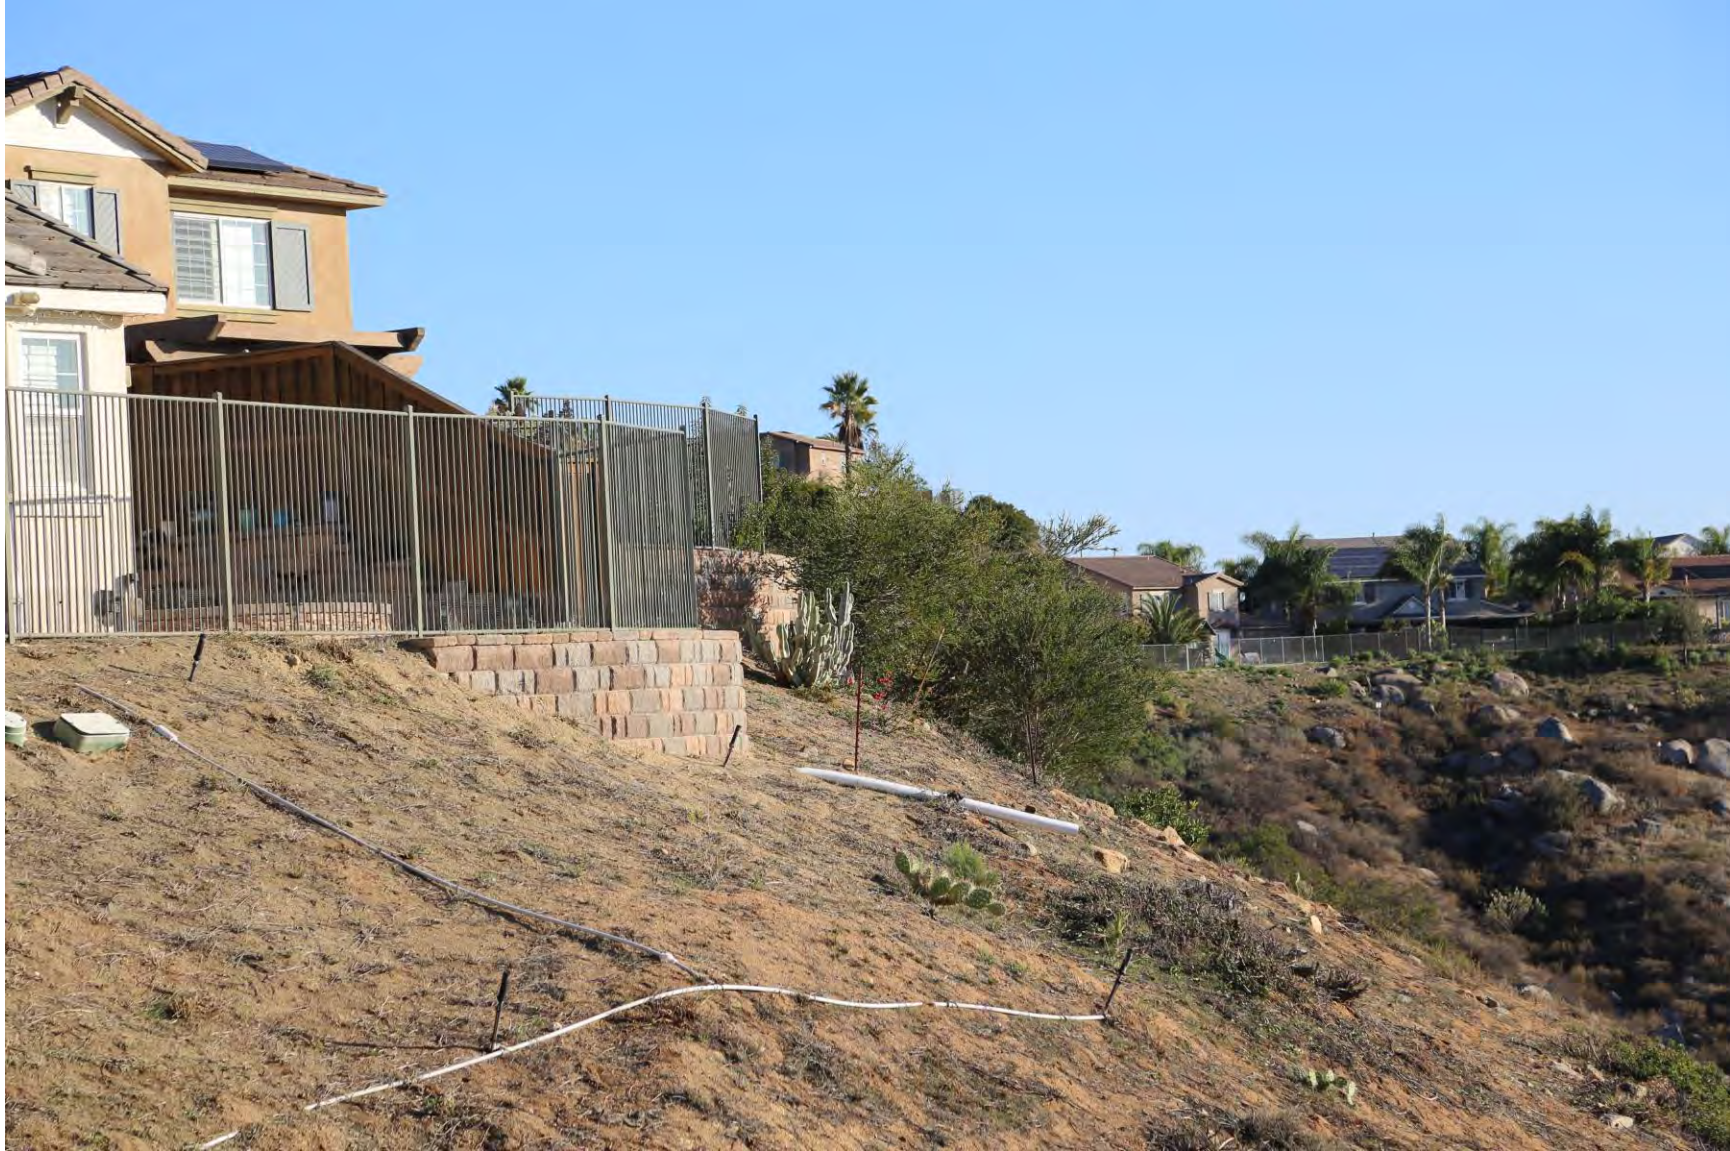
Exposed ground in FMZ, fence not cleared 18"

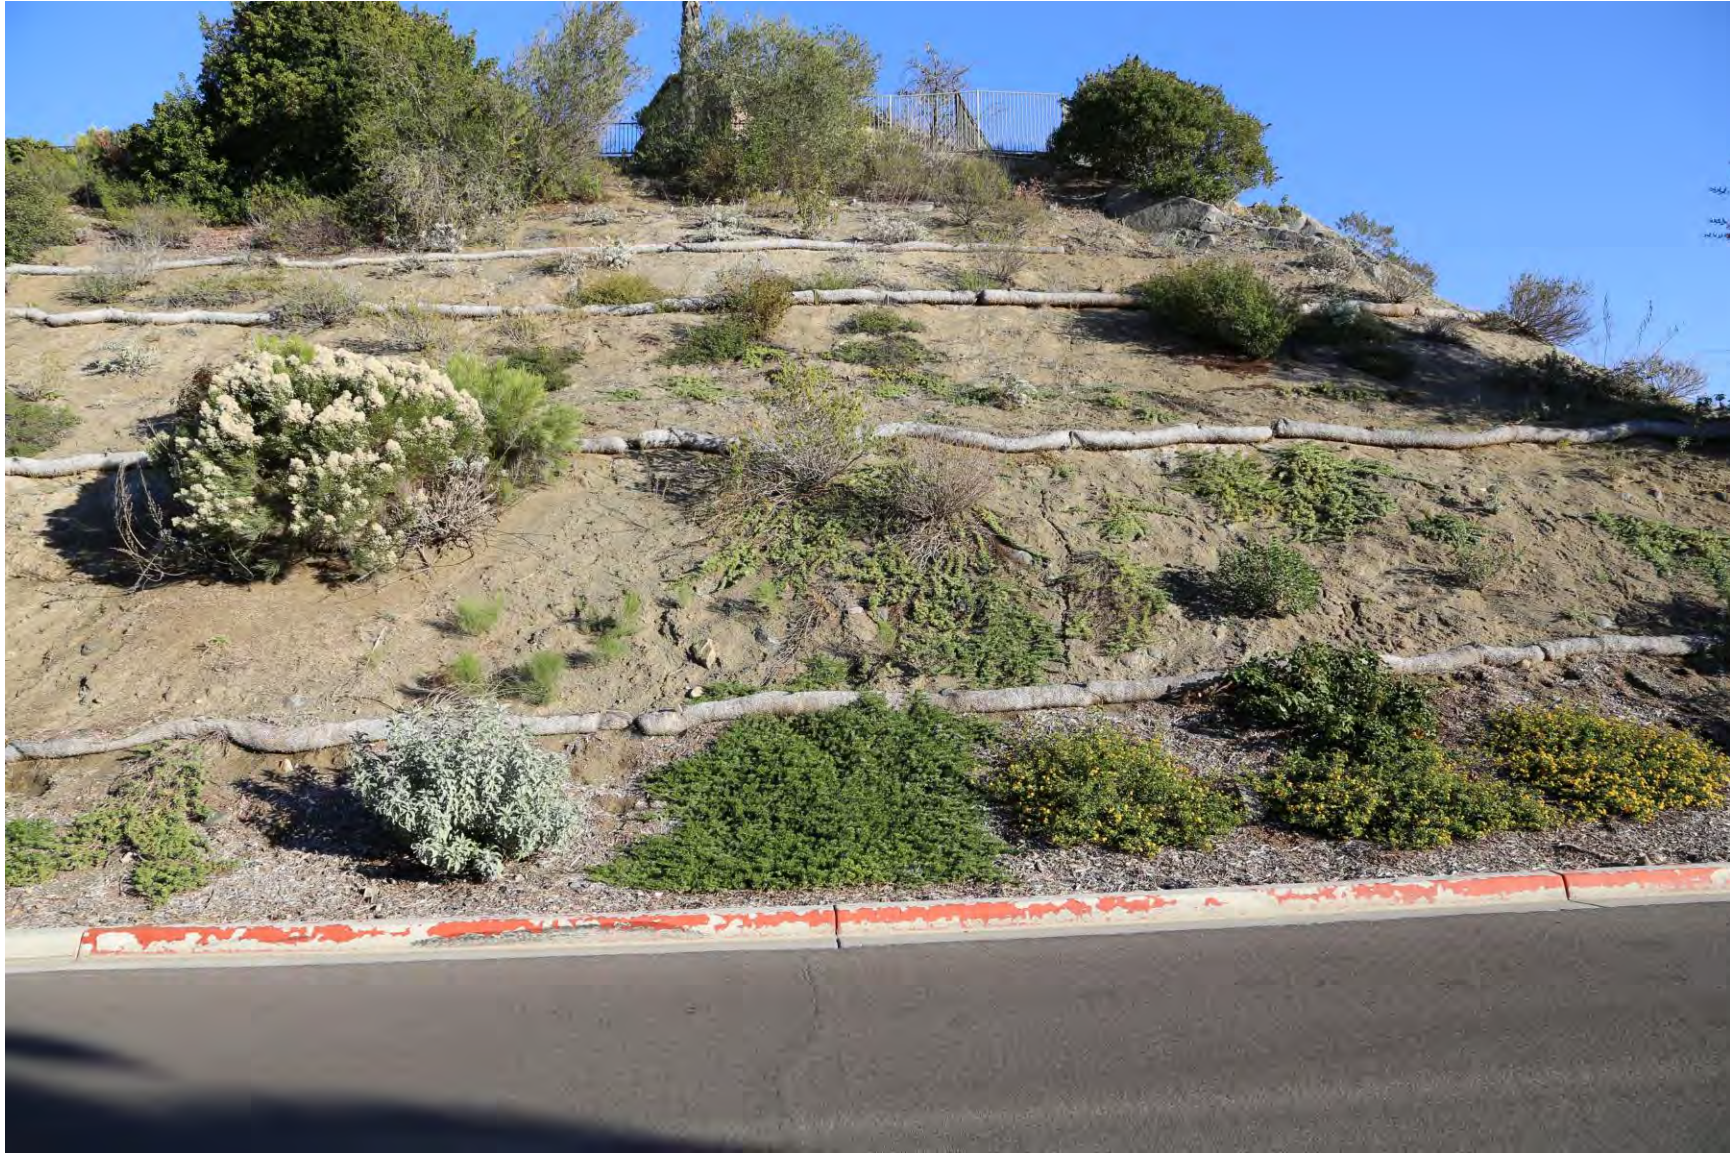
Exposed ground, erosion
