Landscape work issues (not a comprehensive list)

Fuel Modification Zones and Storm Water

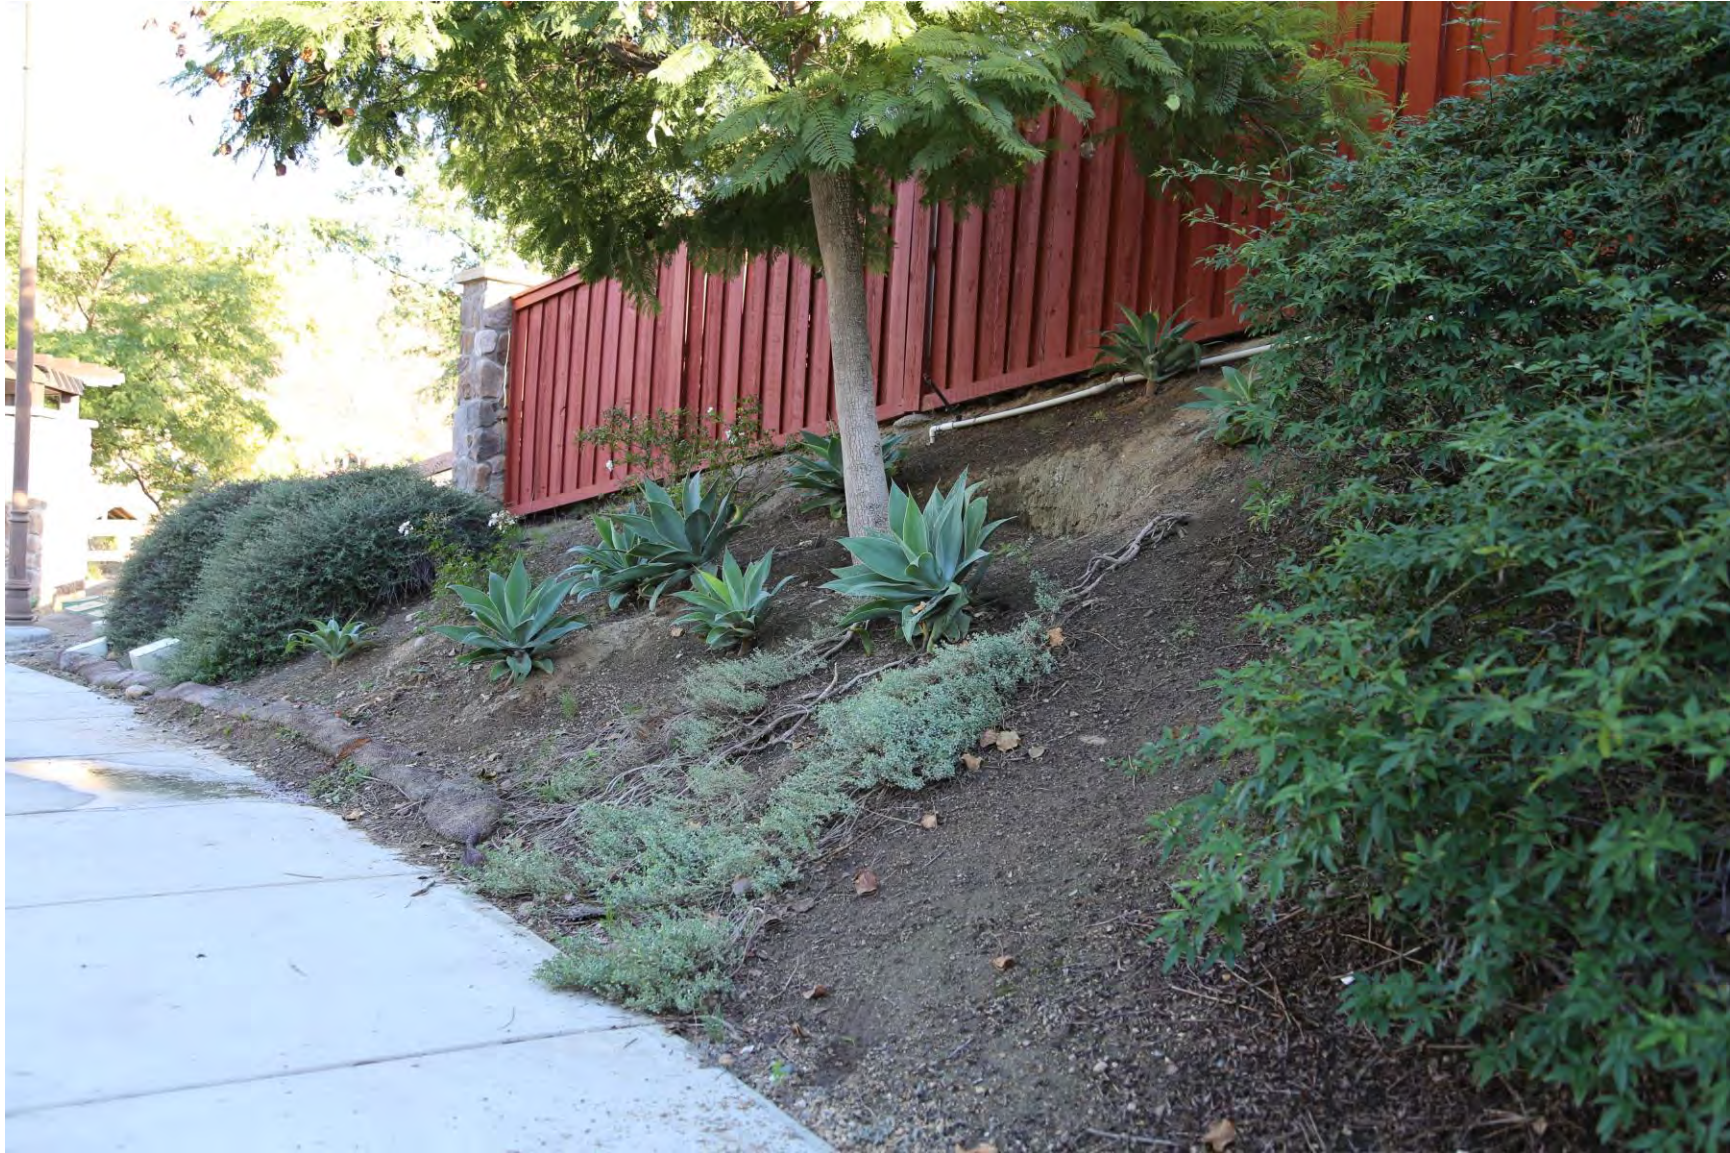
Homeowner destroyed landscape when installing pool. Green bushes to the right and left weren't used to fill the gap, now it is a soggy inconsistent mess, and erosion.

Agave fix for everything that fails. There is a sprinkler head by the trash can. It either doesn't function or is now a waste of water.

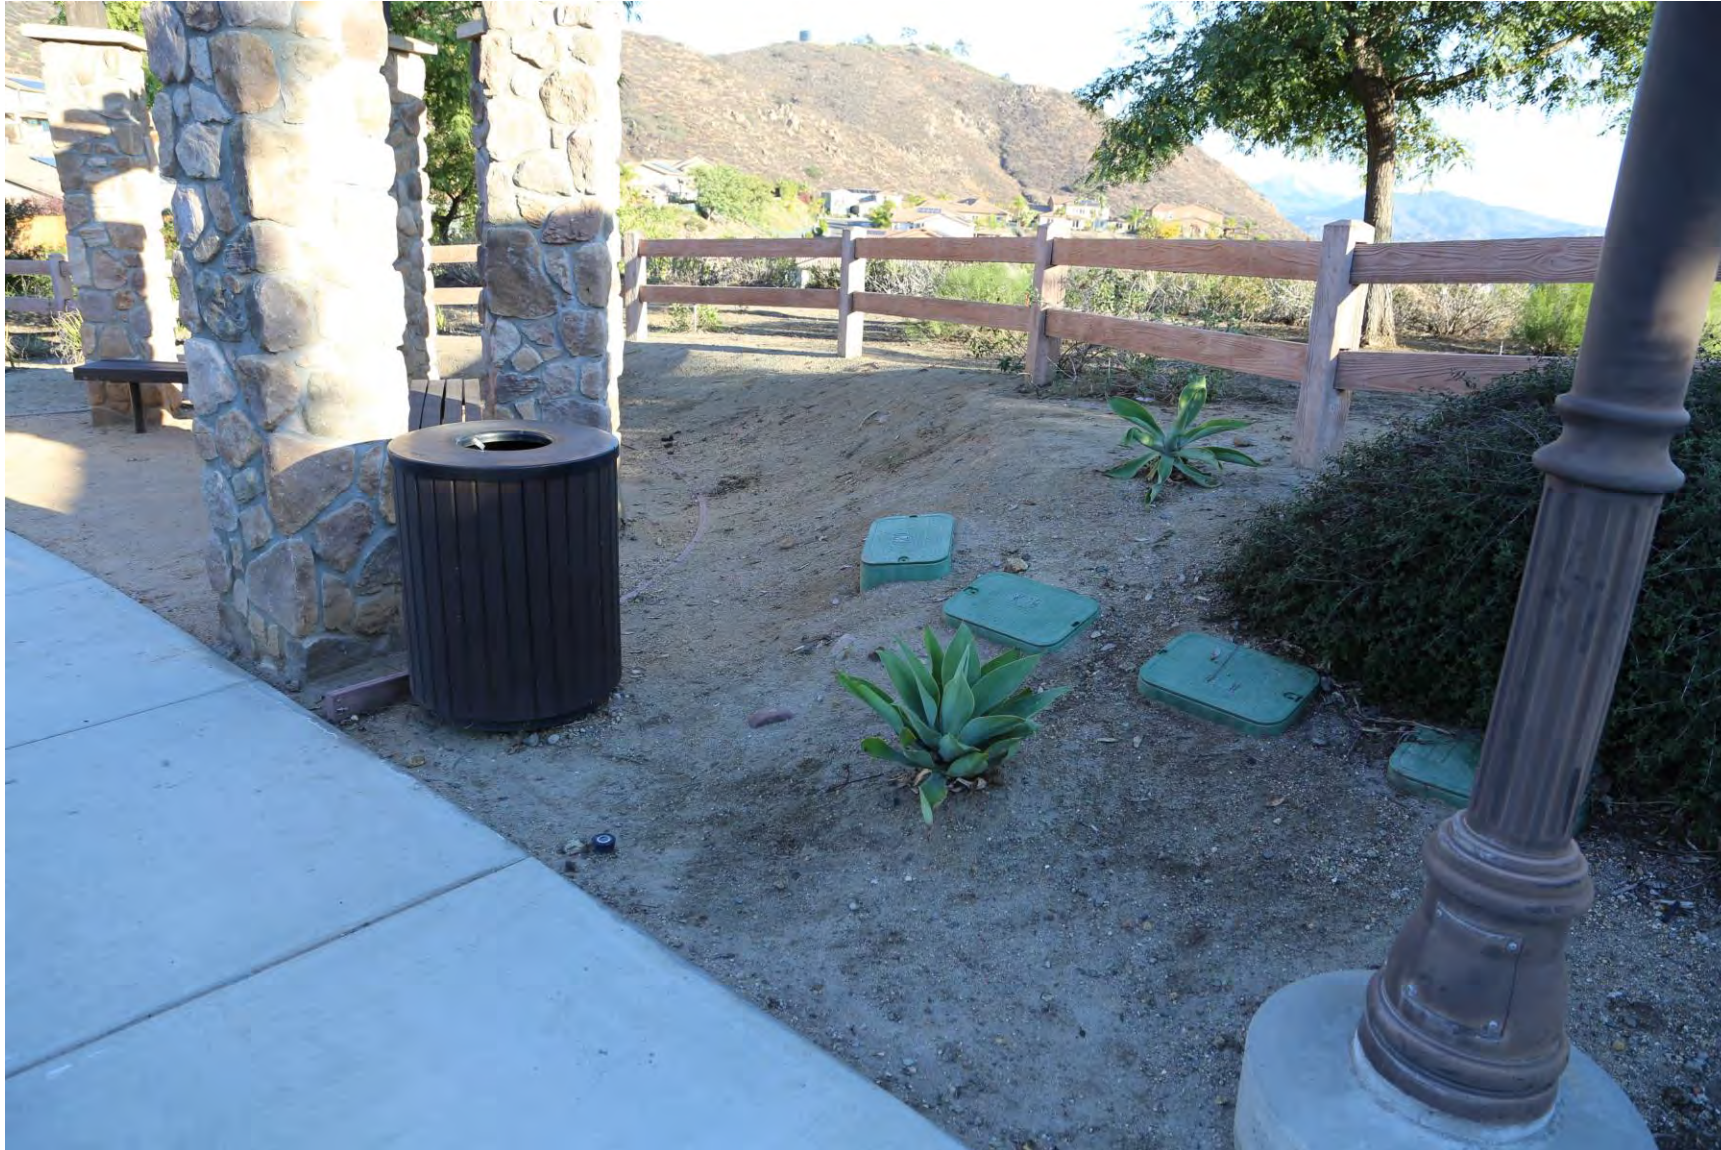
Exposed ground

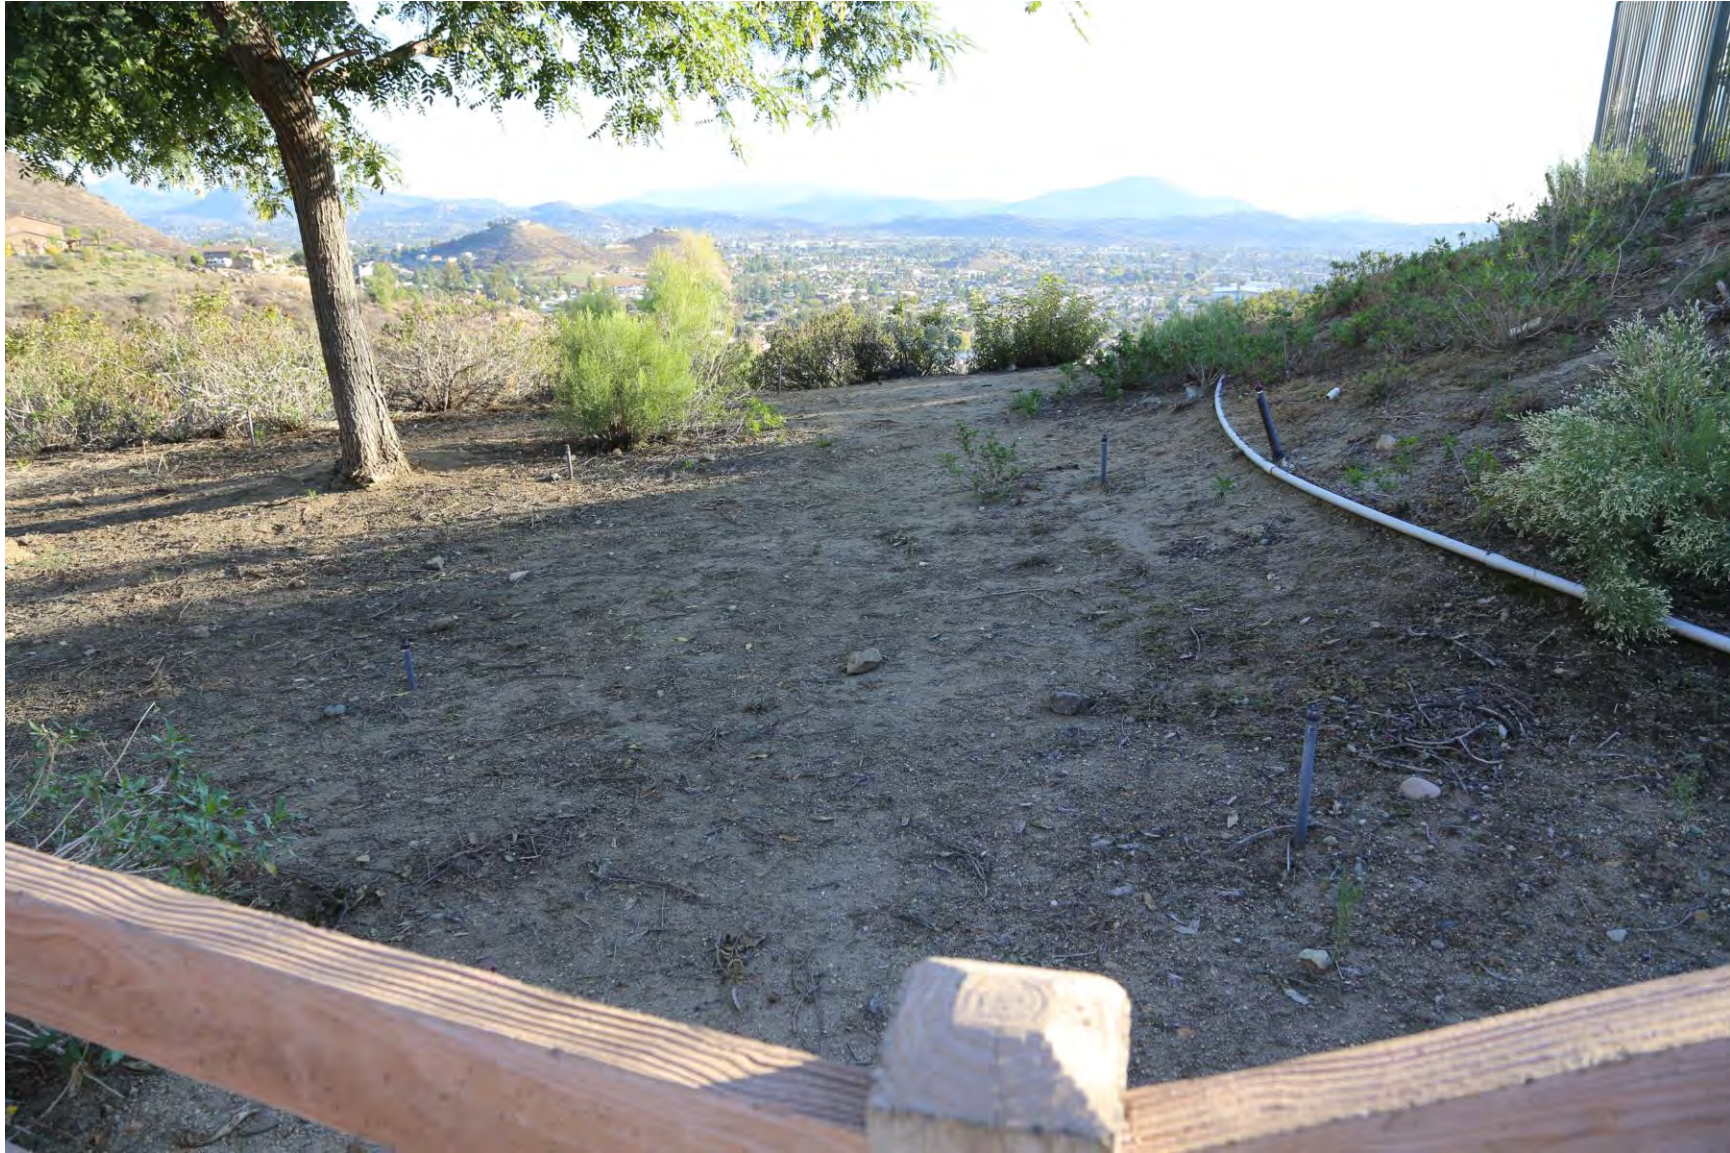
Exposed ground, plants gone

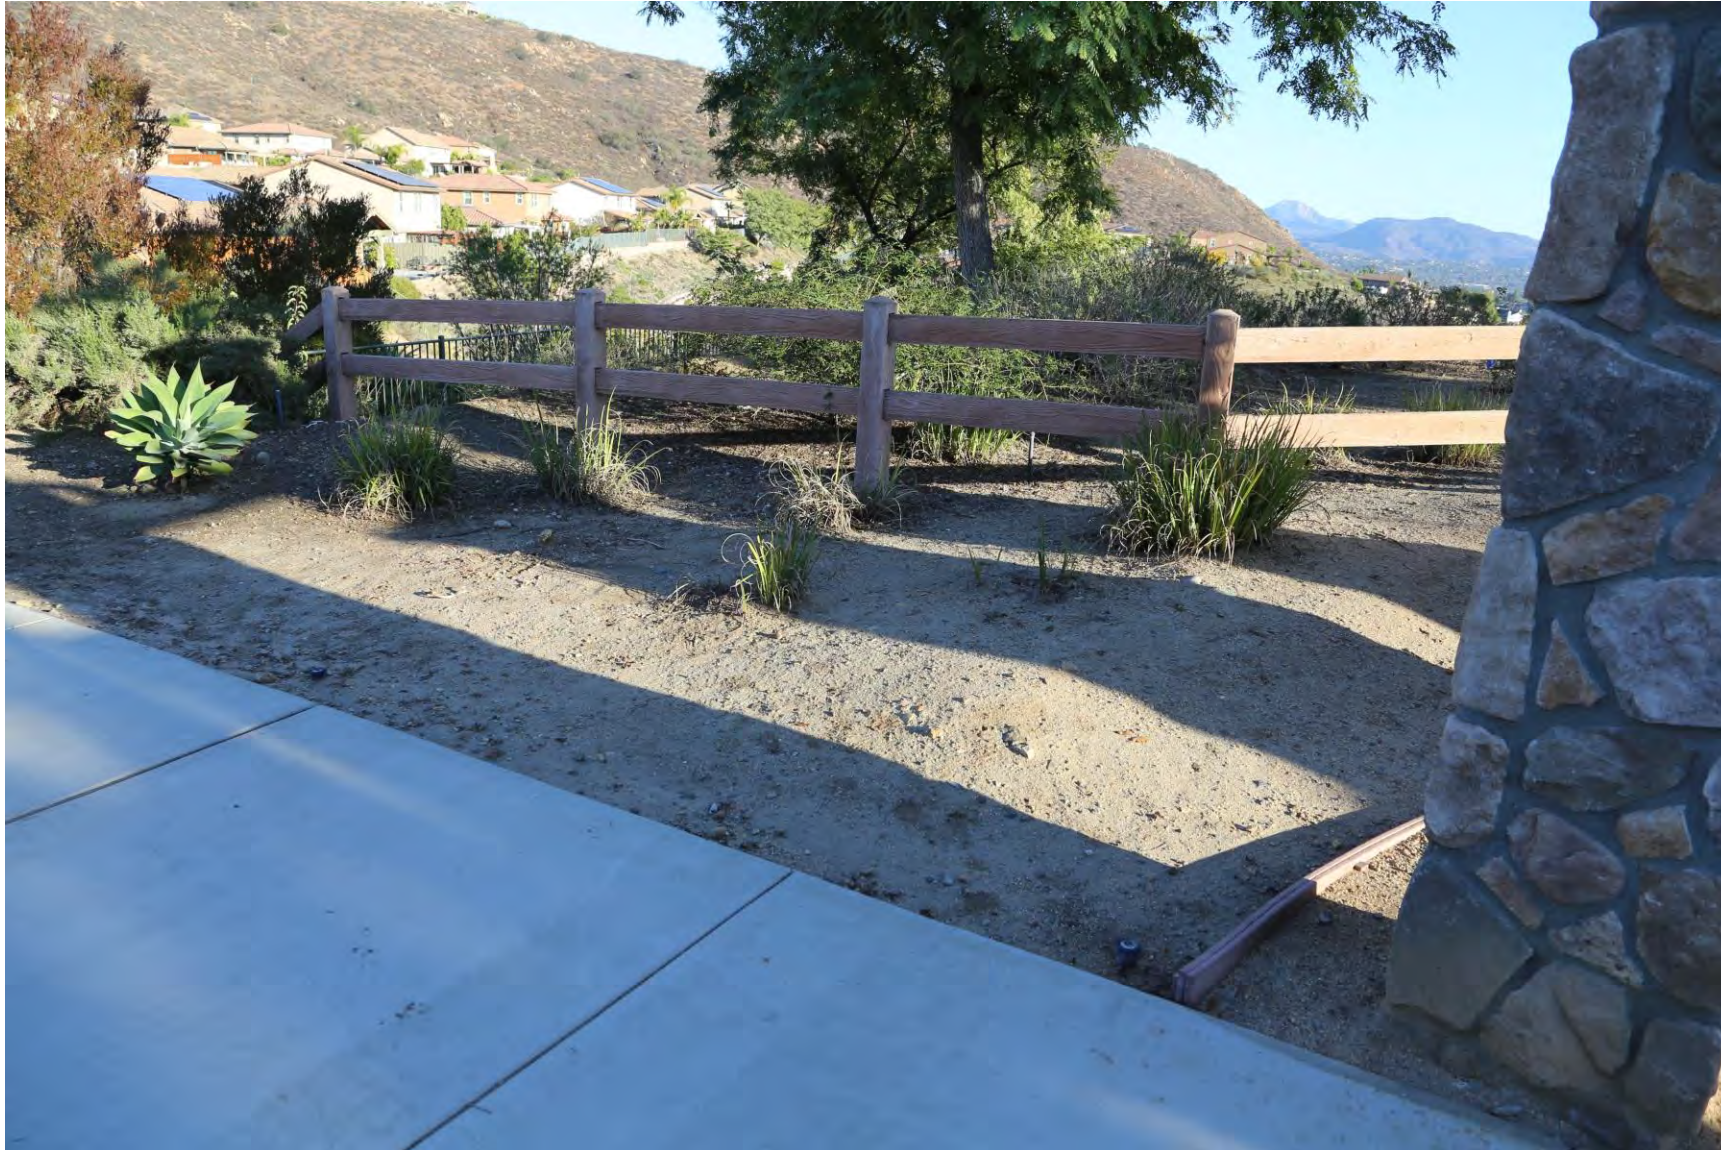
Exposed ground, plants died, more dying, Agave fix (rather than plant replacement) has started.
Note that there are sprinklers near the sidewalk

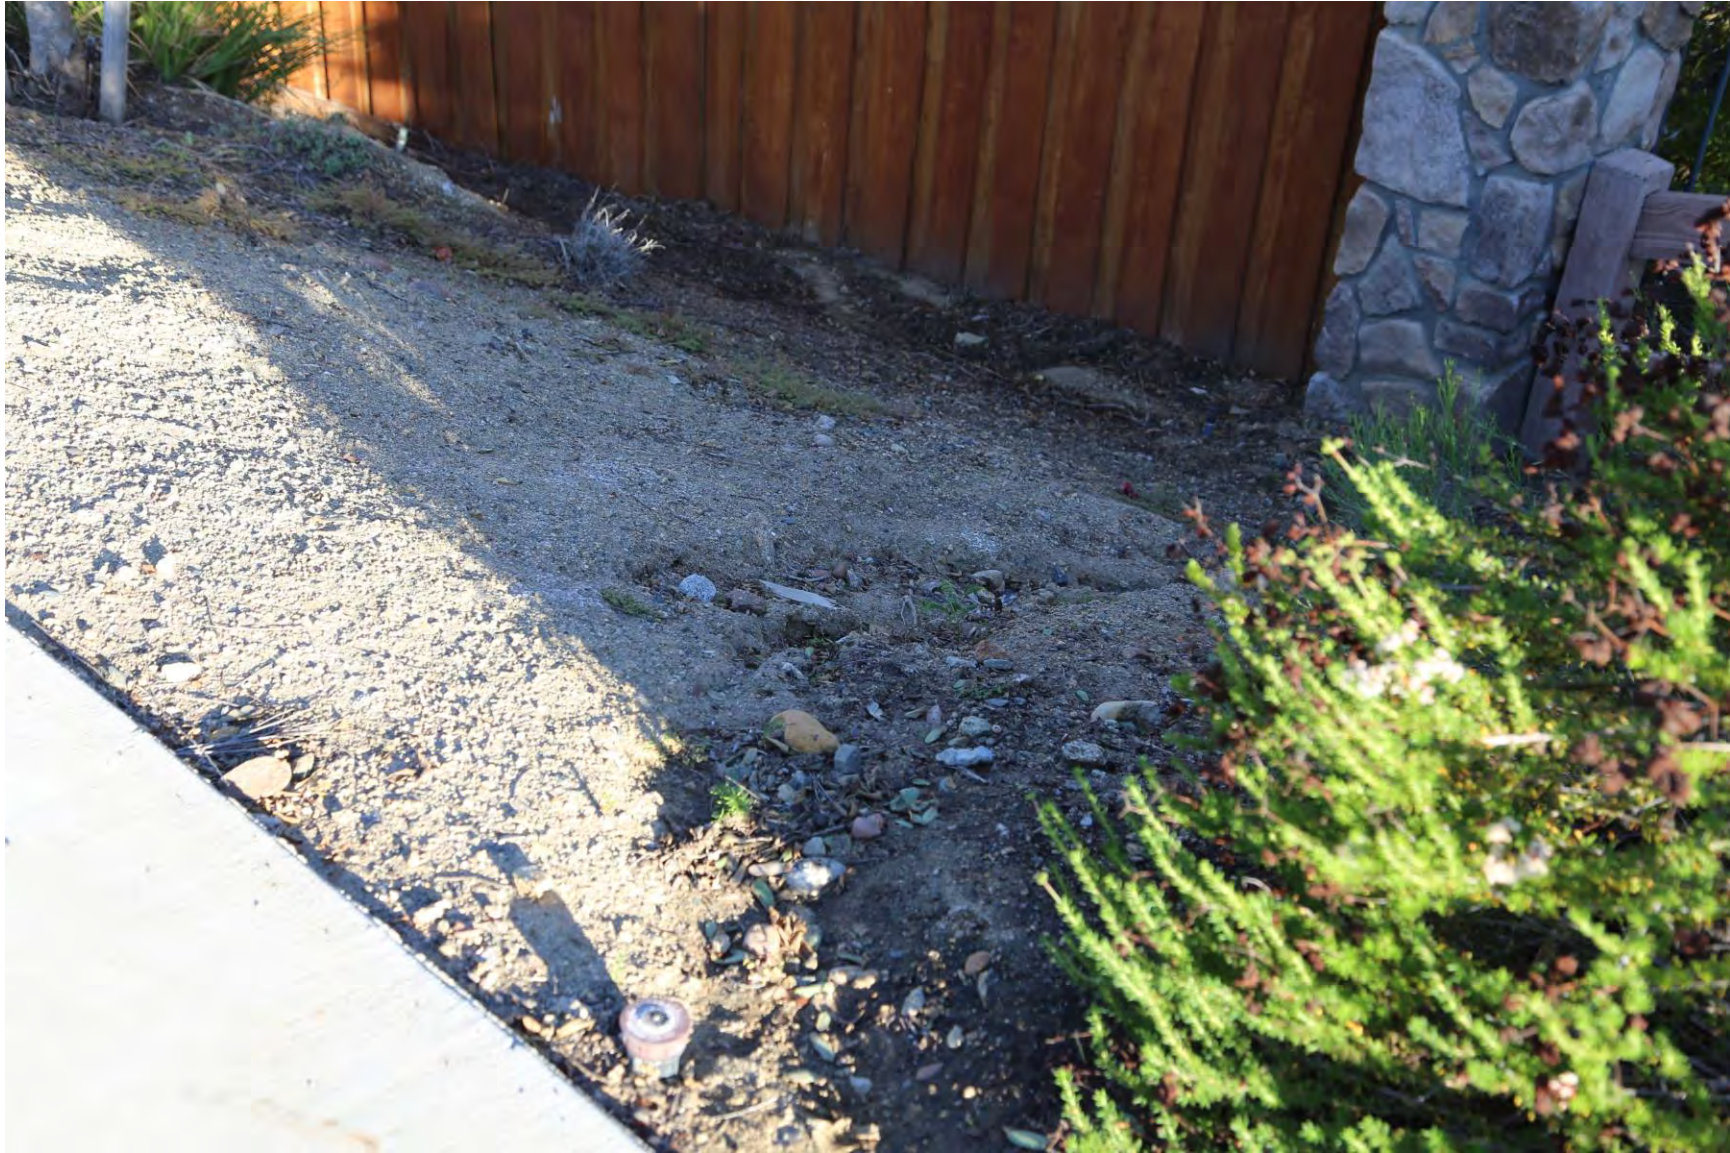
Sprinkler obstructed, ground erodes over the bottom of homeowner fence

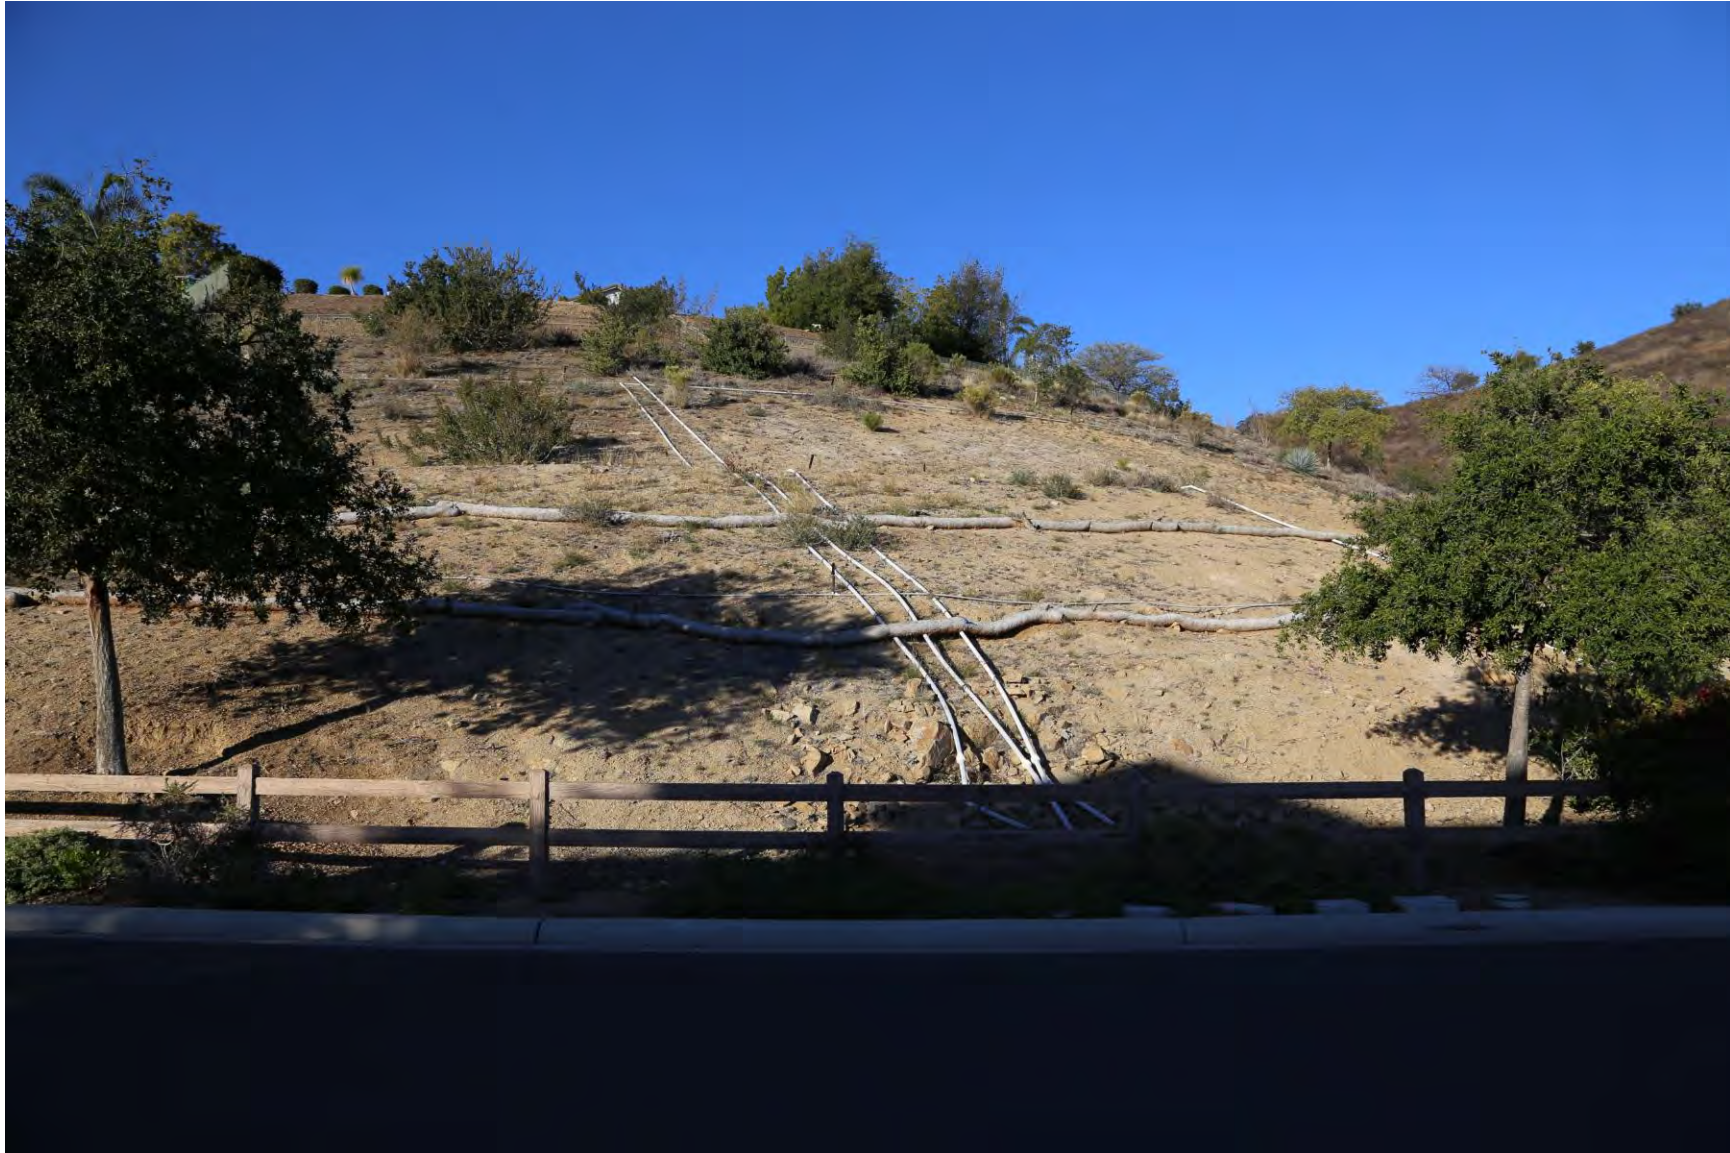
Hydroseed failed, bare ground etc

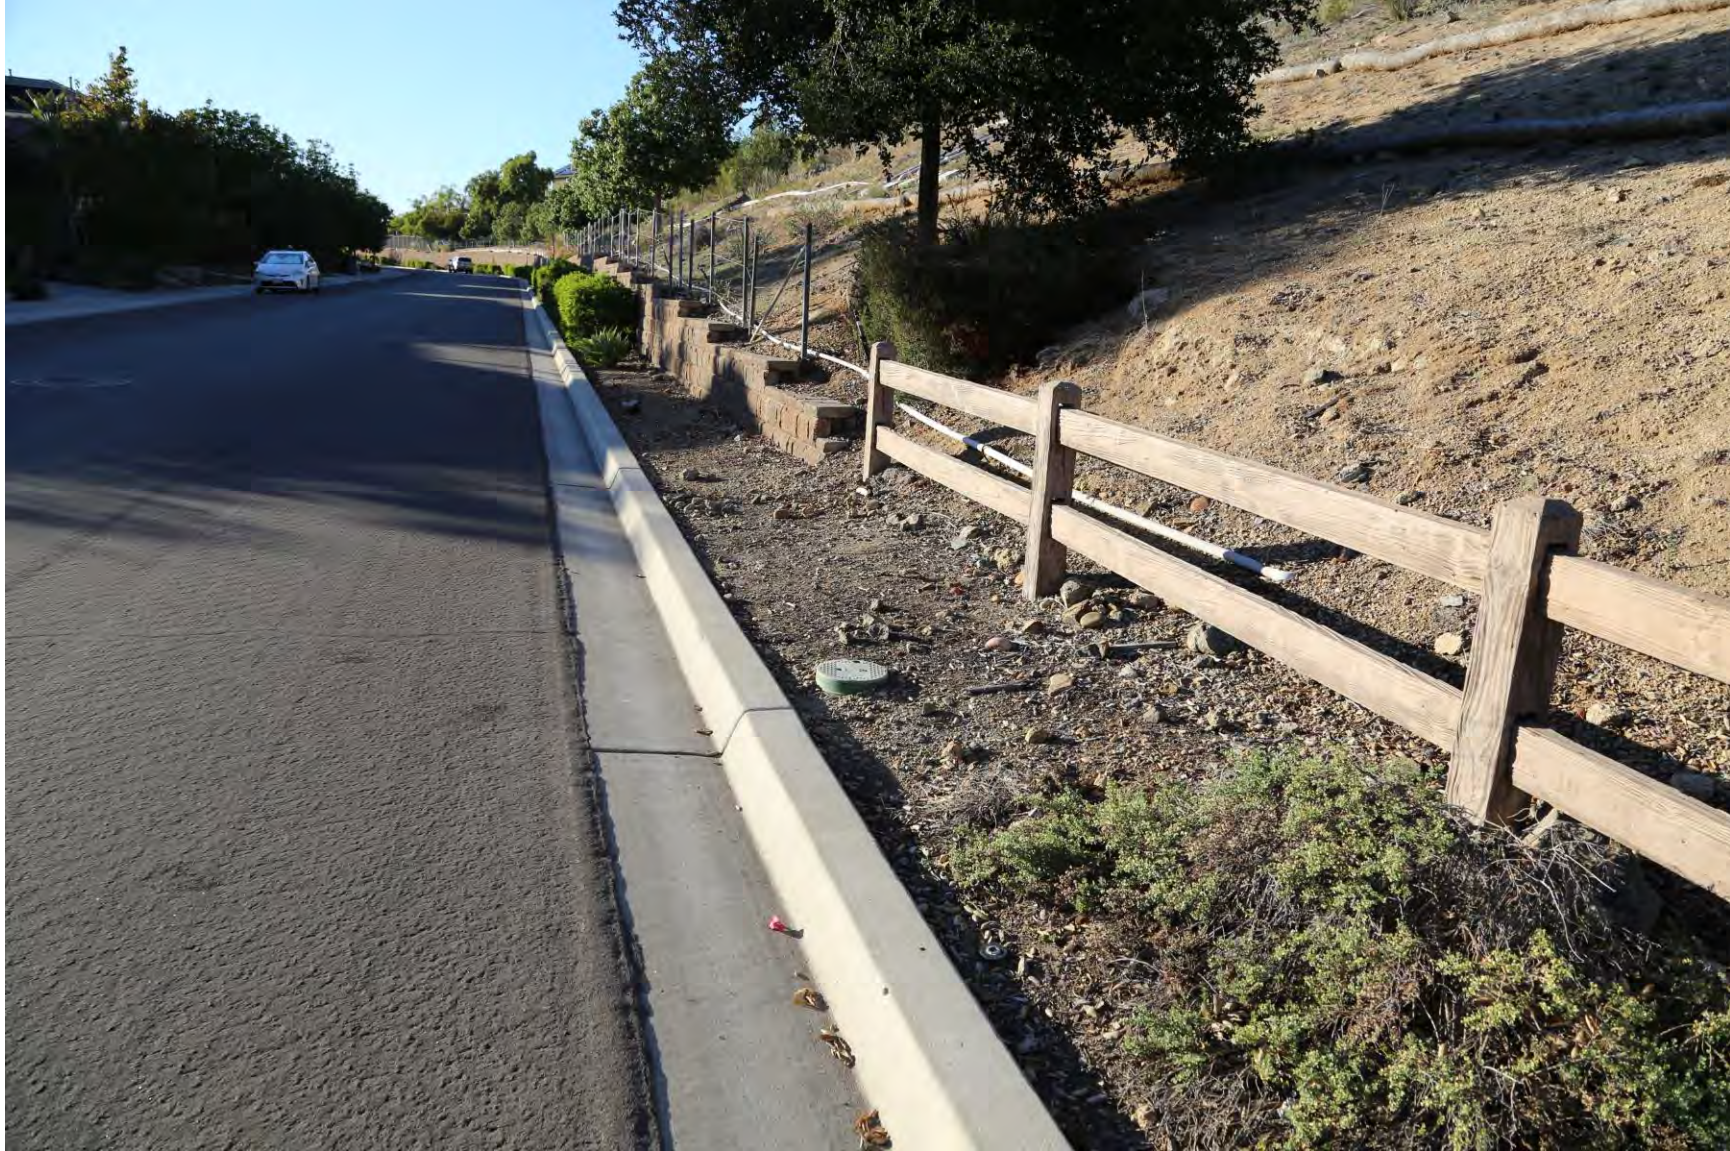
Exposed ground

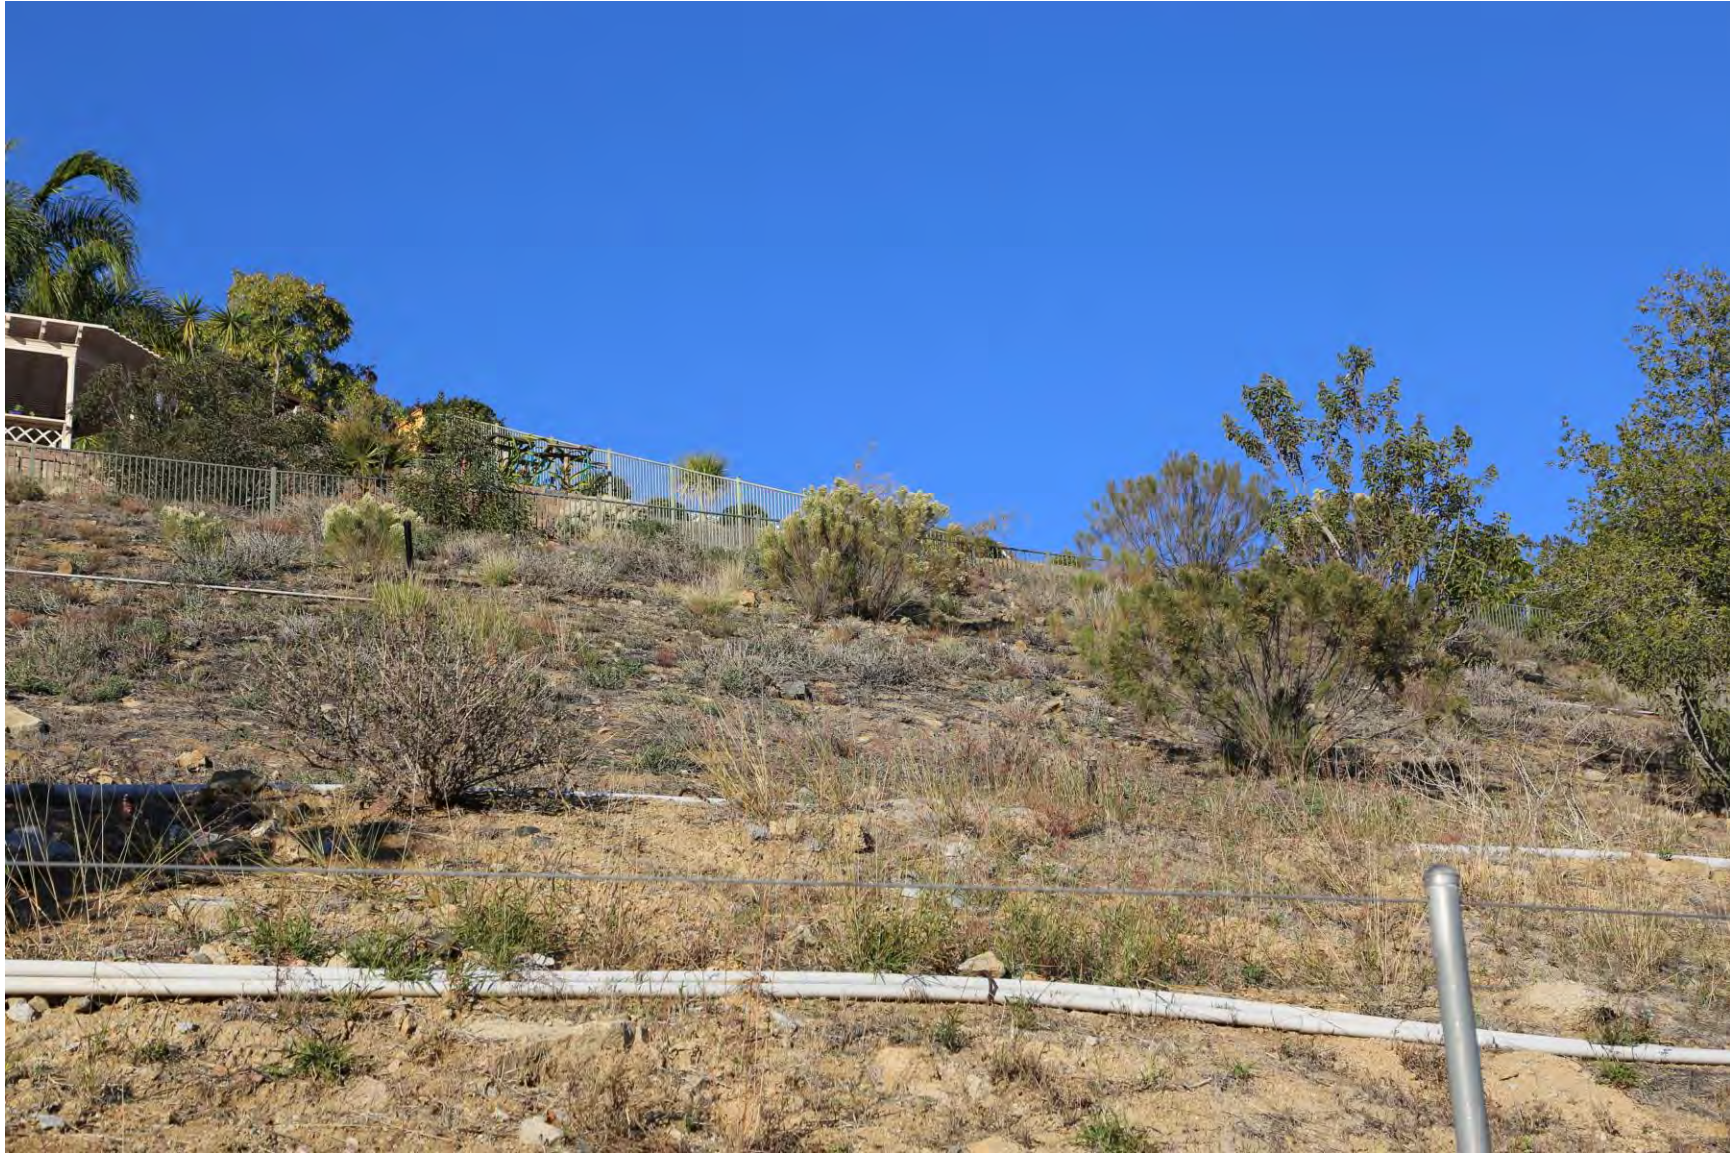
Like other areas, most of what's left is Desert Broom and weeds

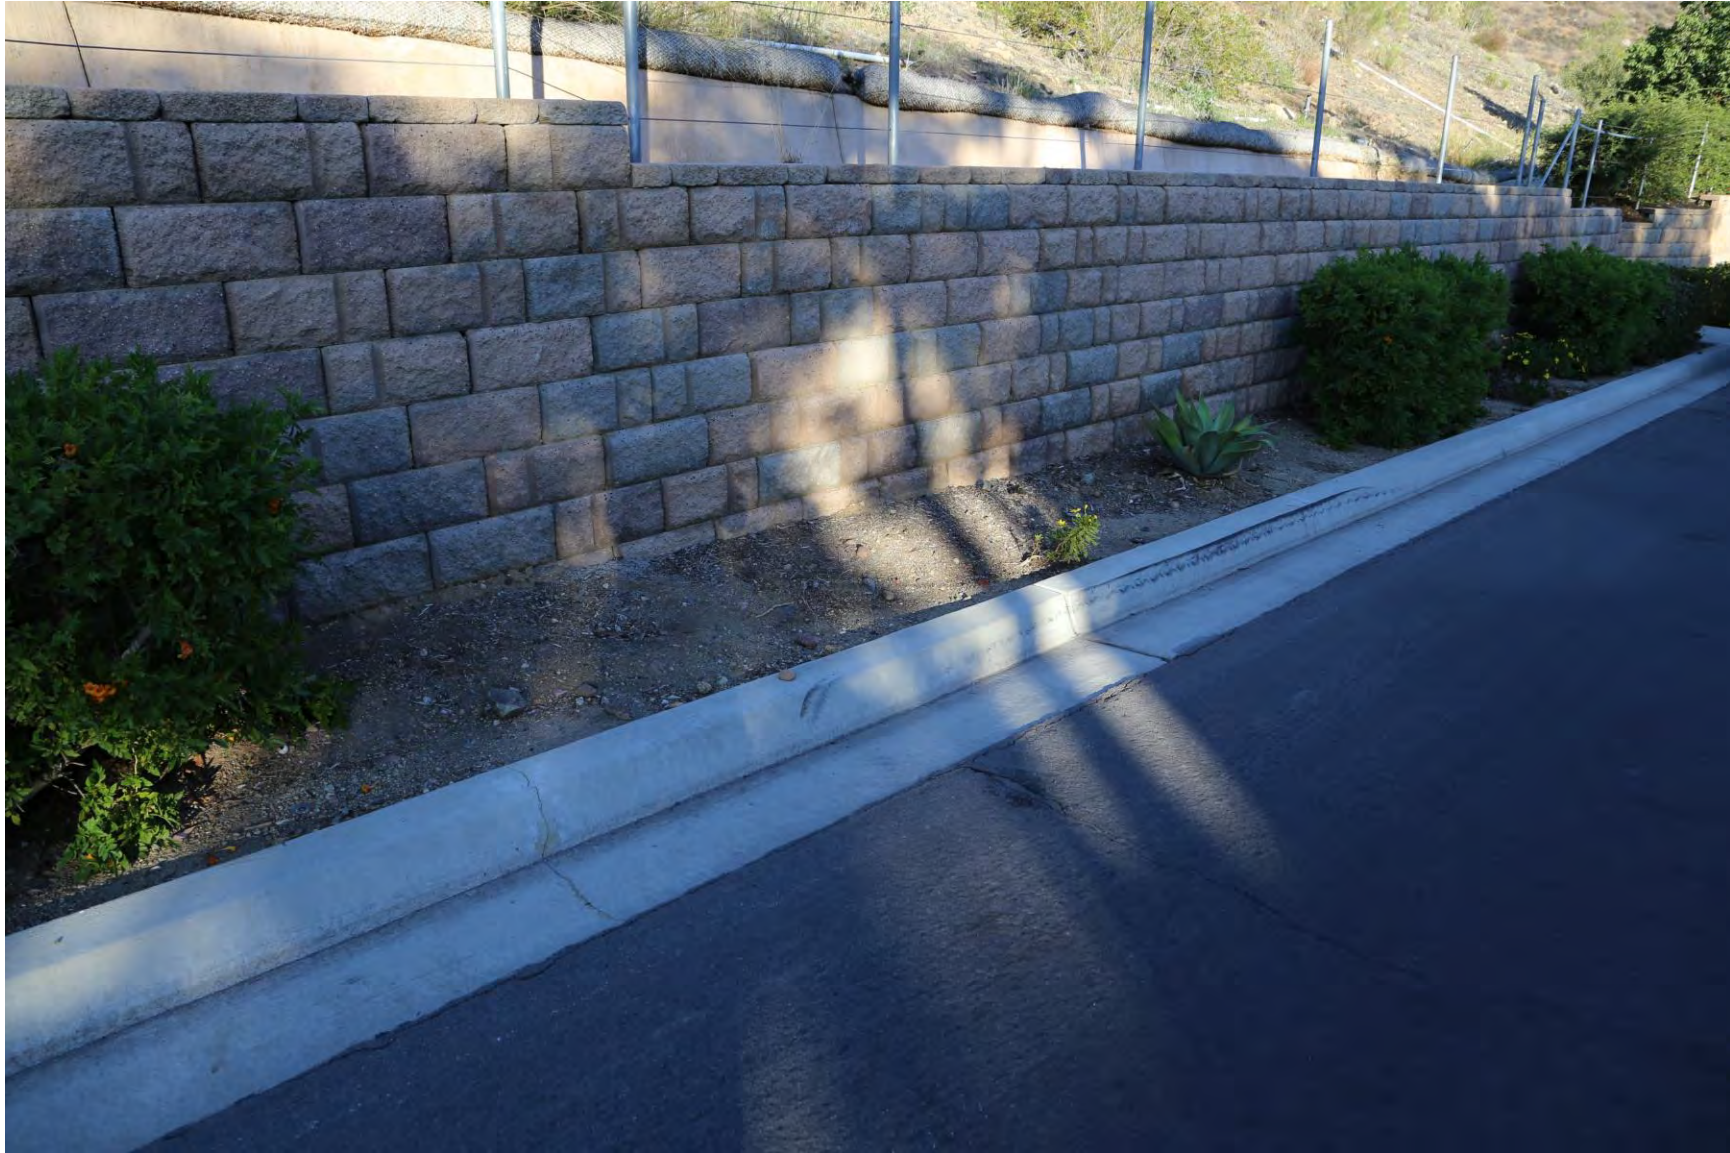
Exposed ground, large gaps in palate, Agave fix begins

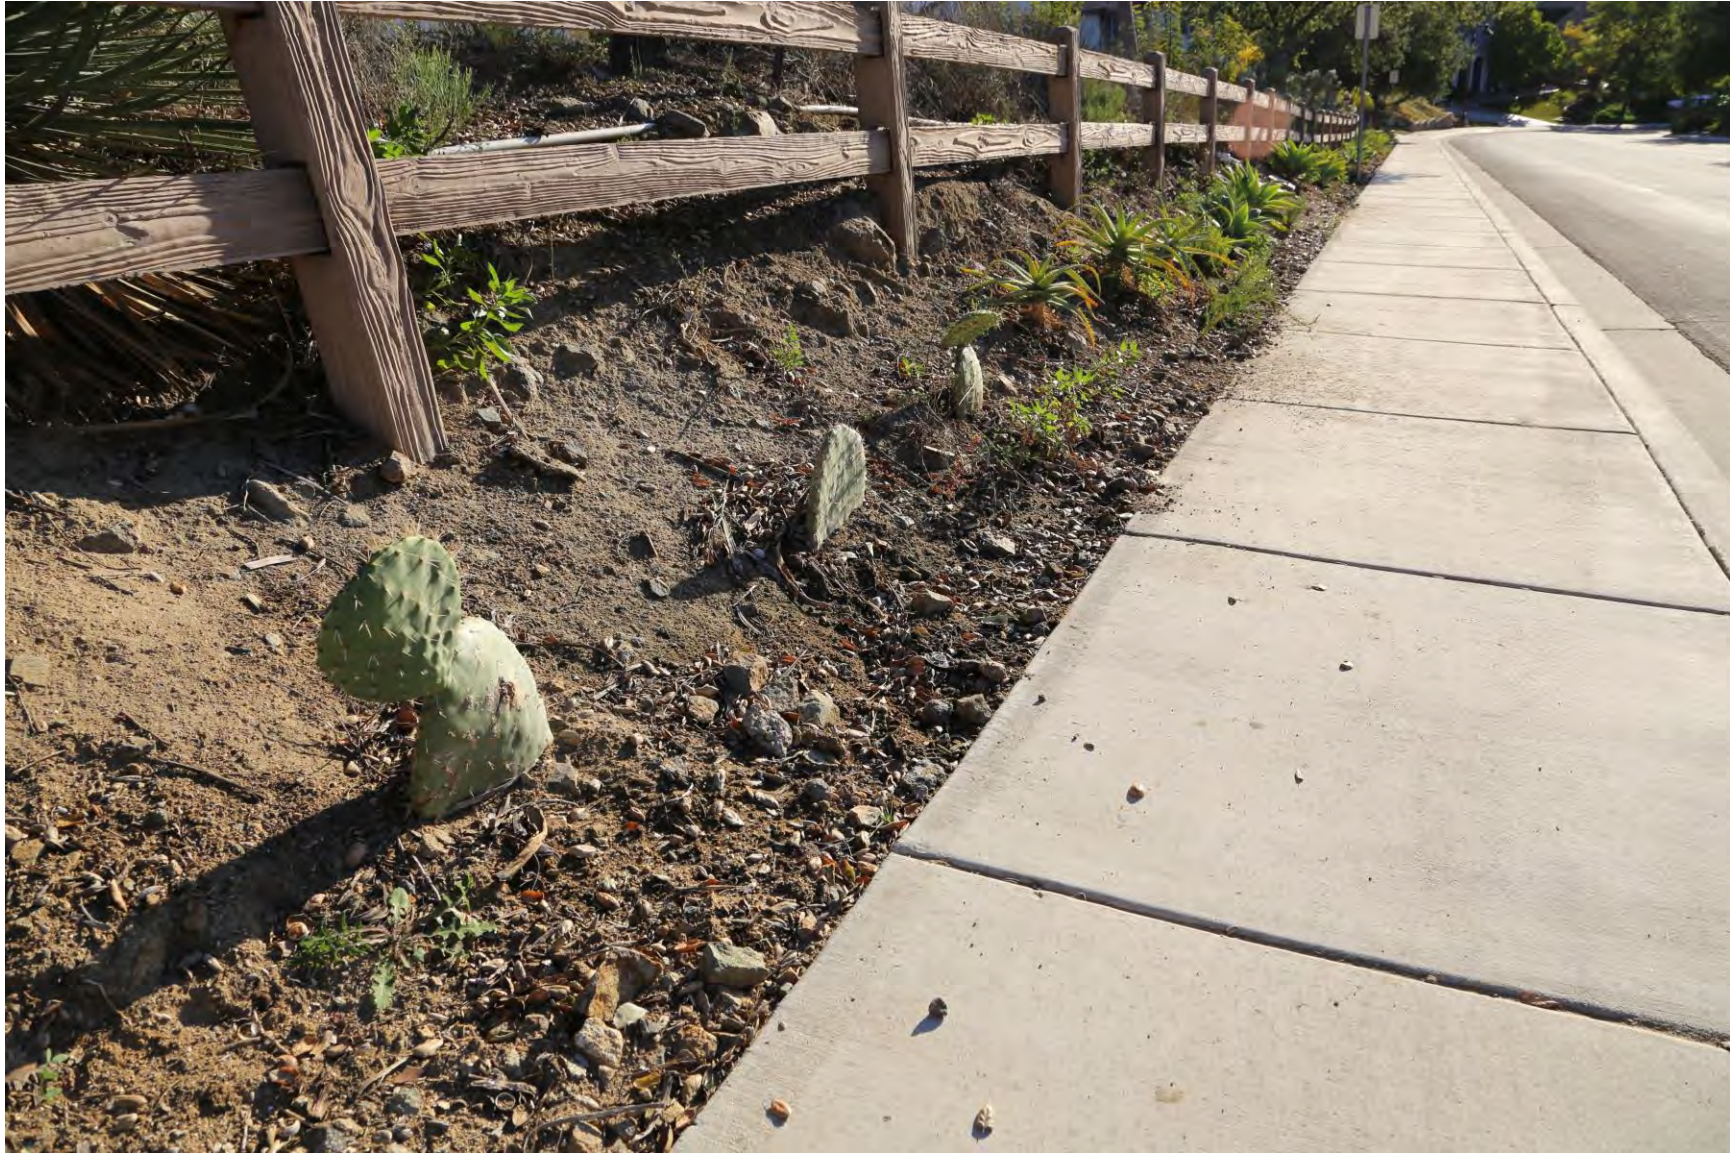
Agave fix. Installed Cactus next to the sidewalk which is a safety issue.

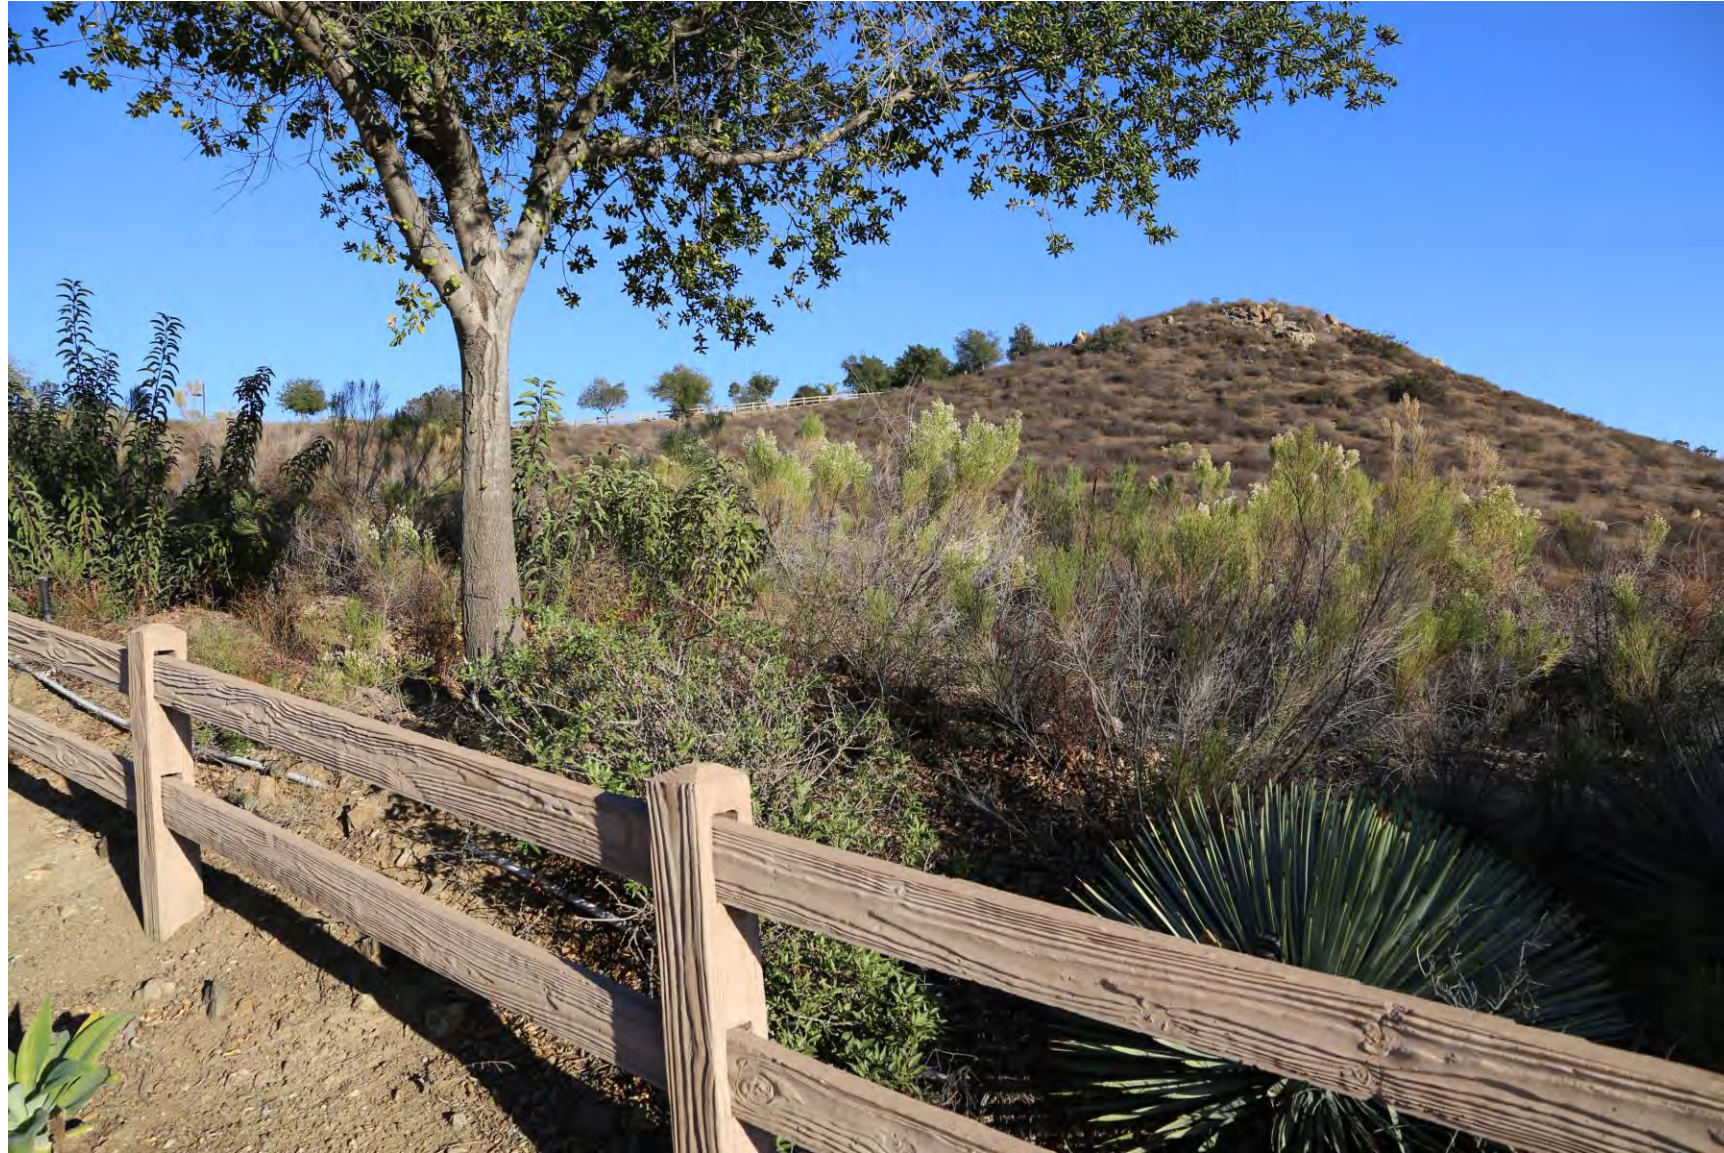
Not maintained to FMZ requirements. Large Sumac, Desert Broom and other plants not trimmed or thinned. Too much of the area is native per FMZ code.
