Landscape work issues (not a comprehensive list)

Fuel Modification Zones and Storm Water

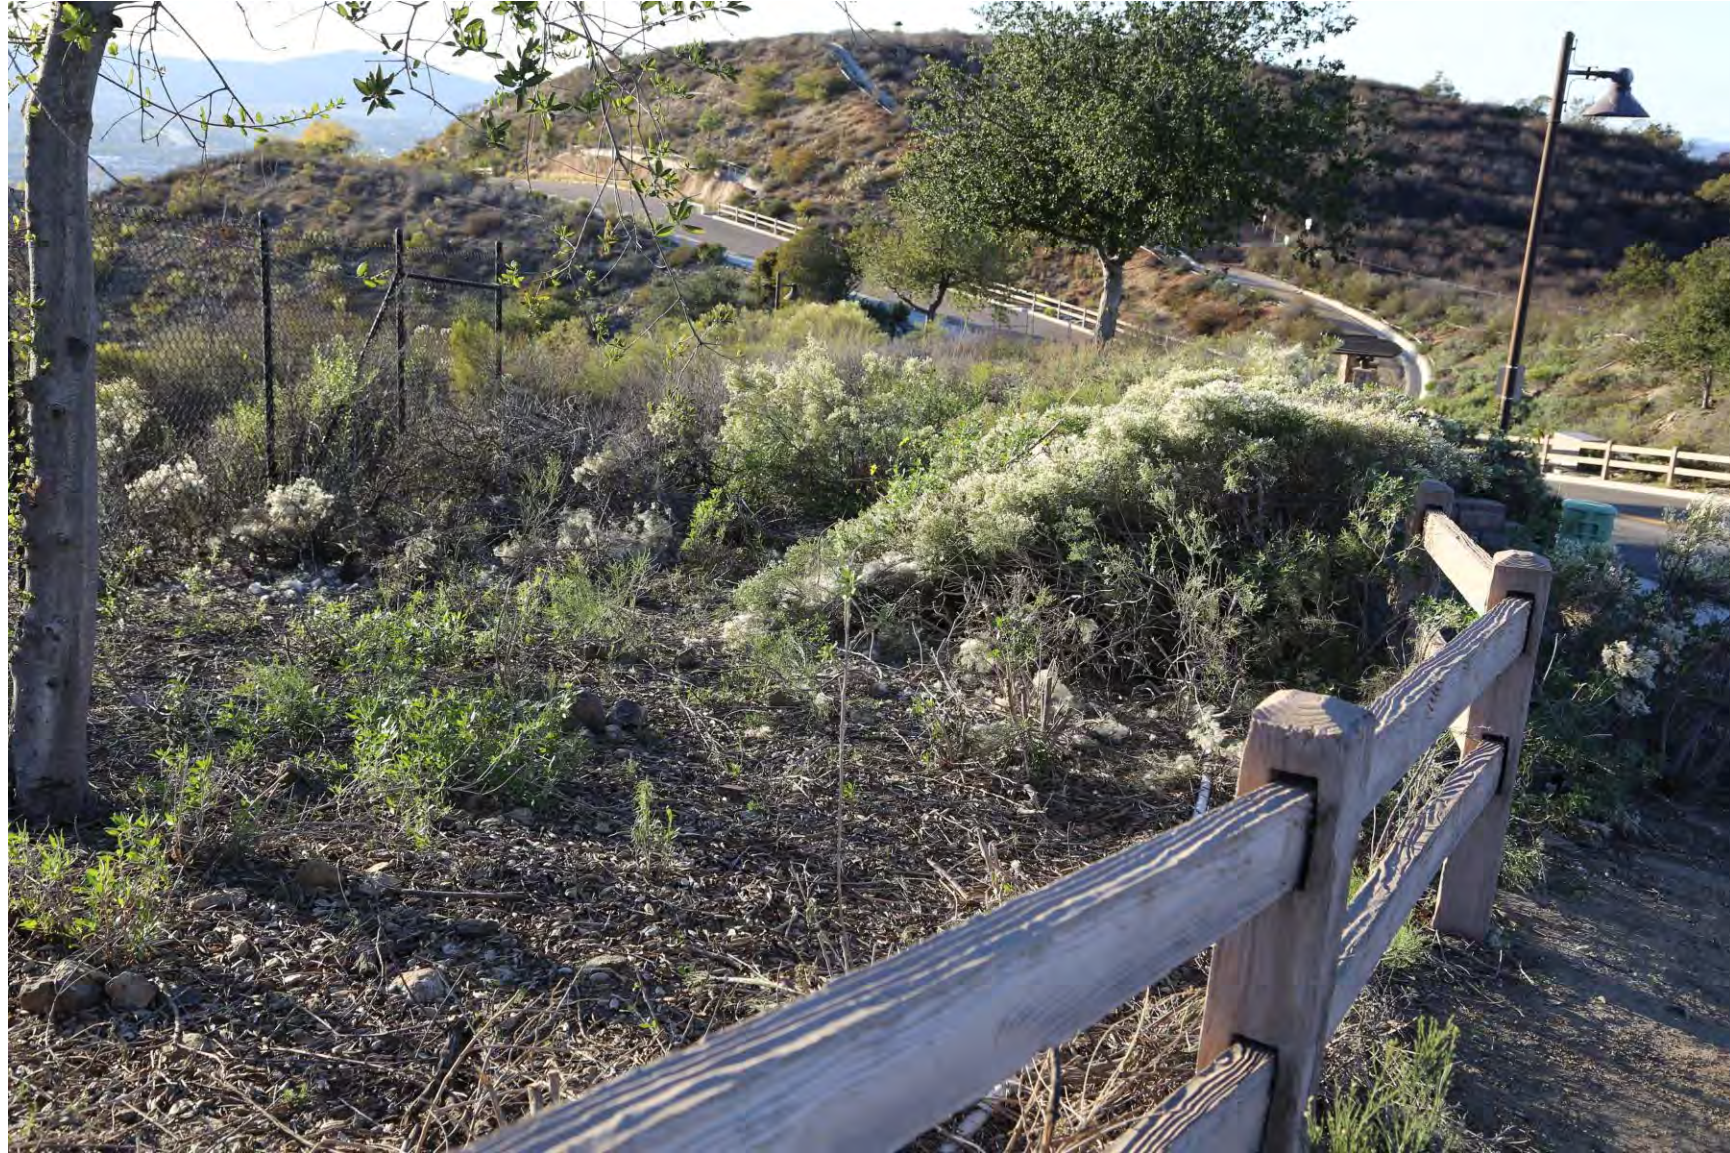
Mass of vegetation in FMZ / Next to Fire Apparatus Road.
Plants should not form masses anywhere.

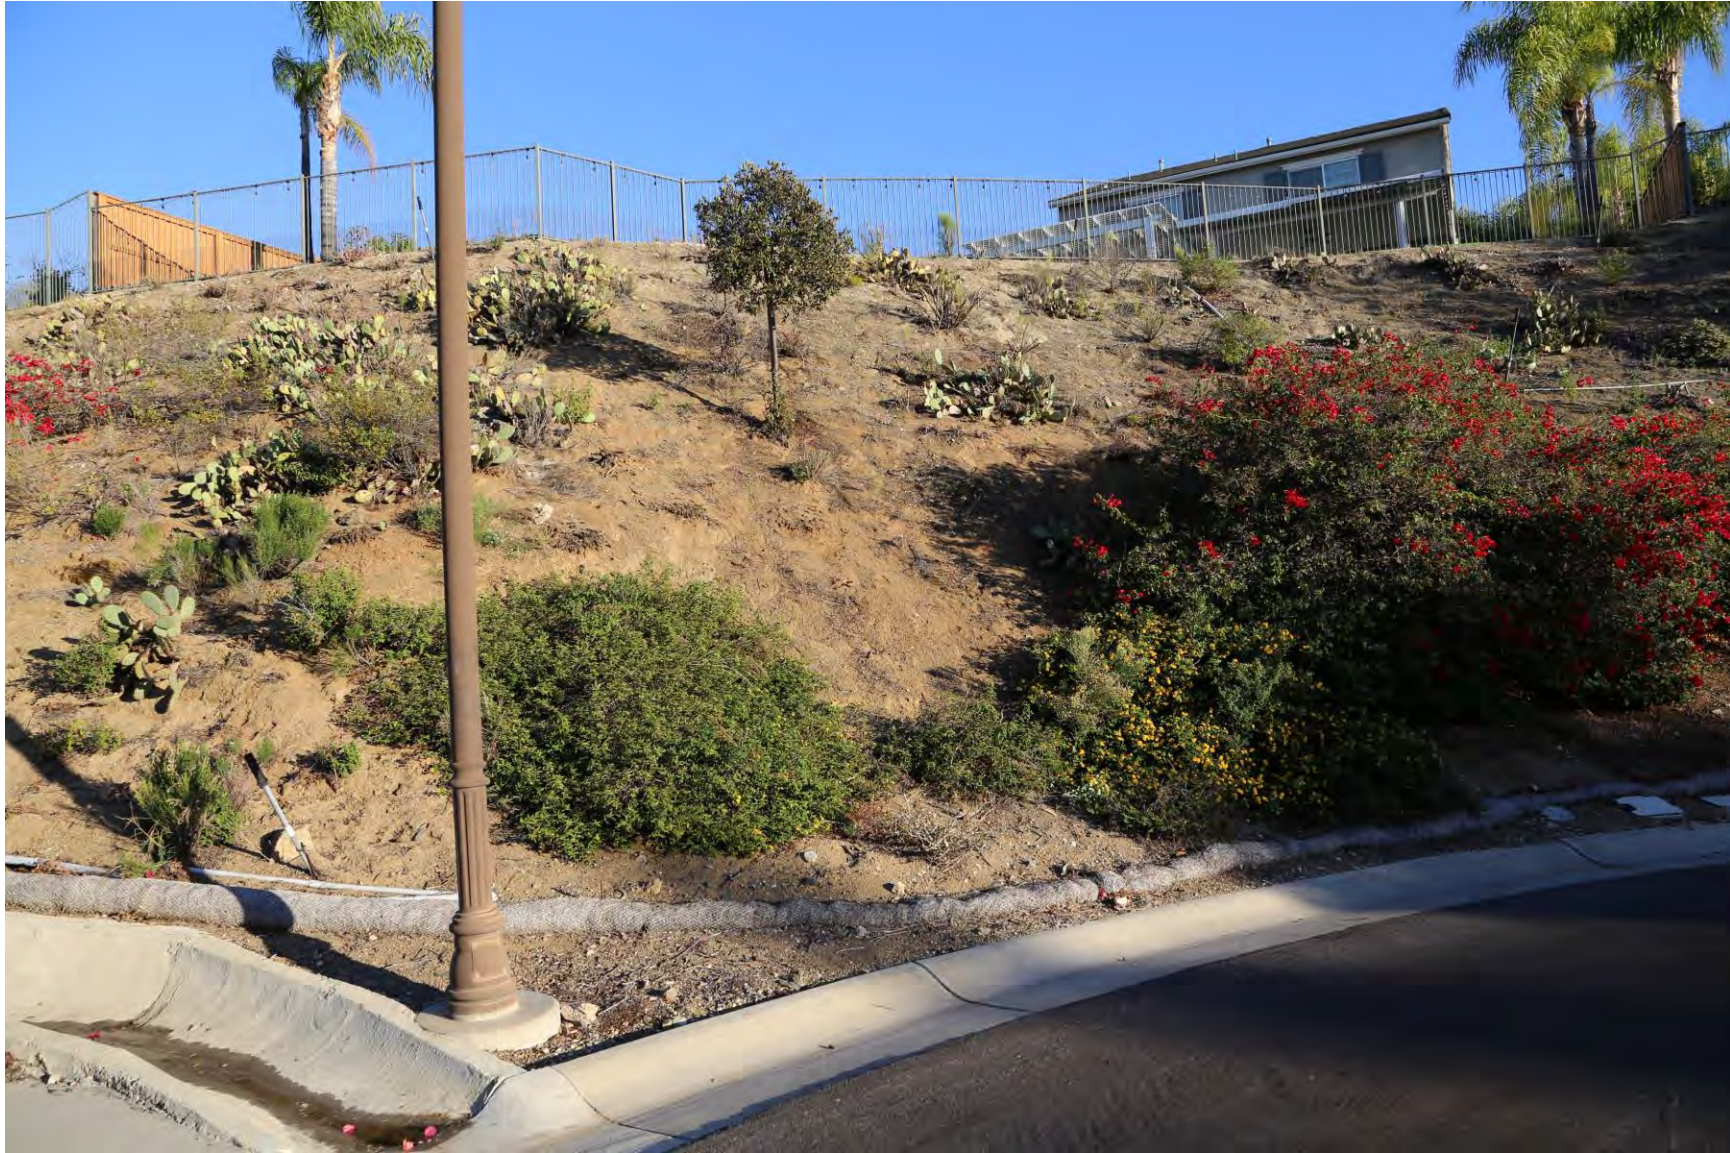
Exposed ground

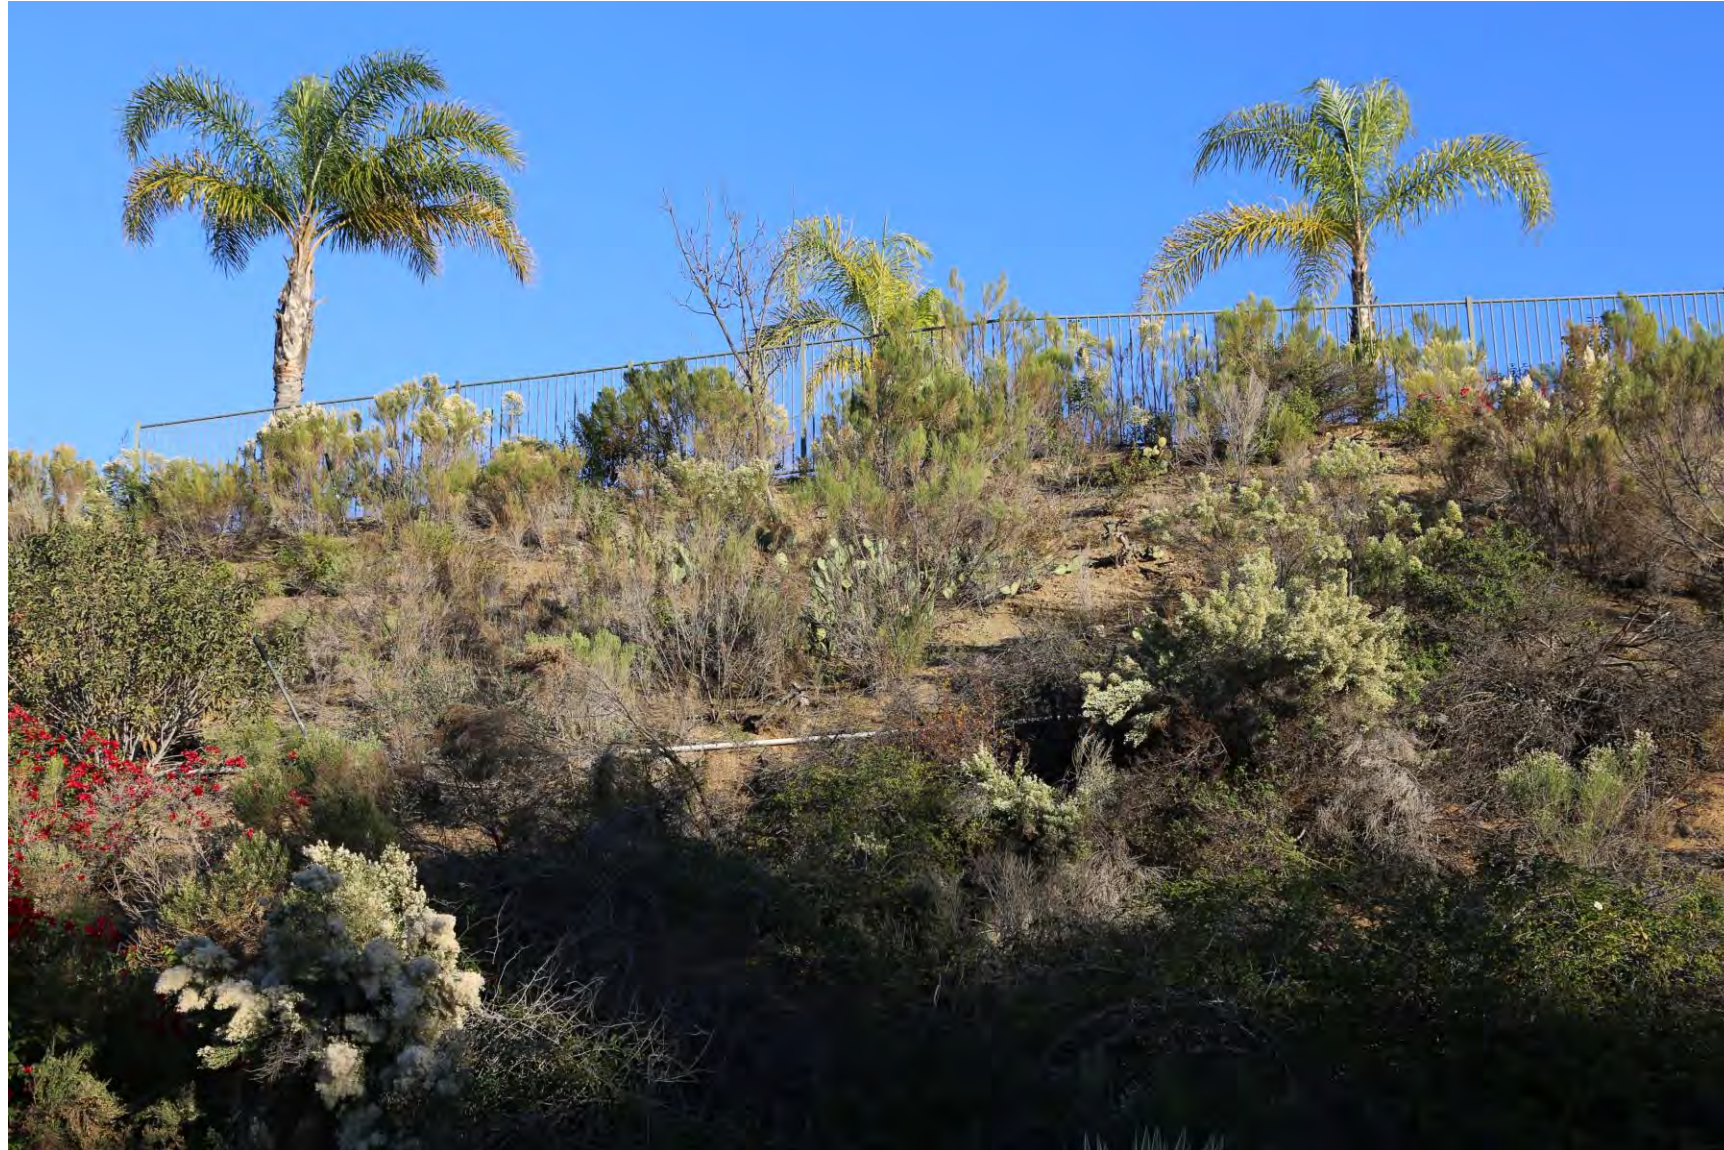
Native plants including Desert Broom have taken over; untrimmed; massed together; fence not cleared 18"

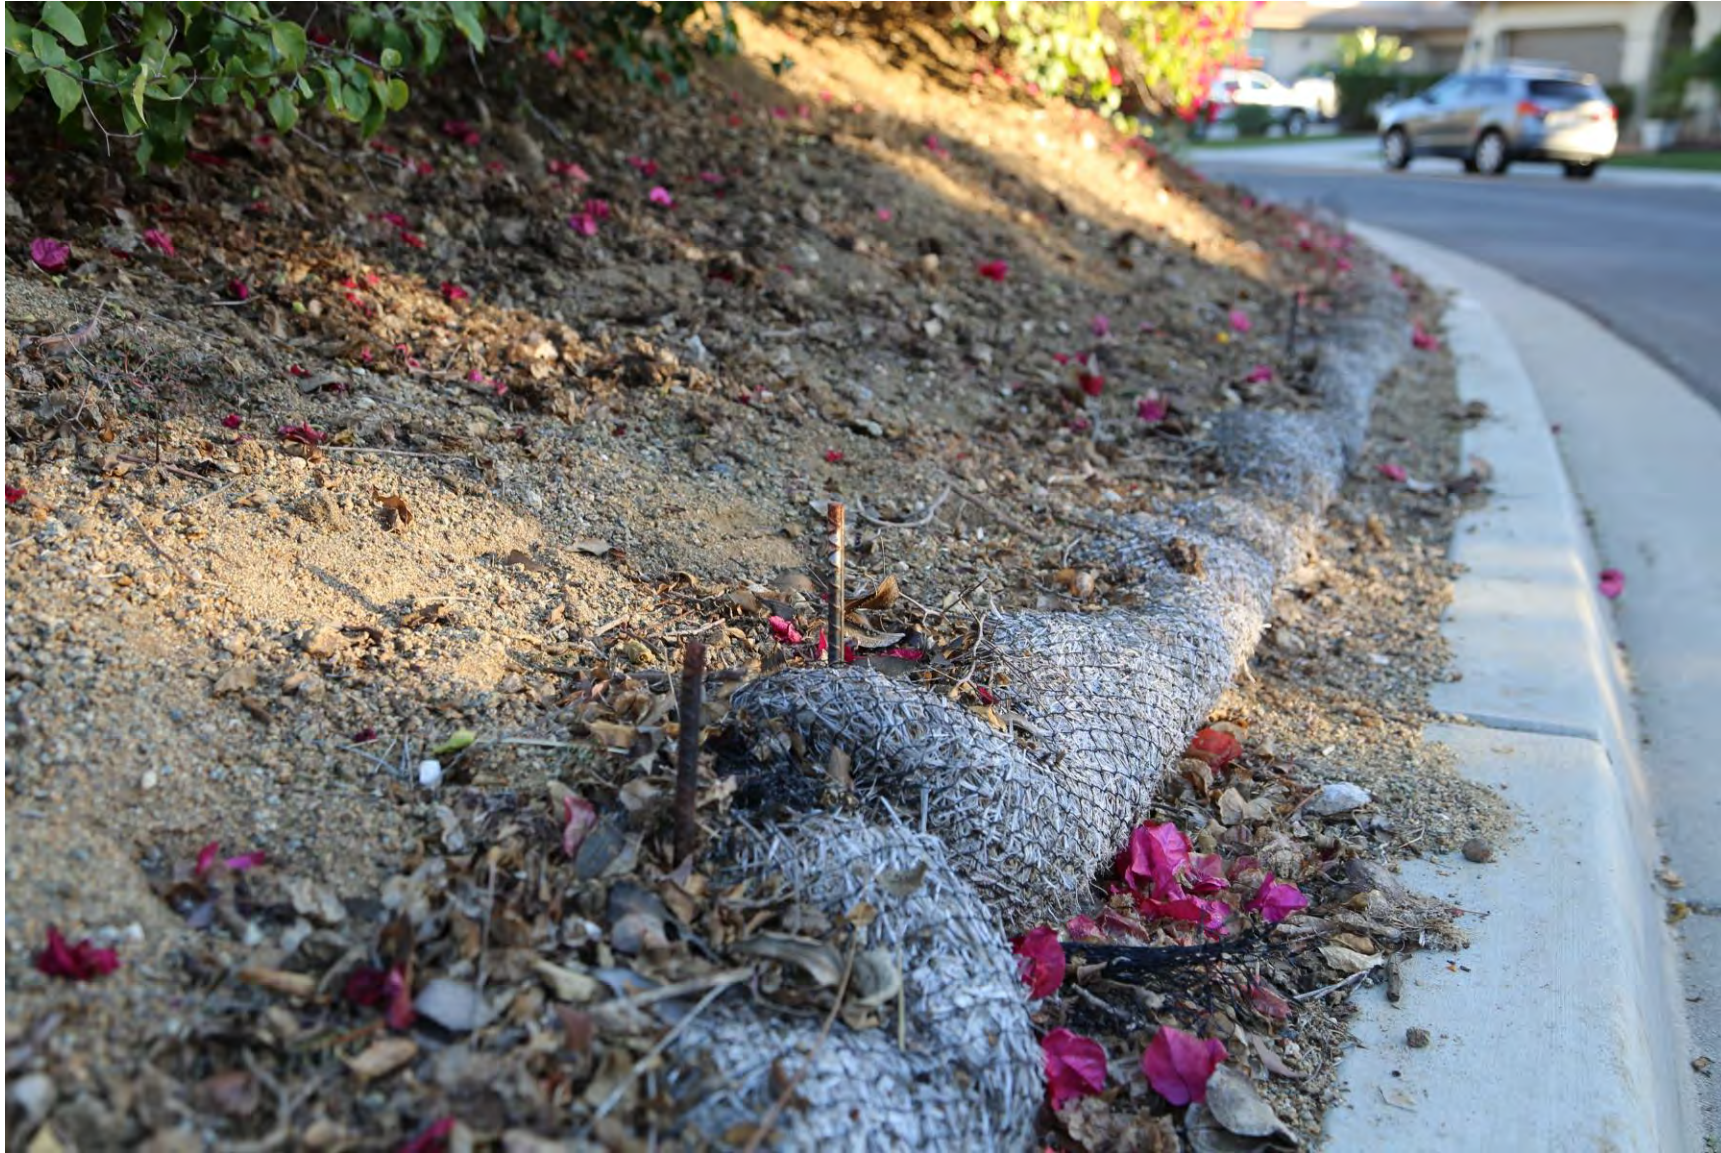
Rebar is protruding from straw wattle in many parts of the community
Erosion
