NOTICE TO COMPLY

RE: Sky Ranch
Sevilla at Graves

STORM WATER TCBMP INSPECTION: 9/21/2021

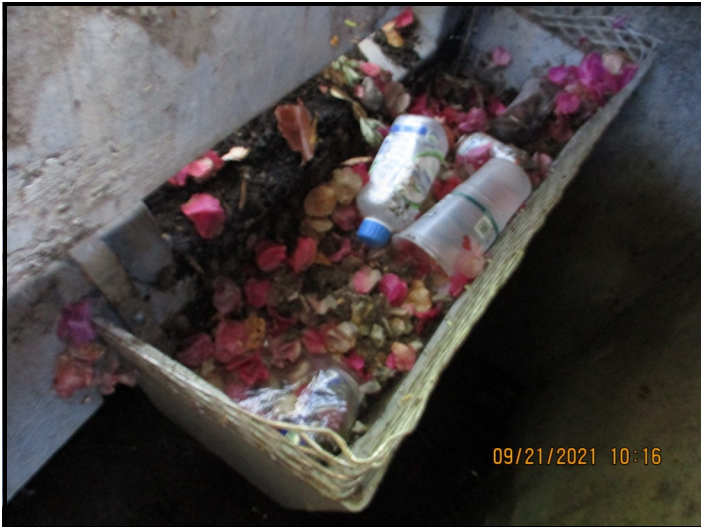
1

This letter is to notify you that the City of Santee has identified violations of the Santee Municipal Code at the above referenced property. On 9/21/2021, City staff conducted a Storm Water Inspection of the structural Best Management Practices (BMPs) and general operational BMPs. Staff observed that that several Inlet Filters and one CDS unit are DEFFICIENT (see enclosed photos).

1. Remove accumulated leaf debris from inlet filters located at (32.83714925649797, -116.9598012829365), (32.835200267687796, -116.96021074208409), and (32.836191834454965, -116.96074081640315)
2. Clean out Sump for CDS unit located at (32.83369354117673, -116.95423898651701).

Photos #1-3: Remove accumulated leaf debris and trash from filter inserts.
